Disaster in Rudraprayag District of Uttarakhand Himalaya: A Special Emphasis on Geomorphic Changes and Slope Instability

Abstract

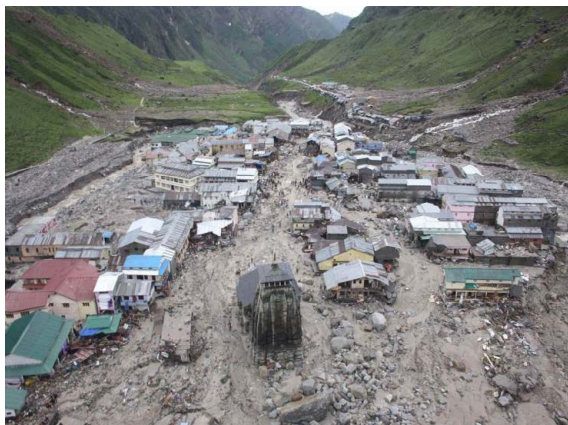
Downstream side to Kedarnath, Rambara town was washed off together with pedestrian trek. Besides, Gaurikund, Sonprayag, Sitapur, Barasu, Khat, Semi, Gaundar, Jal Talla, Kalimath, Kunj, Taljaman,

Figure 3: View of Kedarnath after the disaster of 16-17 June 2013.

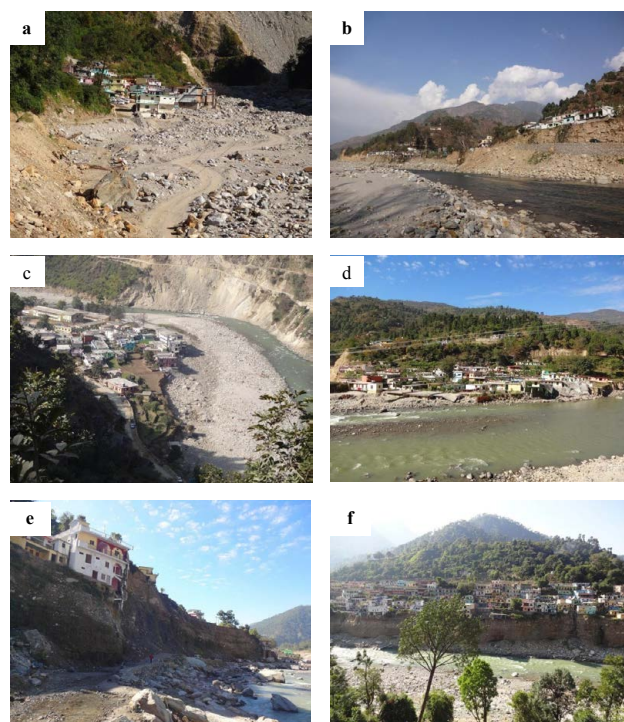
around Sonprayag, Chandrapuri, Tilaknagar, Ganganagar, Vijaynagar and Tilwara towns along the course of Mandakini river (Figure 4). These observations related to change and deposition are summarized in Table 1.

Figure 4: Deluge of June, 2013 events caused devastation in these towns; (a) Sonprayag, (b) Chandrapuri (c) Tilaknagar, (d) Ganganagar, (e) Vijaynagar, (f) Tilwara. All these towns situated over river borne materials (RBM) terraces along the banks of Mandakini river.

Most devastation has taken place on the river borne material terraces, particularly around Sonprayag, Chandrapuri, Tilaknagar, Ganganagar, Vijaynagar and Tilwara towns along the course of Mandakini river. It is therefore that some portions of these towns required to be relocated.

It is highly recommended that all the constructions in the townships located along the Mandakini river should maintain respectable distance from recent high flood level (HFL). Appropriately designed awareness drive is highly recommended for persuading people to maintain a respectable distance from streams and rivers when deciding to settle down. As a rule of thumb, message has to be sent across that the structures should be sited 50 to 100 meters from river bank. These however depend on the specific site conditions.

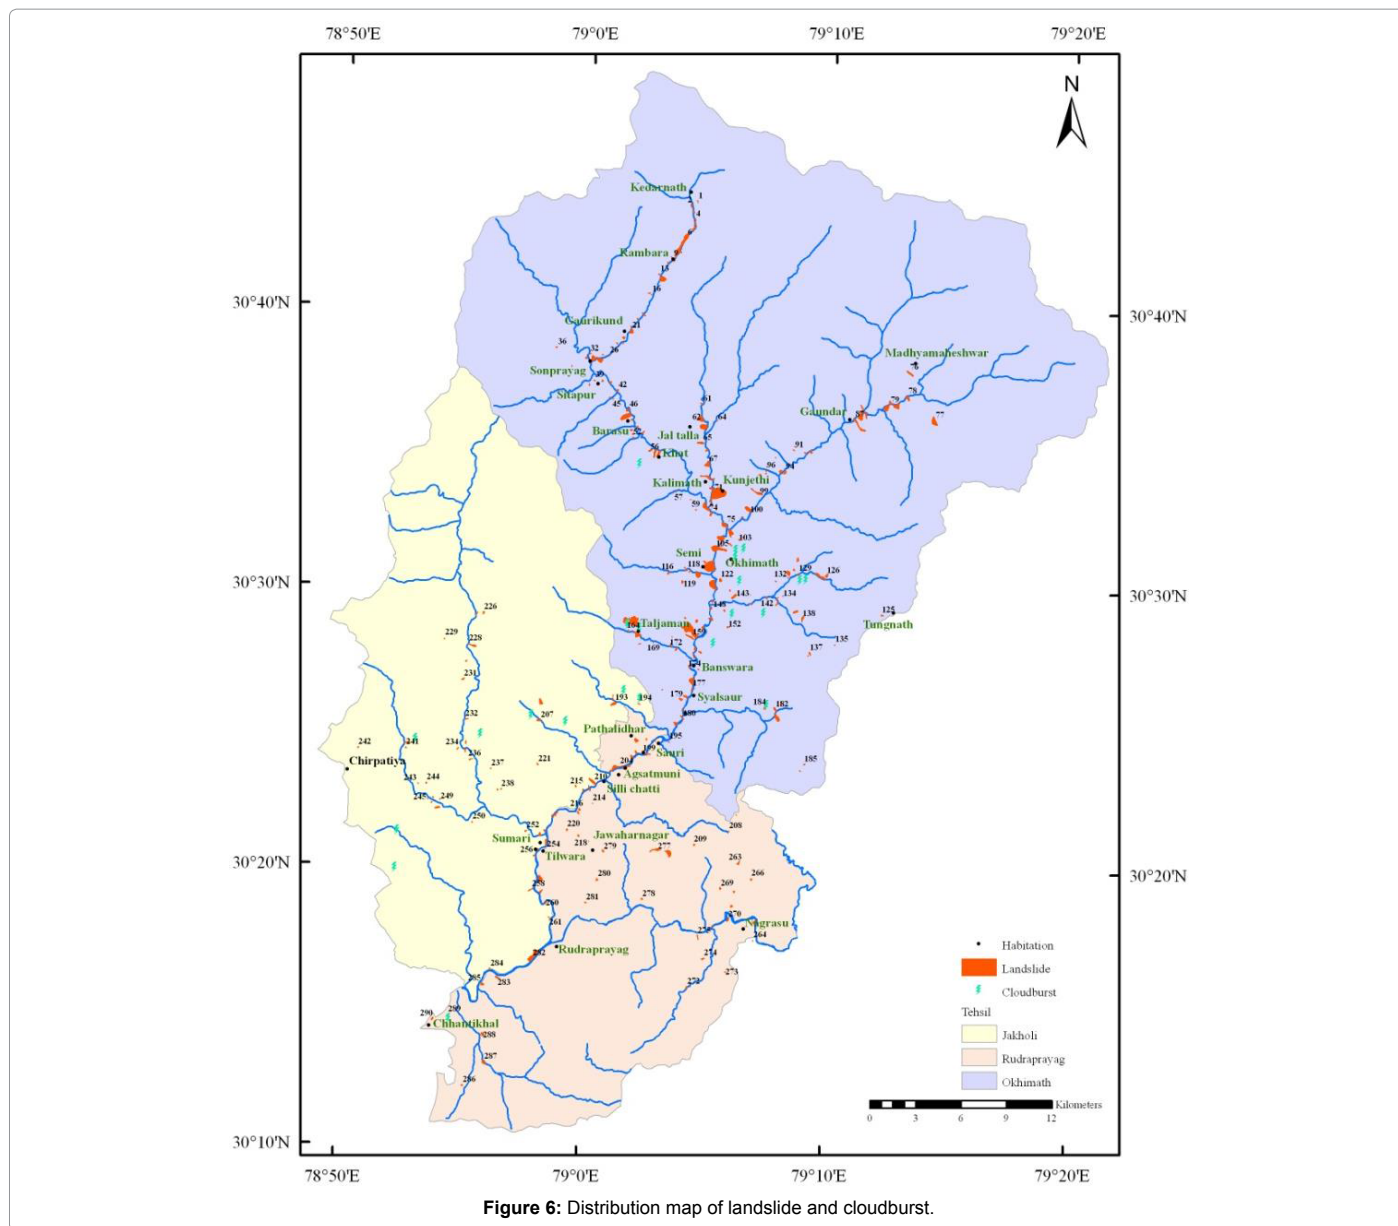
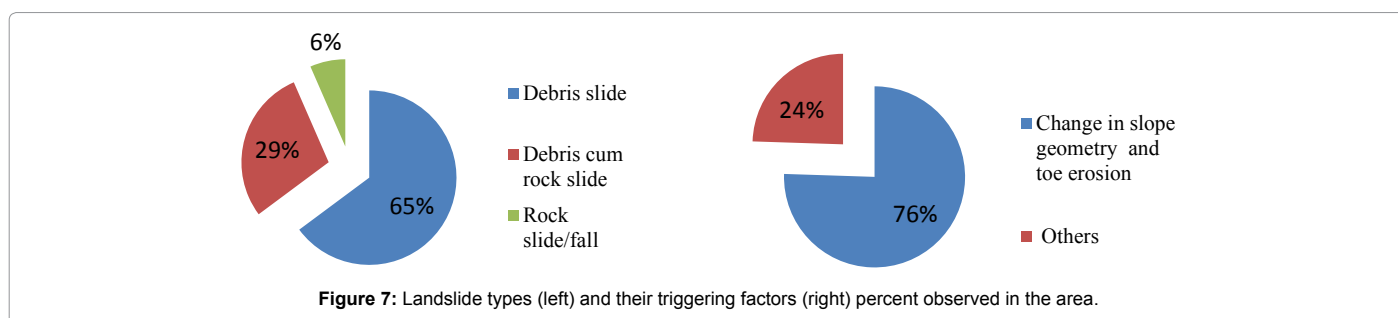
Analysis to data pertaining to the landslide observed in the field shows that the majority (65 percent) falls in the category of debris slide (Figure 7). This makes it amply clear that the overburden or debris material was saturated by prolonged heavy rainfall and the same was the responsible for the initiation of landslides.

Out of total landslide incidences recorded in entire district, 219 numbers are caused by change in slope geometry for infrastructural developments and toe erosion by stream. Another 71 numbers are however also caused by other factors that include heavy rainfall, lithological and structural condition of the bed rocks, surface and sub-surface water and deforestation. Majority of landslide incidences in this area largely (76 percent) are observed to be triggered either by change in slope geometry or toe erosion (Figure 7).
