Integrated Geophysical and Packer Test for the Water Tightness Evaluation of Gullele Botanic Garden Dam Site, Northwest of Addis Ababa, Ethiopia

Moges B^{1*}, Meten M² and Solomon H³

ABSTRACT

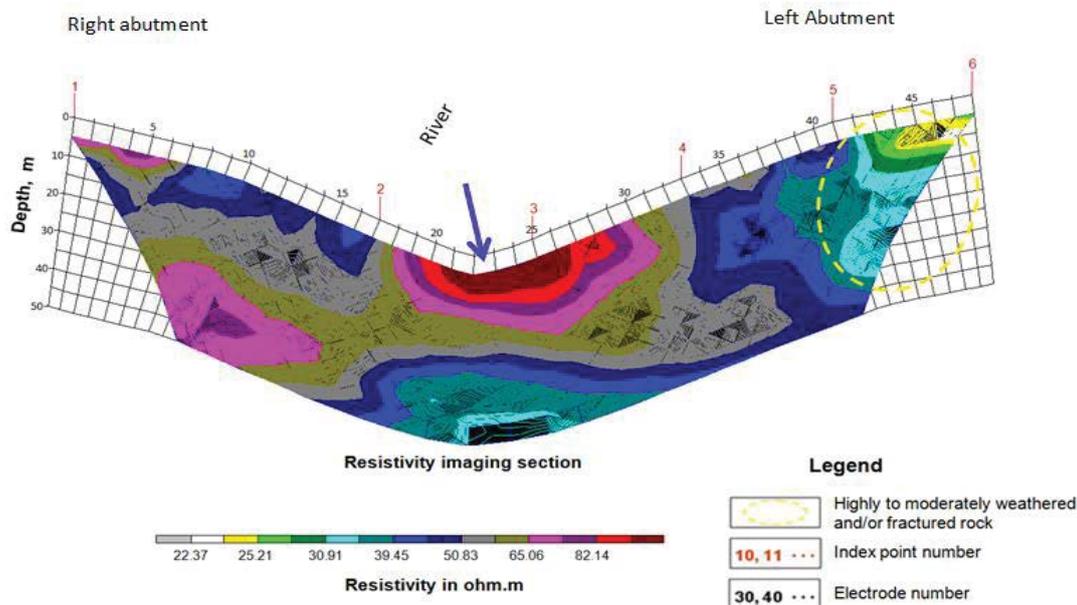
From the resistivity imaging section, the low resistivity values are reflected at the sub part marked with elliptical block between electrode number 40 and 48, which is considered the response of highly to moderately weathered ignimbrite. As shown on the resistivity imaging section, the high resistivity values are reflected at the upper part between electrode number 19 and 30 located at and around the river, and it is interpreted to be the response of moderately fractured ignimbrites. The resistivity responses ranging from about 36 $\Omega\cdot m$ to less than 55 $\Omega\cdot m$ reflected below this upper part with the relatively high resistivity values may be due to the existence of ground water in the inside of moderately fractured ignimbrite. In the other case, the resistivity responses ranging from about 39 $\Omega\cdot m$ to less than 55 $\Omega\cdot m$ reflected at the blocks between electrode number 1 and 18 located at the right side as well as between electrode number 31 and 40 located at the left side may be due to the moderately weathered and fractured ignimbrite. Analyzing the resistivity imaging section with VES survey data (VES1 and VES3), it is estimated that the thickness of

Figure 3: Resistivity imaging section along survey line ERI-1 (along of dam axis).

this ignimbrite is about 10 m around electrode number 16 located at the right side and less than 25 m around electrode number 35 located at the left side. There may be the moderately fractured ignimbrite below this ignimbrite. From the borehole and surface geological data it is confirmed that at the center of this survey line or at the river, it is covered by relatively massive and less fractured ignimbrite rock unit. However, with the fractured are intensive and saturated by water that why it shows low resistivity value.

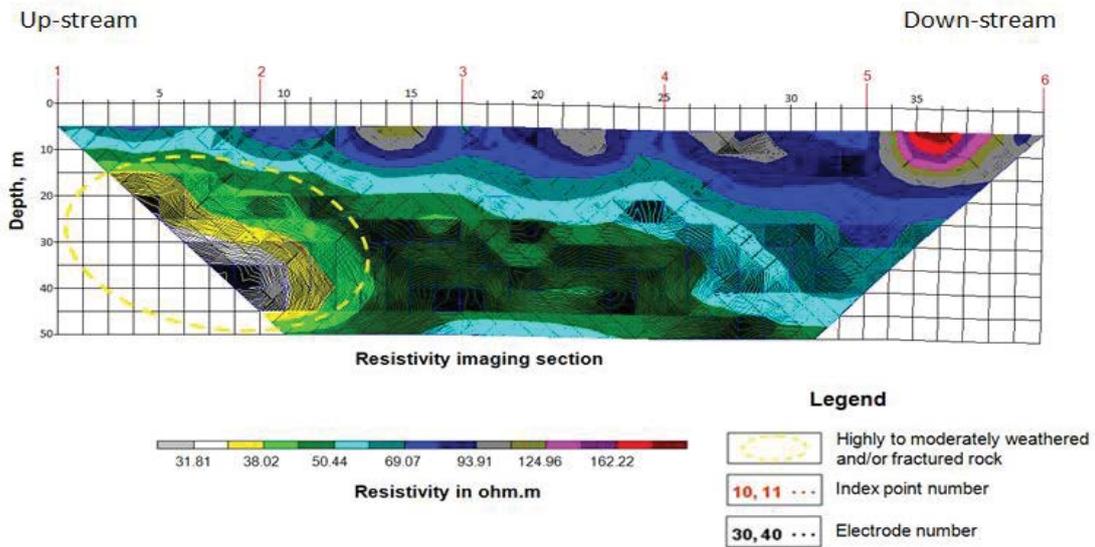
On the resistivity imaging section, the low resistivity values less than $43 \Omega\cdot\text{m}$ reflected at the sub part marked with elliptical block between electrode number 1 and 14 may be due to the highly to moderately weathered and fractured bedrock. The relatively high resistivity values observed at the upper part between electrode number 14 and 40 on the section may be because of the moderately fractured ignimbrite. The resistivity responses ranging from about $42 \Omega\cdot\text{m}$ to less than $55 \Omega\cdot\text{m}$ reflected below this upper part with the relatively high resistivity values may be due to the existence of ground water in the inside of moderately fractured ignimbrite.

Figure 4: Resistivity imaging section along survey line ERI_2 (ECDSWC, 2017).

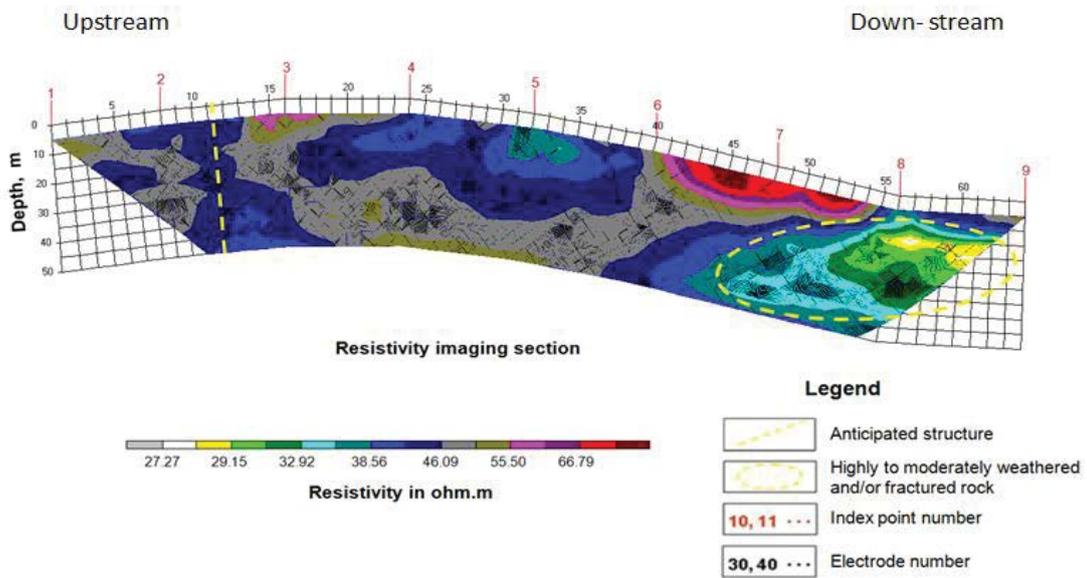
According to the resistivity imaging section, it is expected that there is geological structure around electrode number 11. Moreover, low resistivity zone with values less than $35 \Omega\cdot\text{m}$ reflected at the sub part marked with elliptical block between electrode number 45 and 64 is considered to be highly weathered and fractured ignimbrite. Particularly, the resistivity responses ranging from about $34 \Omega\cdot\text{m}$ to less than $46 \Omega\cdot\text{m}$ reflected at the block between electrode number 17 and 39 may be due to the moderately weathered and fractured ignimbrite.

Figure 5: Resistivity imaging section along survey line ERI_3 (ECDSWC, 2017).

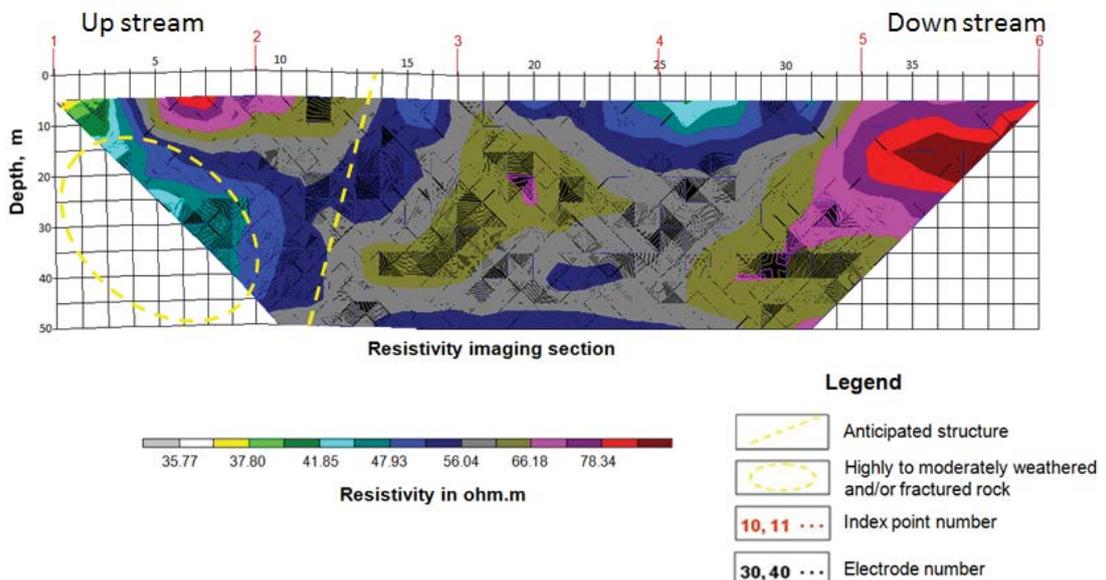
According to the resistivity imaging section on the ERI4, the relatively low resistivity values ($35 \Omega\cdot\text{m} \sim 48 \Omega\cdot\text{m}$) are reflected at the sub section marked with elliptical block between electrode number 1 and 9 located at the upstream of propose dam, which is considered to be the response of highly to moderately weathered and fractured bedrock. It is also considered that there may be geological structure around electrode number 14. On the resistivity imaging section, the resistivity responses ranging from about $40 \Omega\cdot\text{m}$ to less than $57 \Omega\cdot\text{m}$ reflected at the block between electrode number 19 and 32 may be because of the moderately weathered and fractured ignimbrite.

Figure 6: Resistivity imaging section along survey line ERI_4 (ECDSWC, 2017).

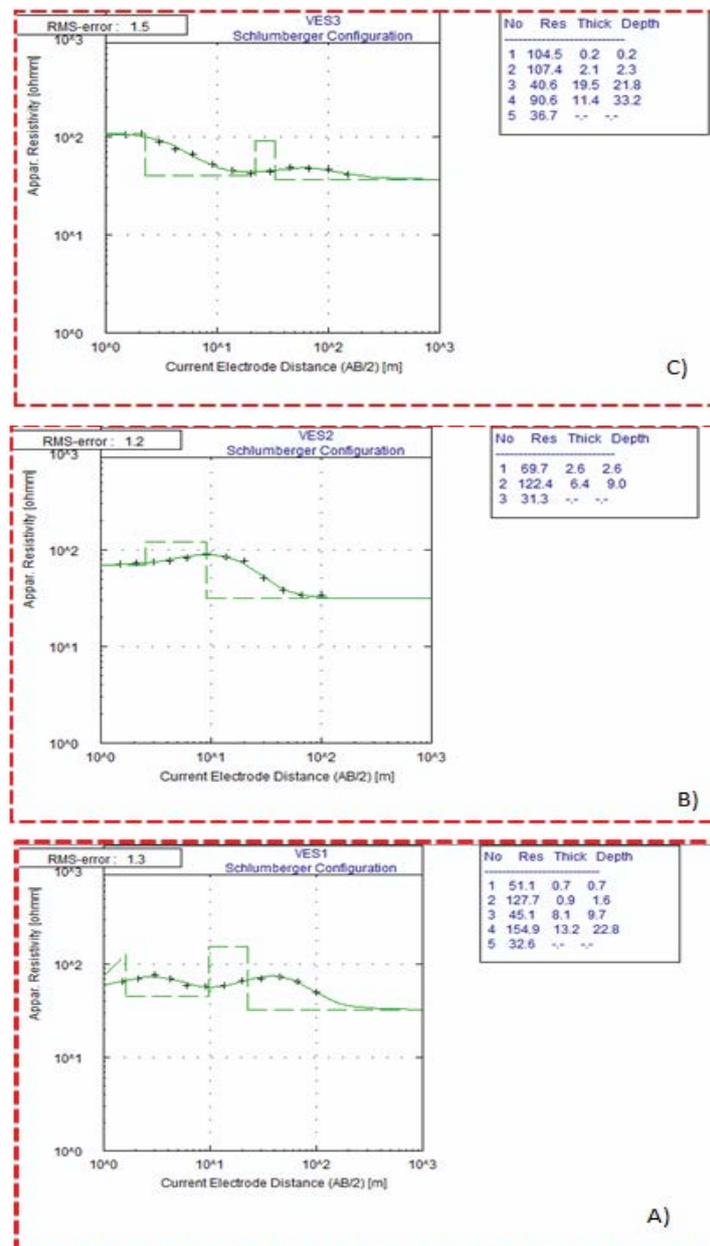
In order to determine the depth of bedrock for the proposed dam, VES survey (VES1, VES2 and VES3) were conducted in the survey line shown from right abutment, riverbed and left abutment of the proposed. The model and the description of those VES point are shown in the following Figure 7 and Table 2.

Figure 7: Model used the interpretation with vertical electrical sounding data (A), shows the model from VES_1, (B) shows the model from VES_2 and (C), shows the VES model from VES_3.

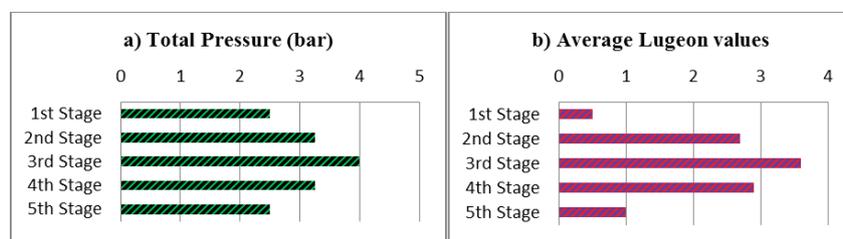
water pressure applied is greater than the minimum principal stress of the rock mass, thus causing a temporary dilatancy (hydro jacking) of the fissures within the rock mass. Dilatancy causes an increase in the cross sectional area available for water to flow, and there by increases the hydraulic conductivity. In this type of flow behavior the representative Lugeon value is the average of the 1st, 2nd, 4th and 5th stages. The following figures shows the dilation behavior of the left abutment in the proposed BH-3 in the test section between 15 m and 20 m (Figure 8).

Figure 8: The dilation behavior from borehole three (test section 15 to 20 m), (a) the packer test pressures the test stage, (b) The average Lugeon values vs. test stages.

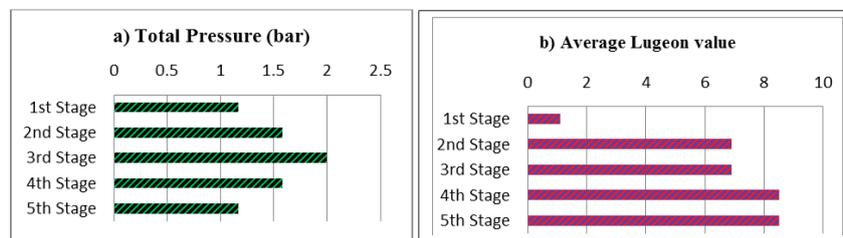
The other packer test results in the left abutment from borehole three in the test section between 6 m to 9 m and from borehole six in the test section between 13 m to 20 m showed wash out behavior. According to Houlsby [12], wash out behavior is characterized by progressive increment of Lugeon values in the five stage tests without any return to the pre-peak pressure values after the peak value has passed. This type of flow behavior indicates that permanent washing-out of joint filling materials or permanent rock movements by the test. From the core sample, there are some soft filling materials inside fractures. The wash out of this

materials give the flow behavior, which continuously increase the Lugeon values from the first stage to the last stage. For these types of behavior, the representative Lugeon value is the last (5th stage). From the results, the wash out behavior is the most dangerous phenomenon in a certain dam site because the wash out of infilling materials will result the development of an open fracture that cause seepage problem. Therefore, site with this types of behavior need appropriate mitigation measure, must be taken during the construction of the dam. The following Figure 9, shows the wash out flow behavior from borehole three in the test section of 6 m to 10 m.

Figure 9: The above chart show the wash out behavior from borehole three in the test section 6m to 10m, (a) the packer test pressures Vs. the test stage, (b) The average Lugeon values Vs. test stages, this graph shows the behavior of the flow is Wash-out, and the representative Lugeon values is values corresponding to the 5th stage.

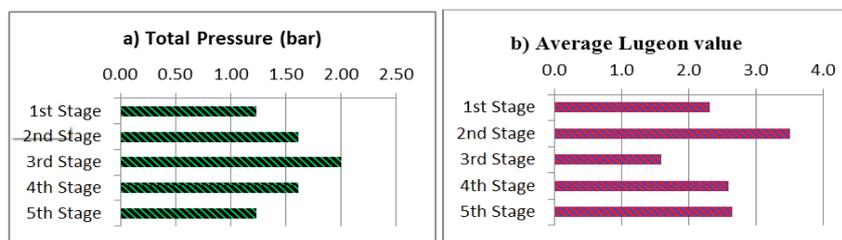
The other result from packer test investigation in the left abutment from borehole five in the test section between 7 m and 10 m showed turbulent type of flow behavior. According to Houlby [12], this type of behavior is characterized by a decrease in hydraulic conductivity of the rock mass as the water pressure increases. This behavior is characteristic of rock masses exhibiting partly open to moderately wide cracks. When these types of behavior observed during the investigation the representative Lugeon values is a value corresponding to the 3rd stage. Figure 10 shows turbulent flow behavior from borehole five in the test section between 7 m and 10 m. This shows that the application of high pressure results in low Lugeon values. The packer test investigation in the left abutment

Figure 10: The above chart shows turbulent flow behavior from borehole five, (a) the packer test pressures the test stage, (b) the average Lugeon values Vs test stages.

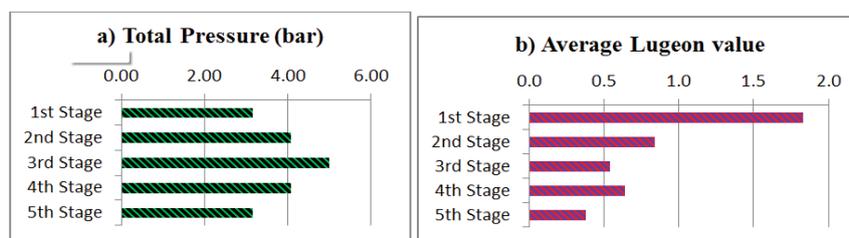
also showed the void filling behavior of borehole five in the test section ranges between 20 m to 25 m and 25 m to 30 m and from borehole six in the test depth range between 4.5 m to 10.3 m. Void filling behavior is characterized by a decrease in the hydraulic conductivity as the test proceeds regardless of the changes in the water pressure. According to Houlby [12] this behavior indicates that either, water progressively fills isolated/non-persistent discontinuities or swelling occurs in the discontinuities, or fines flow slowly into the discontinuities building up a cake layer that blocks them. From core sample, the soft filling materials were observed. Therefore, during the packer test, these materials are filling the fractures and the permeability of the rock mass decreases as the test proceeds from the first stage to the fifth stage. For this type of flow behavior, the representative Lugeon values are value corresponding to the 5th stage. The following Figure 10, shows void filling behavior from borehole five in the test section from 20 m to 25 m.

Figure 11: The above chart shows void filling behavior from borehole five (test section 20 to 25 m), (a) the packer test pressures the test stage. (b) The average Lugeon values Vs test stages.

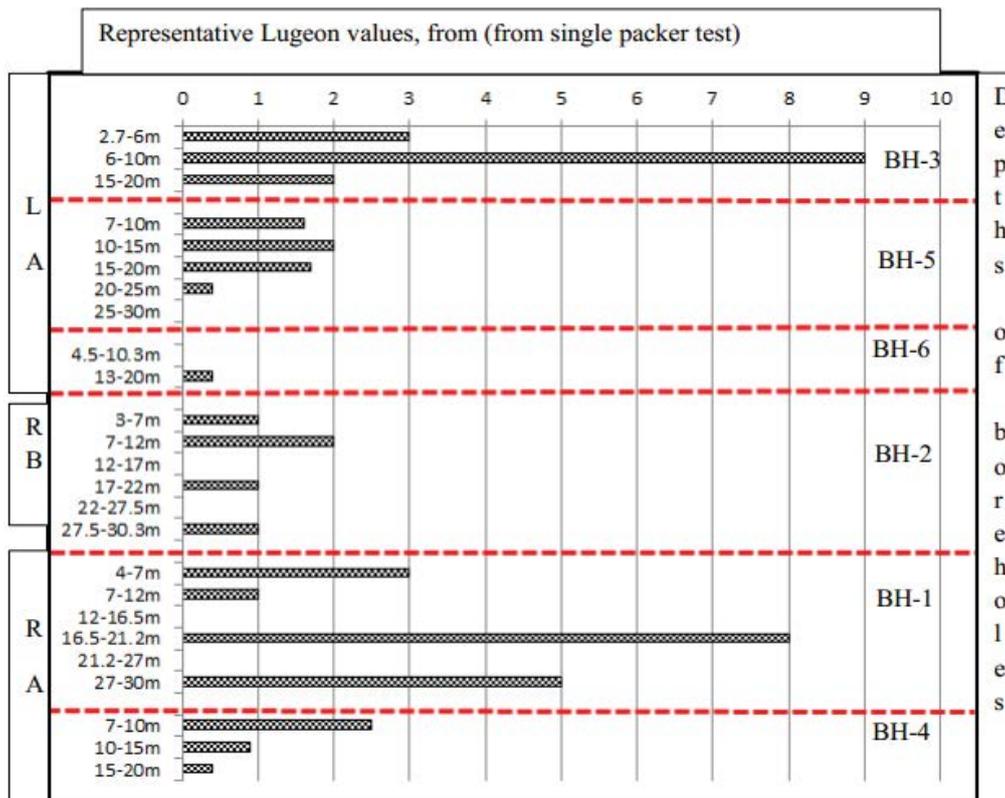
permeability the rock mass in the proposed dam site has inverse relationships i.e. when depth increases the permeability of the rock mass decreases. The permeability of rock mass at the proposed dam site ranges from 0 to 9 Lugeon values. As shown in Figure 12, the permeability of rock classified into impermeable, low permeable and permeable. From packer test result the highest permeability values of rock mass were found at borehole three (depths from 6 to 10 m) and borehole one (depths from 16.5 to 21.2 m) at the left and right abutment of the proposed dam respectively. Generally, from the packer test permeability results of the rock mass along the dam axis of GBG dam site (A), dilation, turbulent, void filling and wash out behaviors were observed. Among these behaviors, the most problematic one is washing out behavior that was investigated in the left abutment. The wash out behavior at the left abutment has 9 Lugeon value from borehole three and 0.4 Lugeon value from borehole six. Even if the permeability corresponding to this behavior is less since the filling materials are washed, the fracture will remain open and it will be the pathway for seepage. The other maximum permeability of rock mass, which was investigated in the right abutment close to the river bed, from borehole one in a depth range between 16.5 to 21.2 m is 8 Lugeon value. From the surface geological map at this location, vertical fractures are observed, as the same time from borehole sample the fractures are investigated. Since this borehole is close to the river, the existence of fracture will be the potential zone for seepage through the foundation of the proposed dam. The high permeability results from packer tests in the left abutment of the proposed dam and through the foundation along the river bed showed the presence of potential seepage problem. Hence, the foundation and the left abutment of the proposed dam need ground improvement before the construction of the dam. As the result obtained from the packer test investigation, the foundation and the left abutment of the proposed dam need ground improvement before the construction of the dam. The most appropriate ground improvement methods to avoid the expected potential seepage, curtain grout is recommended up to the impermeable zone of the layer.

Figure 12: The relationship between rock mass permeability and depth, from proposed GBG dam site (dam A), where the abbreviation from the above figure are LA-left abutment, RB- river bed, RA-right abutment and BH-borehole.

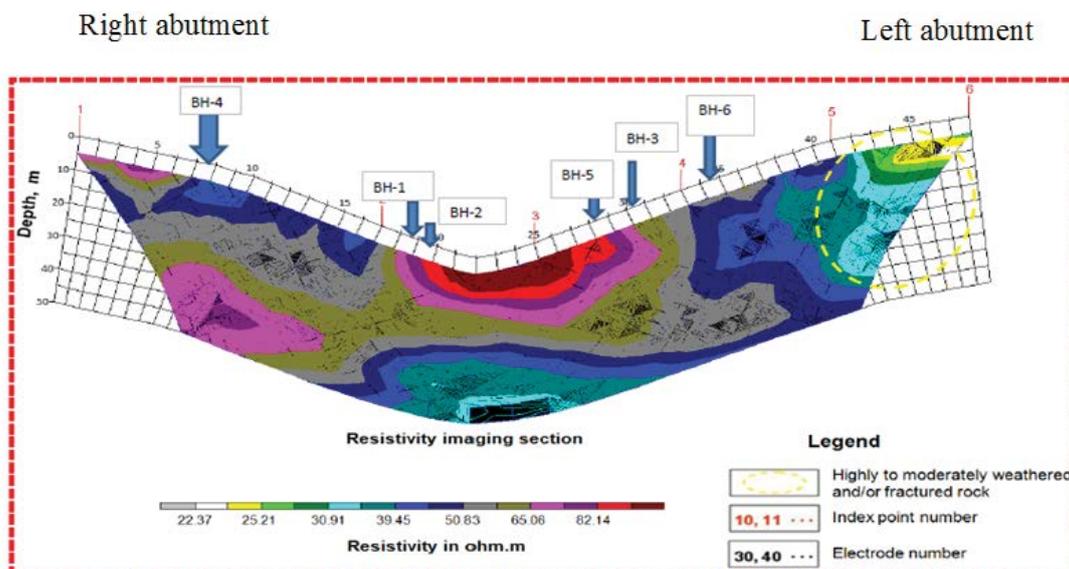
the geophysical investigation result the above located borehole give the representative information of the dam site. The general stratigraphy of the area from the bore whole data shows the top most 1 to 3 m depth covered by the residual soil relatively stiff and has rock fragments on it. Below this, it consists of ignimbrite rock unit with different degree of weathering and fractures. From the six boreholes the RQD values increase with depth and this indicates the degree of weathering is relatively decreased from the surface to depth. The relation between the resistivity, RQD and Lugeon values (Permeability of the rock mas are shown in Figures 13 and 14. The figures show the integrated result of VES, RQD and permeability of rock mass at right abutment of the proposed dam. Along this section the resistivity values at the top shows low values due to the presence of residual soil and highly weathered fractured ignimbrite, and the RQD also very low, from 7 to 10 m the resistivity response show relatively low value and the RQD also low, but the permeability shows relatively high. From this data the RQD and VES shows direct relation and invers relation with permeability. At the right abutment the VES, RQD and permeability values shows, the rock at the right abutment are characterized by relatively higher resistivity, high RQD and low permeability. Therefore from Figure 15 the right abutment of the proposed dam are less problematic interms of seepage.

Figure 13: The Resistivity imaging section along dam axis and the Borehole location modified from ECDSWC, 2017.

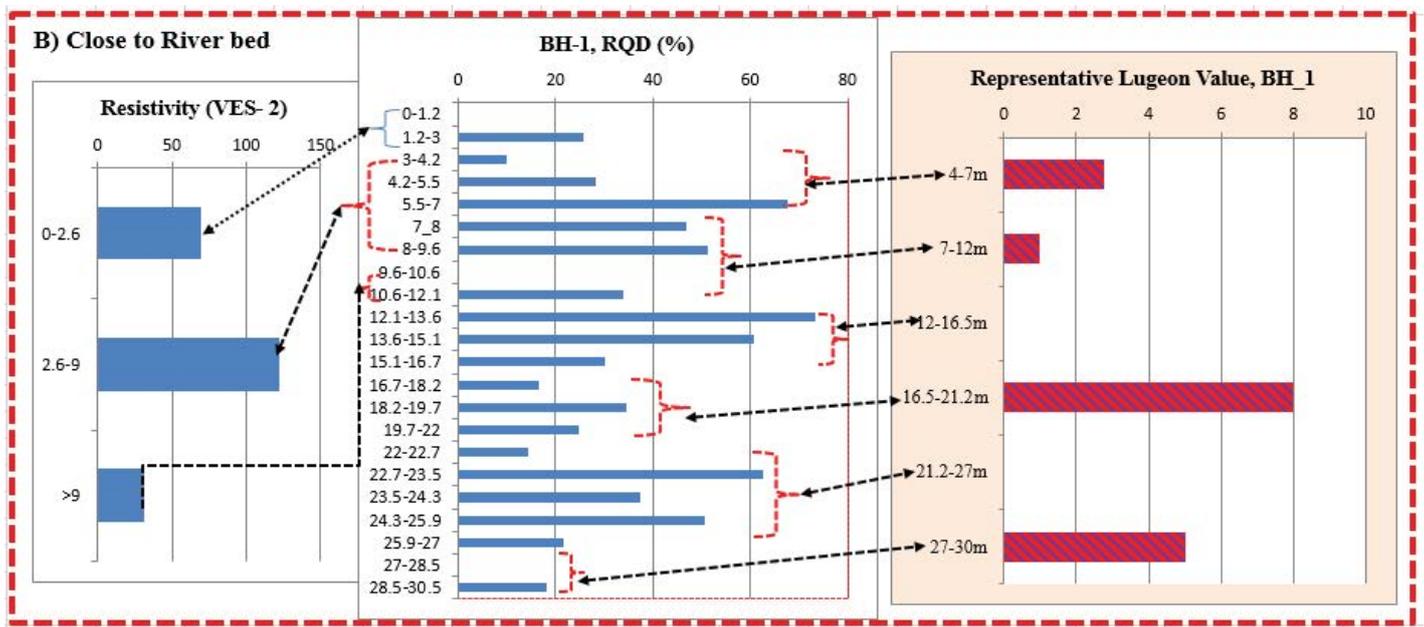
Figure 15 shows the integrated result of different investigation at the right abutment close to the riverbed. From this abutment of the proposed dam it is observed that zero RQD value at 9.6 to 10.6 m, and 27 to 28.5 m depth. When we correlate with the resistivity data shows low resistivity values below 9 m depth, the permeability at this section at the top part low permeability this indicates even if the rock are fractured the fractures are not persistence that is the reason to show low permeability. However, at the lower section both RQD and permeability shows, low RQD and high permeability, it indicates that rock are highly fractured and persistence. In the other section, the relation is RQD increase, resistivity increase, Permeability decrease. The result from this location shows relatively permeable zone at the depth of 16.5 to 21.2 m, at the same time the RQD values are less and the resistivity are low, therefore at this location the potential seepage problem will be expected.

Figure 15: The integrated result of VES, RQD and permeability of rock mass at the right abutment close to riverbed.

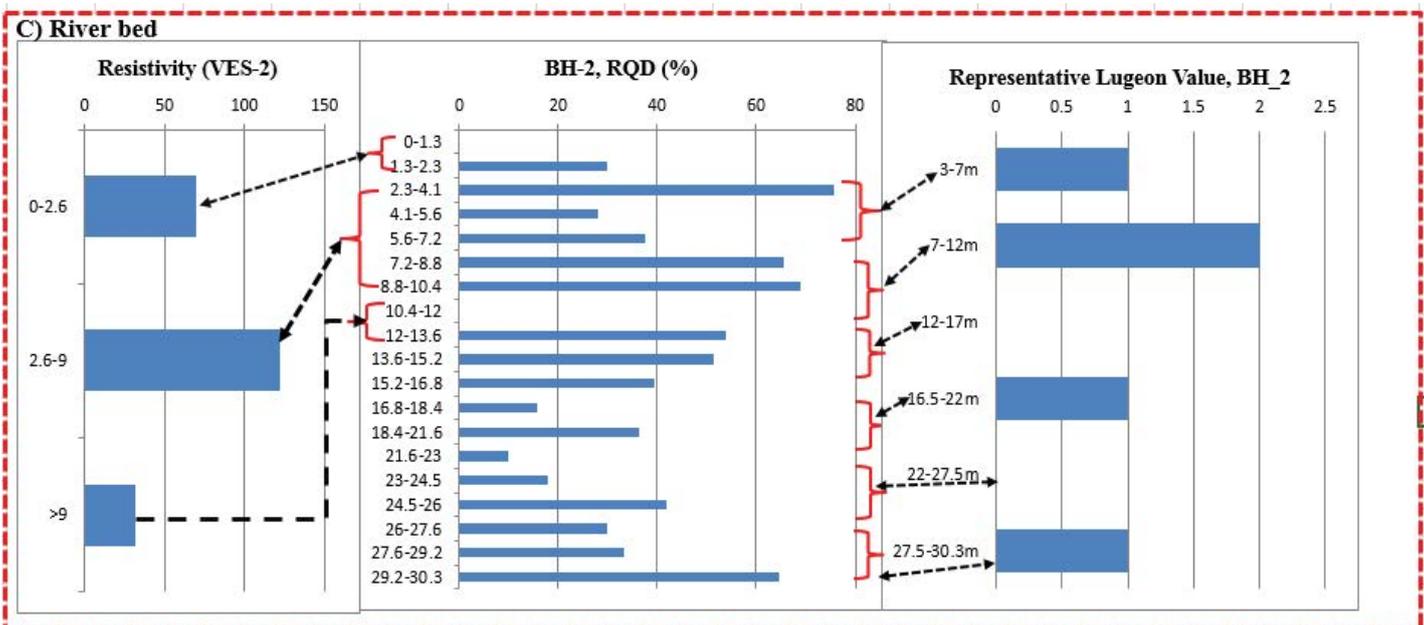
Figure 16 shows the relationship between VES, RQD and permeability of rock mass at the riverbed. The relation of resistivity, RQD and permeability at this location show that below 9 m low resistivity, and RQD ranges from 0 to 64% and the permeability is 0 to 1 Lugeon, this shows that the rock are highly fractured and but the discontinuity are not persistence, that make low permeability at this station. Figure 17 shows the relationship of VES, RQD and permeability result of rock mass at the left abutment of the proposed dam. From this section, it is interpreted that with the range of 6 to 10 m depth, the permeability values are relatively high. Corresponding to this the resistivity values also low and the RQD value s ranging between low at this depth. From the Lugeon test with the depth of 6 to 10 m it is observed that

the wash out behavior and the most problematic zone interms of seepage. Generally, the relation of the three-investigation result shows that at this location the potential seepage will happen due to the existence of fractured low resistivity, low RQD and high permeability materials.

Figure 16: The above figure shows the relationship between VES, RQD and permeability of rock mass at the riverbed.

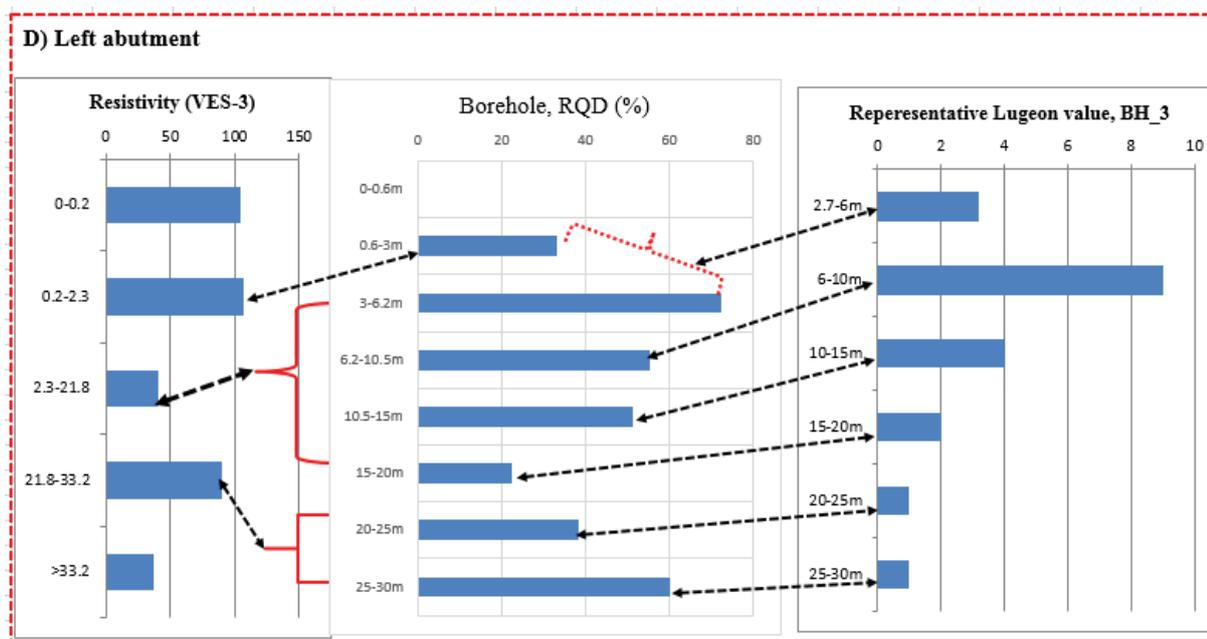
Figure 17: The relationship between VES, RQD and permeability of rock mass at left abutment of the proposed dam.

Generally, from those integrated analysis at the riverbed and left abutment of the proposed dam the potential seepage problem will happen due to the existence of fractured and weathered ignimbrite rock having low resistivity, low RQD and relatively permeable. Packer test result is the direct test for the water tightness of the rock mass in the dam site. Therefor this test shows at the left abutment the maximum permeability values observed with wash out behavior and around riverbed with dilation behavior. Therefore, from the result of the investigation, the left abutment and the riverbed of

the proposed dam site the potential seepage will happen and it need ground improvement.
