## Landslide Distribution and Damages during 2013 Deluge: A Case Study of Chamoli District, Uttarakhand

Khanduri S\*

Department of Disaster Management, Disaster Mitigation and Management Centre, Rajpur Road, Uttarakhand Secretariat, Dehradun, Uttarakhand 248001, India

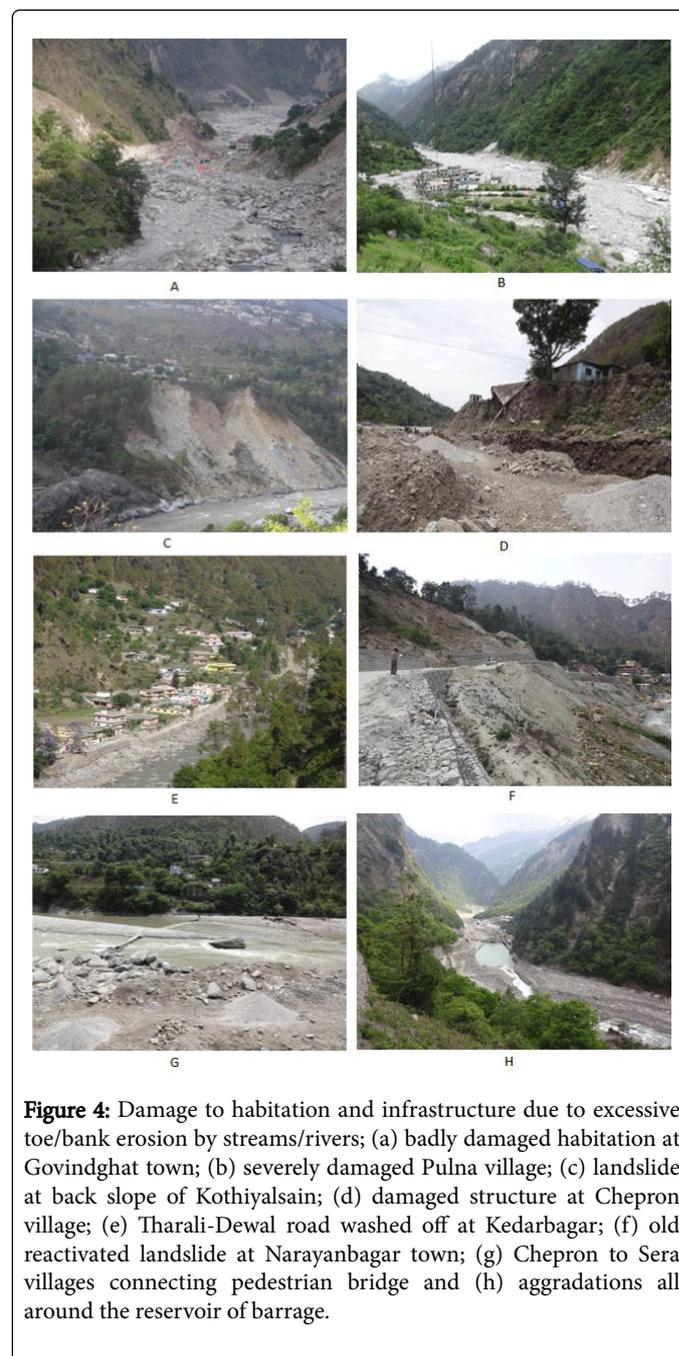
Benakuli village on the confluence of Alaknanda river and Khiro Ganga, on the national highway (NH 58) were partially damaged along with downstream side to Lambagar market area a number of shops, houses and vehicles by flash floods. In Govindghat area the Alaknanda river left more than 10 meters thick pile of sediments along right bank thus raising its level and burying 2-3 stories of the premises completely in the river debris. At the same locality, around 350 meters downstream of main Gurdwara premises, multistoried parking structure, commercial buildings and part of main approach road to Gurdwara from national highway (NH-58) were completely washed away (Figure 4a).

Govindghat-Hemkund pedestrian trek. Downstream to this, the part of the Pulna village with about 25-30 houses had been severely damaged (Figure 4b). Besides, leading route to Shri Hemkund Sahib, Holy Shrine of Sikhs was also damaged at a number of places.

In Birahi, the terrace had been cut vertically by the Alaknanda river. An eroded terrace with around 5 to 10 meters vertical cut is observed on the left bank of river. In this eroded terrace Garhwal Mandal Vikas Nigam (GMVN) Guest house and other structures were severely damaged. As also, the toe/bank erosion by Alaknanda river triggered landslide at back slope of Kothiyalsain which is located on Chamoli-Gopeshwar road. Crown portion of this destabilized zone adjacent houses/buildings have been creating future risk (Figure 4c).

In Tharali, a number of buildings and right abutment of connecting Girder Bridge of Tharali-Dewal motor road were severely damaged by flooding of Pinder river. Upstream to this, at Kedarbagar area a number of houses were also completely destroyed and around 0.6 kilometer motor road was swept away on the left bank of river (Figure 4e).

Flooding of Pindar river has resulted in extreme erosion around the market town of Narayanbagar. Due to this, a number of houses, commercial buildings, pedestrian Bridge and old market were completely destroyed while an old landslide had been reactivated on the left bank (Figure 4f).

Constructed right abutment of Tharali bridge was damaged while Chepron-Sera (Figure 4g) and Narayanbagar old market connecting pedestrian bridges were swept away in flooded water of Pinder river.

Besides, pedestrian bridge lead to Kalpeshwar temple in Urgam valley was also washed off by flooding of Kalpa Ganga. Another, Alaknanda river and Khirao Ganga has brought down huge debris material filling the reservoir of Vishnugad hydroelectric project and damaged the barrage along with other appurtenant structures (Figure 4h).

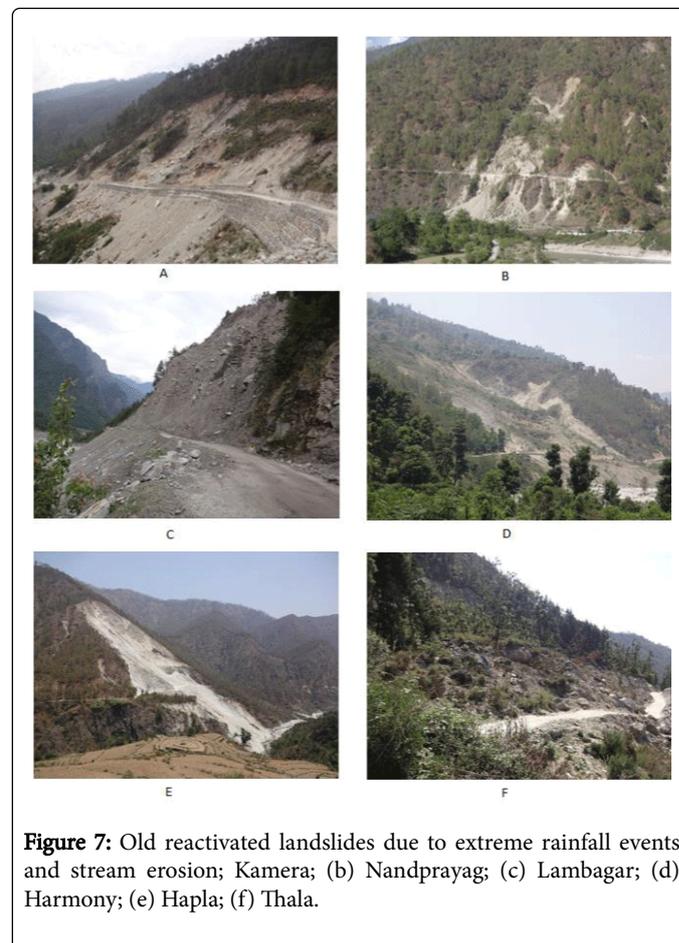
**Figure 7:** Old reactivated landslides due to extreme rainfall events and stream erosion; Kamera; (b) Nandprayag; (c) Lambagar; (d) Harmony; (e) Hapla; (f) Thala.

Heavy rainfall and floods have resulted in development of a number of major landslides, in the Alaknanda and Pinder catchments. At many places old slides are observed to be reactivated. These include Kamera, Nandprayag and Lambagar on the national highway (NH 58) while

Harmony landslide along Karnaprayag – Gwaldam road, Hapla landslide along Hapla – Pokhri road and Thala band landslide along Pokhri – Rudraprayag road on the important hill routes (Figures 7a-7f).

At many places old slides are observed to be reactivated in the area. These include Kamera, Nandprayag and Lambagar on the national highway (NH 58) while Harmony landslide along Karnaprayag – Gwaldam road, Hapla landslide along Hapla – Pokhri road and Thala band landslide along Pokhri – Rudraprayag road on the important hill routes. These landslides should therefore to be studied separately for their treatment and therefore recommended that detailed geological investigations on 1:5000/2000 scale must be carried out for the same.

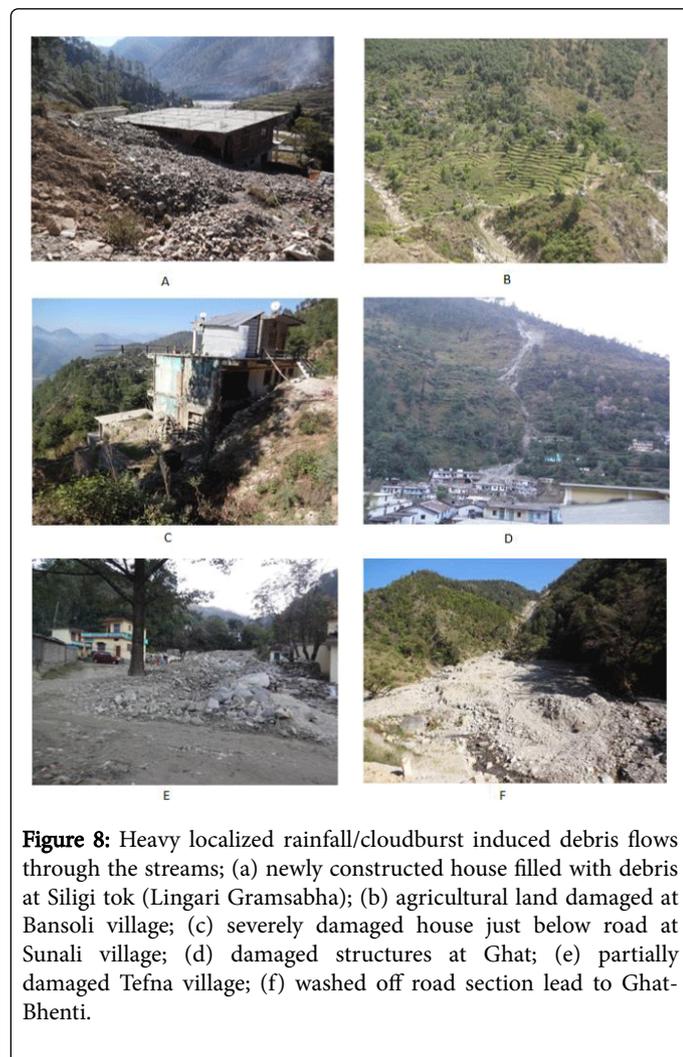
Besides landslides, heavy localized rainfall/cloudbursts through small streams/seasonal streams have caused severe damaged to number of settlements and infrastructure. As many as 30 heavy localized rainfall/cloudburst incidences are to be observed in the area. Kuwarikhal hill (Belakuchi), Bhimtalla and Chamoli, near Gopeshwar, Khankrakhet hill (Gadini), Patidi hill (Musudiyar), Gairsain (Devpuri) were reportedly devastated by such rainfall events in the past [9-11,27-28]. In the years 2013 and 2014, Bhuindar and Pulna (Bhuindar Ganga/Laxman Ganga), Bansoli (Darimiyagad), Ghat, Sunali and Tefna while Gwar (Chuphla Gad), Siligi tok (Lingari Gramsabha) and Urgam valley (Kalpa Ganga) are observed to be devastated by heavy localized rainfall/cloudbursts and associated flash floods/debris flows (Figures 8a-8f).

Heavy localized rainfall/cloudburst is the natural phenomenon occurs during monsoon season over the regions dominated by orography like Himalaya. It can only be identified on the basis of inundation occurred mostly along the 1st and 2nd order drainages in hilly terrain during monsoonal rainfall. Heavy localized rainfall/cloudbursts and associated debris flows have caused severe damage to settlement and infrastructure. Many villages including Ghat, Khunana, Thirpak, Tefna, Sunali, Kamera in the Alaknanda valley and Kanol, Silingi tok of Lingari Gramsabha and Bansoli in the Pinder valley are adversely affected. It is therefore recommended that constructions should be away from natural water courses/seasonal streams. The proposed construction site should be developed in a manner that does not enhance chances of debris flow/mud flow.
