Mapping Spontaneous Ground Fissures using Seismic Refraction, Reflection, and Ground Penetrating Radar in the Letlhakeng Area, Kweneng District, Botswana

Abstract

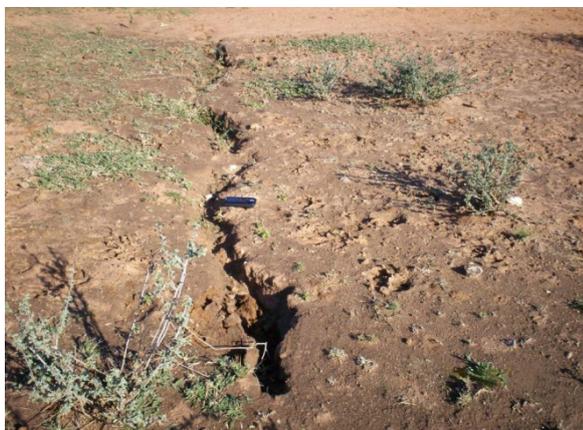
Figure 1: A large ground fissure developed on a sandy surface near Ditshegwane settlement. Note the global positioning system (GPS) device placed near the fissure for scaling. The fissure was open to a depth of ~2 m, measured by inserting a stick.

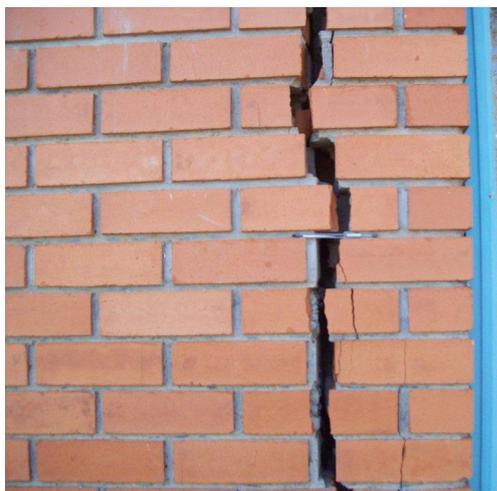
Figure 2: A crack developed through the wall of the Letlhakeng customary court. This building has since been abandoned because of damage caused by the spontaneous ground fissures.

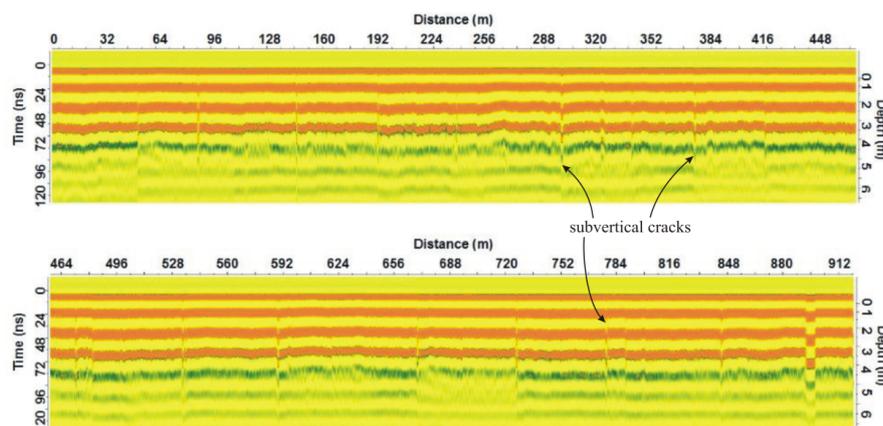
Figure 6: A ground penetrating radar profile recorded along a paved road near Ditshegwane settlement.

50 MHz unshielded antennae GPR survey was used to record a profile parallel to a paved road. The profile was recorded using an inline transmitter and receiver setup with a 2 m separation maintained with a wooden frame and recording at a sample spacing of 30 cm. The transmitter and receiver setup was maintained at a constant height of 5 cm above the ground surface and moved at a walking pace along the profile. Data recording was triggered with a hip chain running on a biodegradable cotton thread. The setup described here recorded a zero offset vertical profile which requires only a limited amount of processing besides signal editing and enhancement. Data editing, contrast enhancement, visualization and plotting was performed using Ground Vision™ 1.4.5 software. The GPR profile in Figure 6 shows that the fissures are sub-vertical and extend to a vertical depth of 4.5-5.0 m. The depth indicated here the electromagnetic signal weakens but the

fissures seem to persist to greater depths. Along the length of the profile, the fissures are sub-vertical and show only minimal displacement.

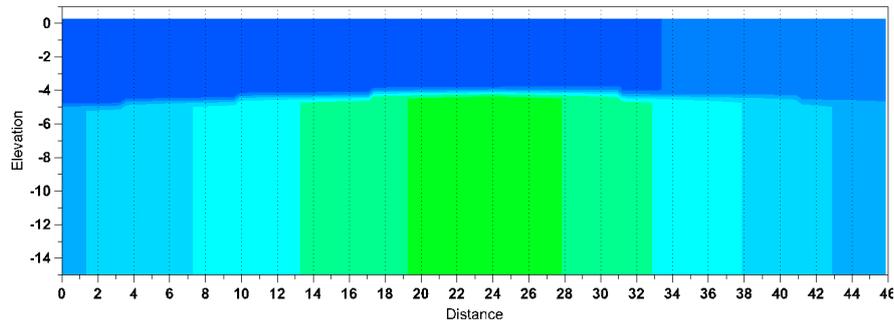
Figure 7: A seismic refraction profile recorded along the Ditshegwane road. The hairline cracks are not visible, but the top layer persists to 5 m, as indicated in the GPR profiles.

Figure 7 is a seismic refraction profile showing a two layer velocity model comprising overburden with a seismic velocity of 400-600 m/s lying over another layer with a seismic velocity of 1200-1400 m/s. The top layer consists of the loose sand observed at the surface which is imaged to a depth of 5 m across the profile. The bottom layer with a seismic velocity of 1200-1400 m/s constitutes more compact and saturated material. The fine sand in the depressions was observed to contain a calcareous cement, which may be responsible for the better compaction, and hence a higher seismic velocity.

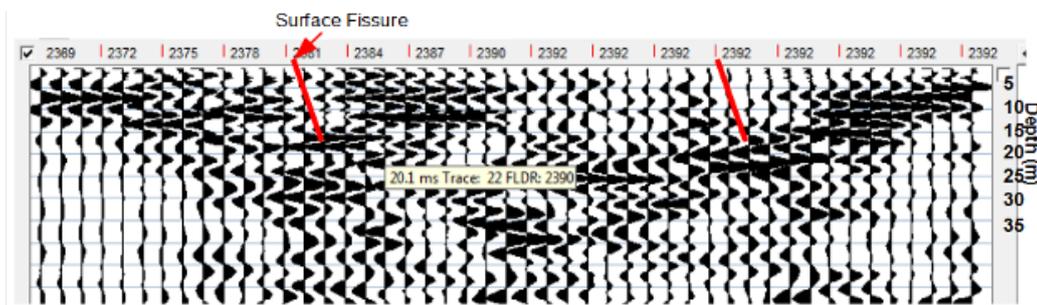
Figure 8: A seismic reflection profile recorded across a visible ground fissure. Note that the fissure continues to a depth of 20 m, indicated with the red lines.

Seismic reflection data were reduced using Visual_SUNT™ 12. Seismic reflection processing followed the standard CMP processing sequence, including both spiking and predictive deconvolution to improve temporal resolution. Figure 8 shows seismic reflection profile recorded perpendicular to the road across a large fissure developed on the edge of the road. This profile achieves a lateral resolution of 0.5 m. The profile shows that the ground at this location consists of sub-horizontal layers from 0-15 m, which have all been broken by the surface fissure observed at the surface.

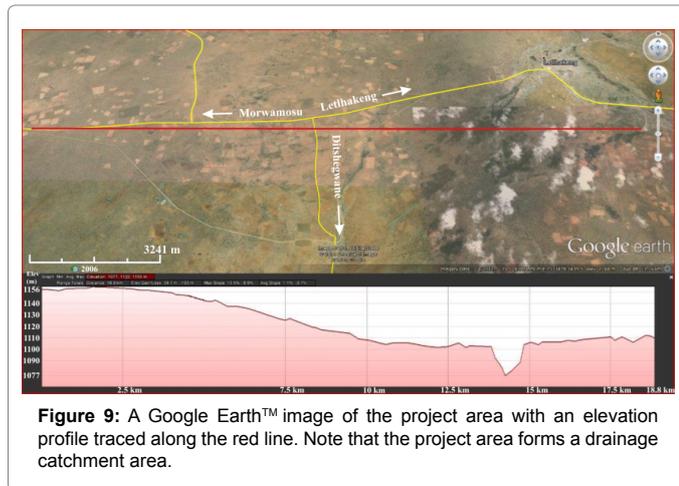
Figure 9: A Google Earth™ image of the project area with an elevation profile traced along the red line. Note that the project area forms a drainage catchment area.

image in Figure 9 which includes an elevation profile shows that the topography is flat to the west of Sesung village, but it decreases rapidly towards the east. The implication of this is that during the wet season surface water percolates through the loose sand and is stopped by the impermeable clay at a shallow depth of ~5 m. This water accumulates and then forms a base flow in the direction of decreasing elevation, and the flow is impeded by the presence of sand. The water will thus reside in the sand for a long time and wet the clay, enhancing its weathering, and also causing it to expand. As the dry season progresses, the clay will dry out and shrink, causing the development of desiccation cracks. The desiccation cracks manifest themselves at the surface as ground fissures. At the valley floor, where the clay is exposed, the desiccation cracks develop much earlier as the groundwater level recedes. The damage on the civil structures such as paved road occurs in two ways; on the valley floor the damage occurs as the clay dries out since they are in contact with it. Where the clay occurs below sand, liquefaction occurs when the loose sand is saturated and the structures collapse into it and later also when the clay dries out.
