Study the 2013 Flood Damages and Risk Assessment in Kedarnath, Himalaya Area Using Geoinformatic Techniques

Prakash P*

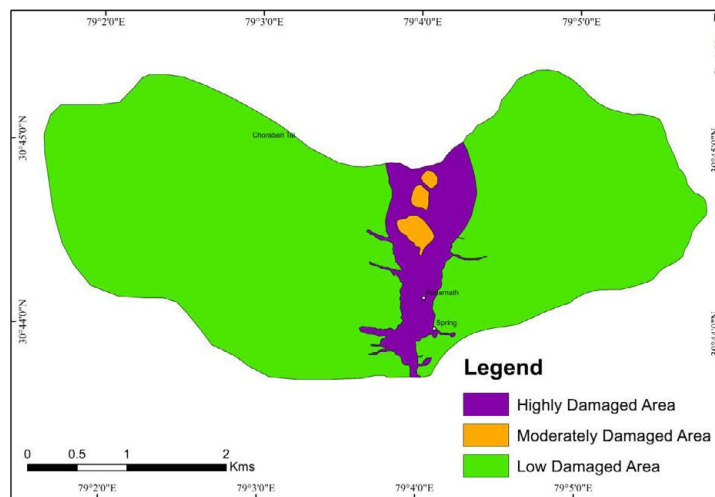
Figure 2: Damage assessment map of the Kedarnath Region.

As we know, this area is tectonically active and not stable due to terrain and texture of this area is not very hard some of the areas are more vulnerable. The present study divides the damaged area into high, moderate, and low damaged area (Figure 2). Then the damage assessment map was integrated with land use and land cover map to analyze the feature wise damage assessment (Table 1).

There are highly damaged area of built-up land is 114233 Sq. m. Because the Chorabari lake is located on the above north of Kedarnath town, after the breaching of the Chorabari Lake the channel took a very irregular path resultant the water began to passing through the middle of Kedarnath town. This area is more vulnerable whereas the low damaged area of built-up land is 5322 Sq. m. Another degraded land use and land cover is glacial snow because of torrential rainfall glaciers of the adjacent area melted rapidly and it is also divided in three categories such as low moderate and highly damaged area. Highly damaged area of glacial snow area is 300290 Sq. m. moderately damaged area is 399 Sq. m. and low damaged area is 4388760 Sq. m.
