Corrosion Failure Analysis of Elbow in LPG Desulfurization Unit

Jianwen Z¹, Guoqing S^{1*}, Chuansheng W²

ABSTRACT

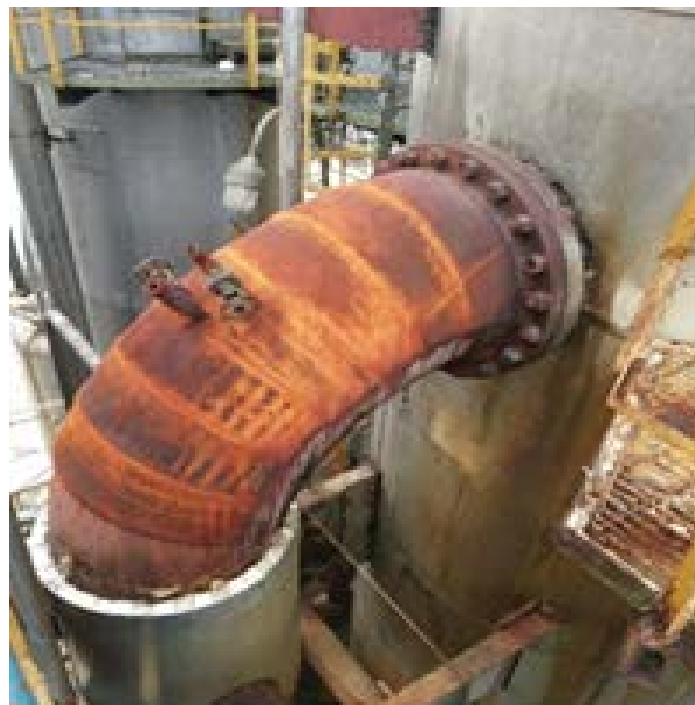
Figure 1: Welding photo of elbow.

The elbow of the regenerator tower of the LPG desulfurization equipment in a petrochemical plant in Shanghai has been seriously leaked because of the corrosion perforation, then the leakage area was repaired, as shown in Figure 1. Four months later, the second leak appeared, physical map of elbow was shown in Figure 2, desulfurization process and failure location shown in Figure 3.

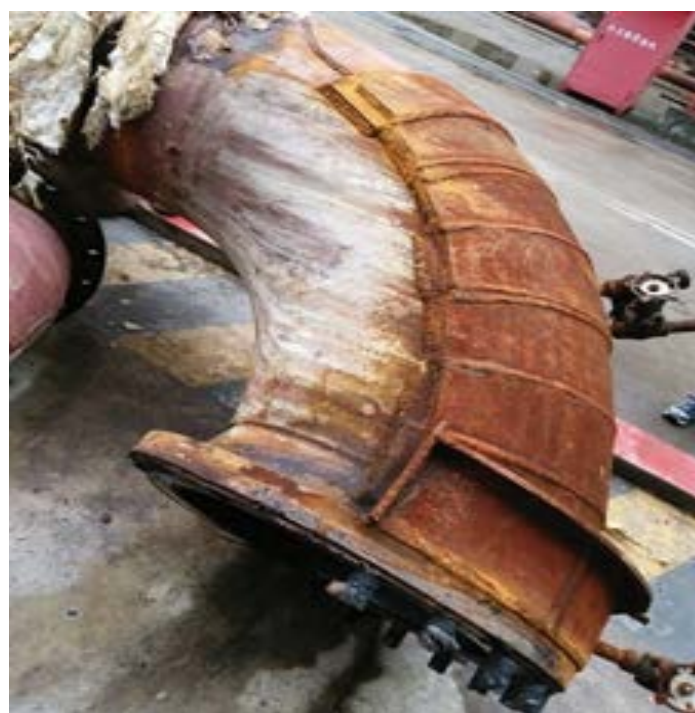
Figure 2: Physical map of elbow.

The failure elbow was cut along the central axis and divided into two parts. No obvious corrosion features were observed on the inner elbow while the other side was heavily corroded. The physical map of outer elbow is shown in Figure 4. It can be seen that the whole inner wall was black and yellow brown, and all had varying degrees of corrosion, especially in the middle and near the flange. What's more, the surface roughness was high, there still remained

a little corrosion product in part area. The elbow surface presented cribriform architecture, which is full of uneven size, regular shape and honeycomb pitting. Due to long-term corrosion, many pits have been in conjunction with each other which formed large-scale destruction area.

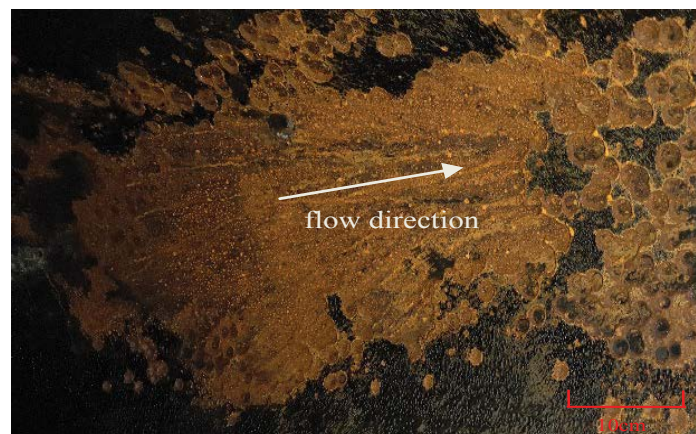
Figure 5: Scour pattern near the outlet.

Figure 5 was the scour appearance of complete destruction area near the exit, and the trace of the fluid scour can be clearly seen from it. The scour path in figures presented orientation, which coincided with flow direction. Figure 6 was the scour morphology near corrosion holes. It was obvious that the thickness of edge region was much smaller than that of center, and there exist typical thinned lip structures which were caused by fluid erosion. Therefore, it can be concluded that the erosion-corrosion was a vital factor that resulted in the failure of elbow.

We have concluded that erosion-corrosion was a vital factor during the failure process of elbow from Figures 5 and 6. Actually, erosion-corrosion is composed of four components, pure corrosion, pure

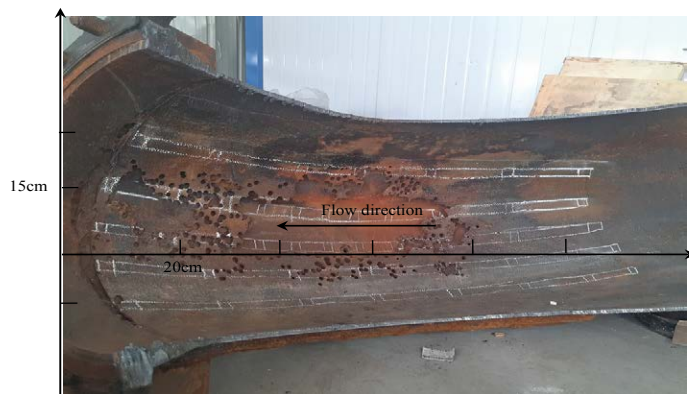
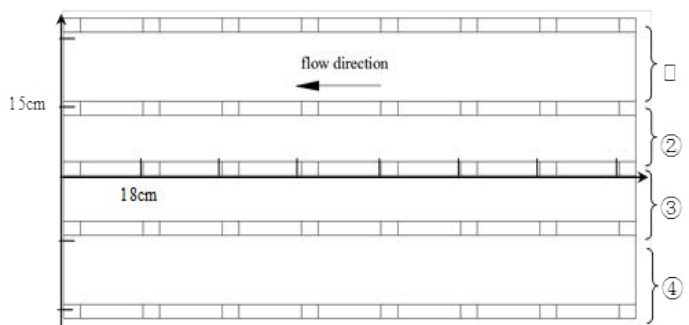
Corrosion hole analysis: The corrosion morphology of the elbow was typical honeycomb appearance which composed of standardized and different size holes. The size of holes was measured and analyzed for mastering distribution law of corrosion holes and deeply studying failure mechanism of the elbow. Taking the thief hole as center, the wall was divided into 4 sections, and the distance was taken as 15 cm, 10 cm, 10 cm and 15 cm, respectively. The physical drawings and schematic diagrams are shown in Figures 7 and 8.

Figure 7: Physical map of regional division.

Figure 8: Sketch map of regional division.

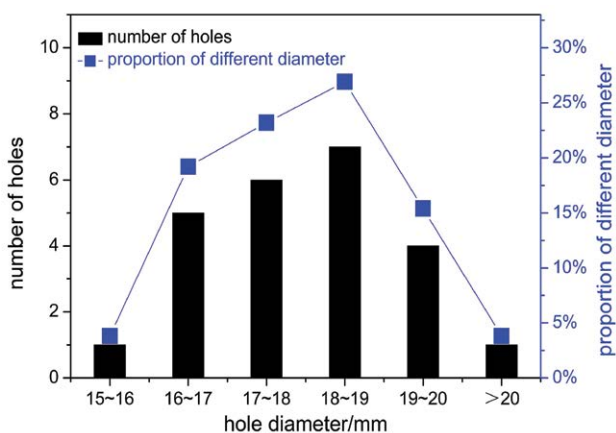
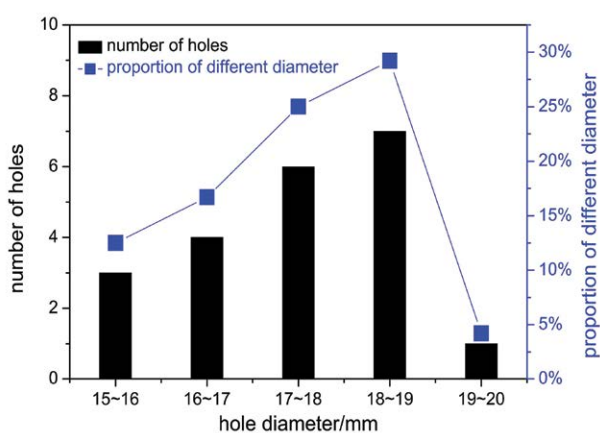
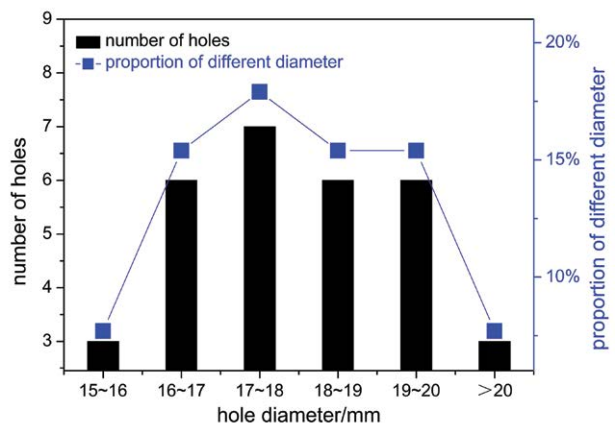
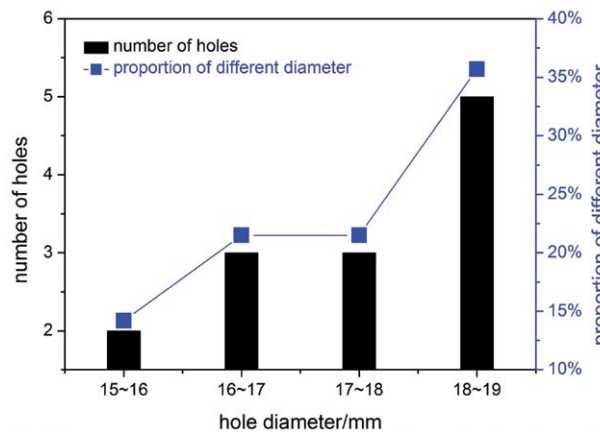
Figure 9: Hole size distribution.

After on-site measurement and analysis, a total of 103 holes were sorted out by regions. It is found that the maximum diameter was 21.1 mm while the minimum was 7.76 mm, partial results shown in Figure 9, and the vast majority of holes were 16 ~ 19 mm. The average size of the middle section was larger, meanwhile, possessed most holes over 19 mm. This showed that when diameter reached or exceeded 21.1 mm, the area around the holes may gradually developed into a complete failure region.

The size and density of corrosion holes reflect the value of V_C . Combining with Figures 9 and 10, V_C in the middle area of elbow (area②and area③) can be obtained, that is, the total rate of V_{C0} and ΔV_C is significantly higher than that in the surrounding area. Therefore, Figure 10 not only reflects the distribution of corrosion

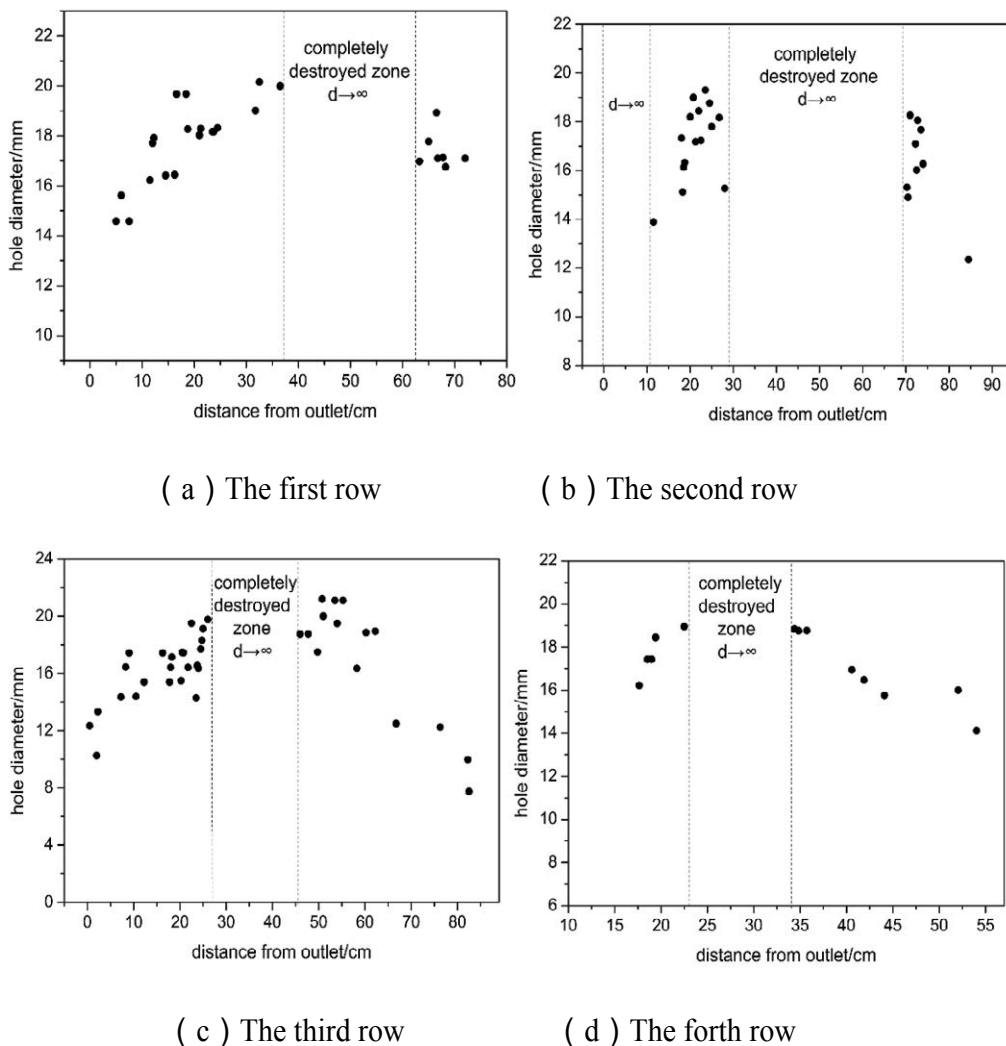
Figure 10: Hole distribution.

To further discuss the distribution of the holes, drawings were made with diameter as ordinate and distance as abscissas, as shown in Figure 10. The dashed area represented complete failure region where corrosion was the worst. It can be easily noticed that the diameter was approximately trapezoid along flow direction. From the inlet of the elbow, the hole size had a tendency to increase

continuously, then later had a large area of complete destruction in the middle of elbow (the area of 20~70 cm from the exit), and then had a decreasing trend. Areas division of elbow is shown in Figure 8. The hole size of the area ① and ③ ④ decreased along with the flow direction until disappeared completely, while there was a small area of complete destruction of area ② in exporting nearby. There may be two reasons for this phenomenon. One possibility was the area near flange, and there will generate far more resistance when fluid passed through, as shown in Figure 11. The second was the area existed legions of gaps caused by corrosion, which may resulted in fluid accumulation and graver corrosion. The radial direction analysis showed that the diameter distribution accorded with the normal distribution. At equidistance, the diameter of the edge area was smaller while the middle was relatively larger.

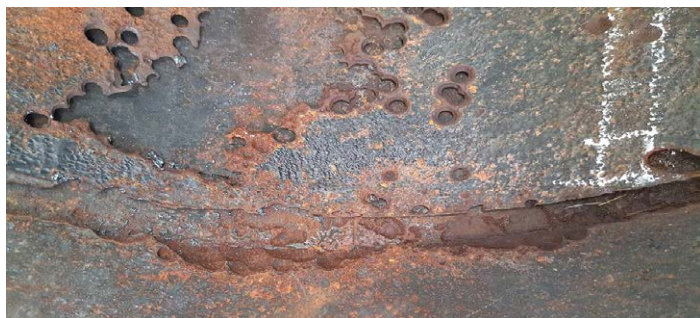
Figure 11: Corrosion morphology in exporting nearby.

Analysis of thinning law: Regional sampling of the inner wall was carried out to obtained corrosion thinning laws of the elbow; the initial scheme was shown in Figure 8. Taking the thief hole as center, the wall was divided into 5 rows, numbered 1~5 from top to bottom. The interval of each row of adjacent samples was 15 cm, numbered 1~8 from left to right. However, samples cannot be removed completely since the edge area was too thick in actual sampling process. Therefore, the following adjustments were made: the 1st row was abandoned, the 2nd and 5th row were moved 5 cm upwards, and 5~6 samples are taken in each row, and the rest remained unchanged, as shown in Figure 12. Firstly, the inner wall

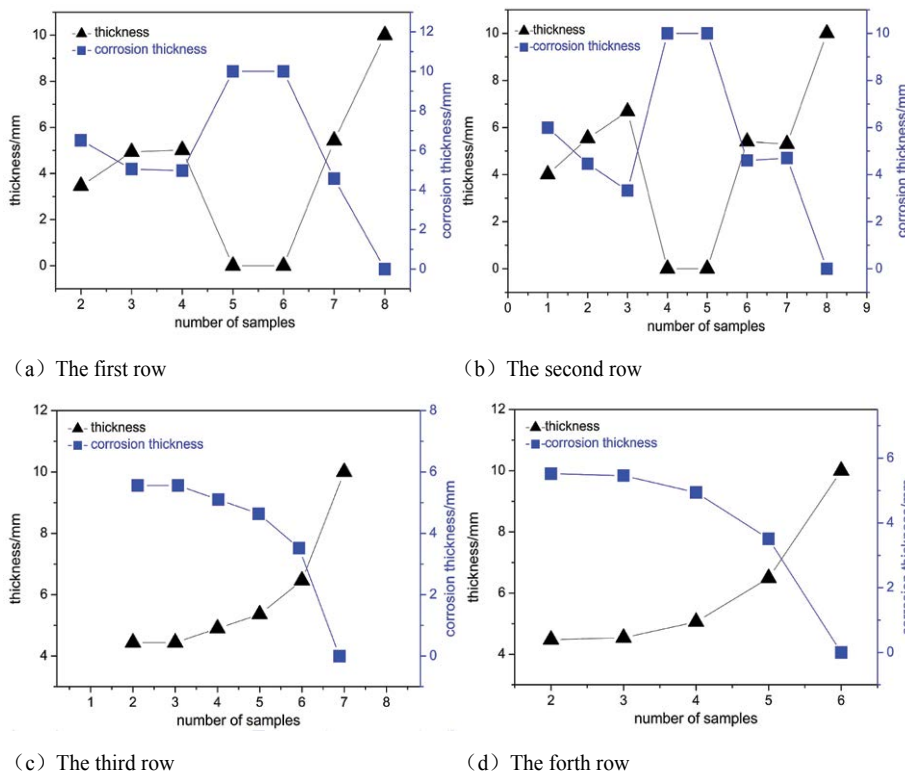
Figure 14: Thickness distribution.

Obviously, there was an identical rule between the 1st and 2nd row of thinning laws. The thickness was equal to initial thickness of the pipe near the inlet, that was, there was no palpable corrosion behaviour in this area. Along the flow direction, corrosion thickness gradually intensified, and then reached the maximum in completely destroyed area. Subsequently, corrosion thickness showed decreasing trend, and then slightly increased. The 3rd and 4th row have not passed through complete destruction area and therefore the corrosion thickness was successive, that was, it increased gradually along the flow direction. The maximum corrosion thickness of the 3rd and 4th row both were near of the export, and both were 5.5 mm.

holes, but also represents the distribution of ΔV_C in elbow. Figure 14 not only reflects the distribution of wall thickness, but also represents the distribution of V_E .

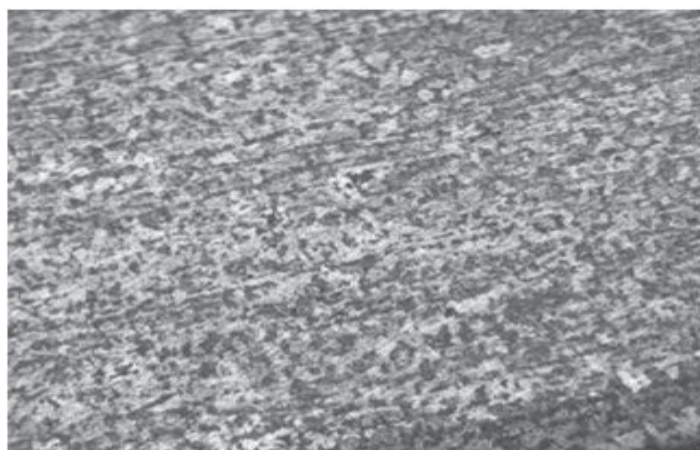
Figure 15: Metallographic structure of failure elbow.

Metallographic examination: In order to determine whether the metallographic structure of the failure elbow is normal, the metallographic examination of the elbow was carried out after simple treatment of the sample. The results show that the metallographic structure of the samples is mainly ferrite and

pearlite, and the grain size of ferrite is 10 grades, as shown in Figure 15. The results showed that the metallographic structure of the site was normal.

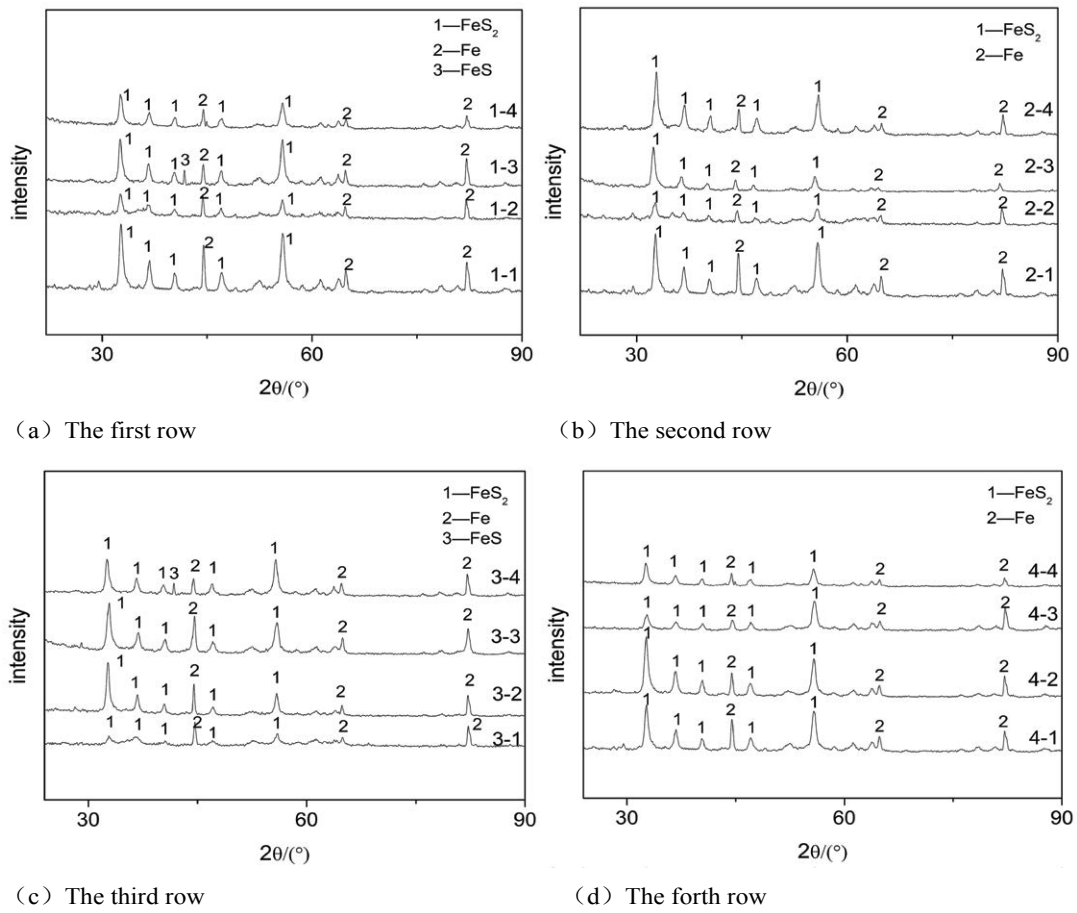
Figure 16: XRD images of samples.

XRD analysis: The composition of corrosion products can be obtained through XRD analysis, which is helpful to further analysis the failure mechanism of elbow. In order to make an accurate and comprehensive analysis, 4 samples are selected in each row. After searched and matched, it was found that the main phases were FeS_2 and Fe, and partial samples contained a small amount of FeS, as shown in Figure 16.

The result of XRD shows that only a small amount of FeS exist in corrosion product, and mostly is FeS₂. A further analysis of corrosion combination with the literature indicates there exist following reactions [24-28]:

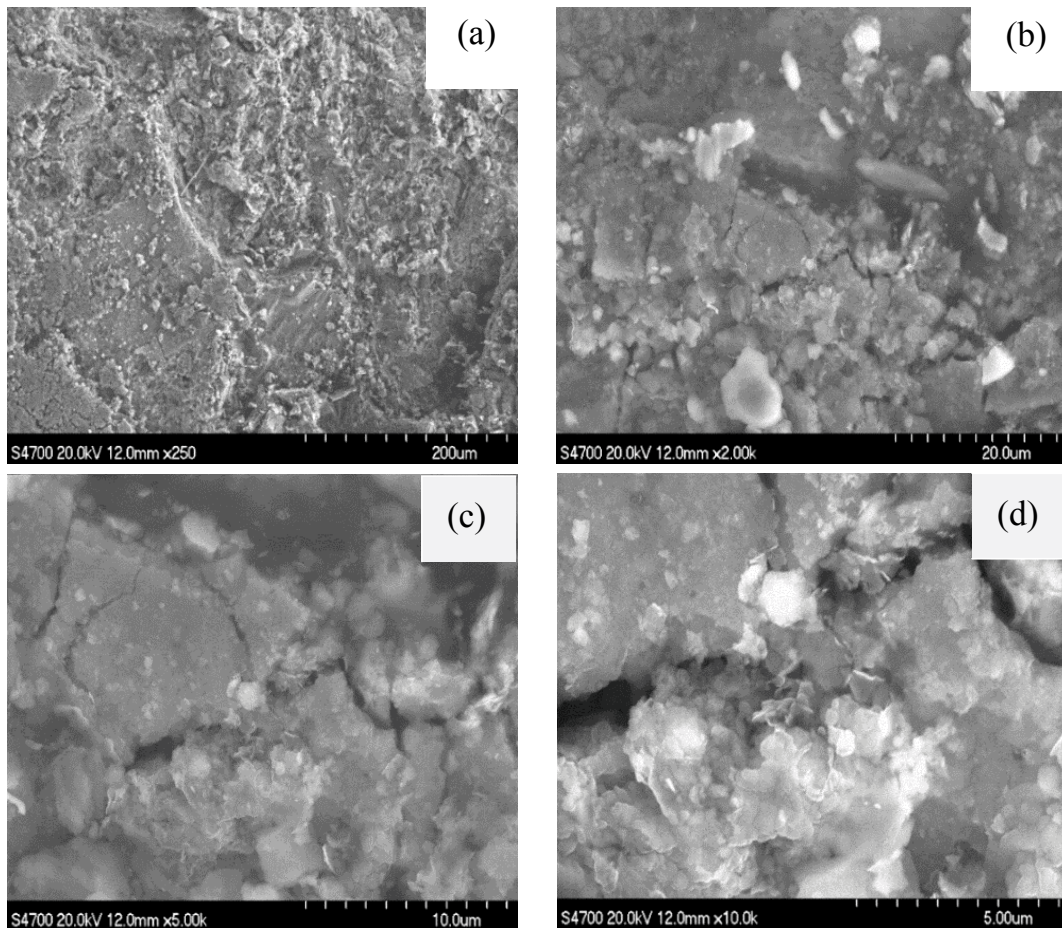
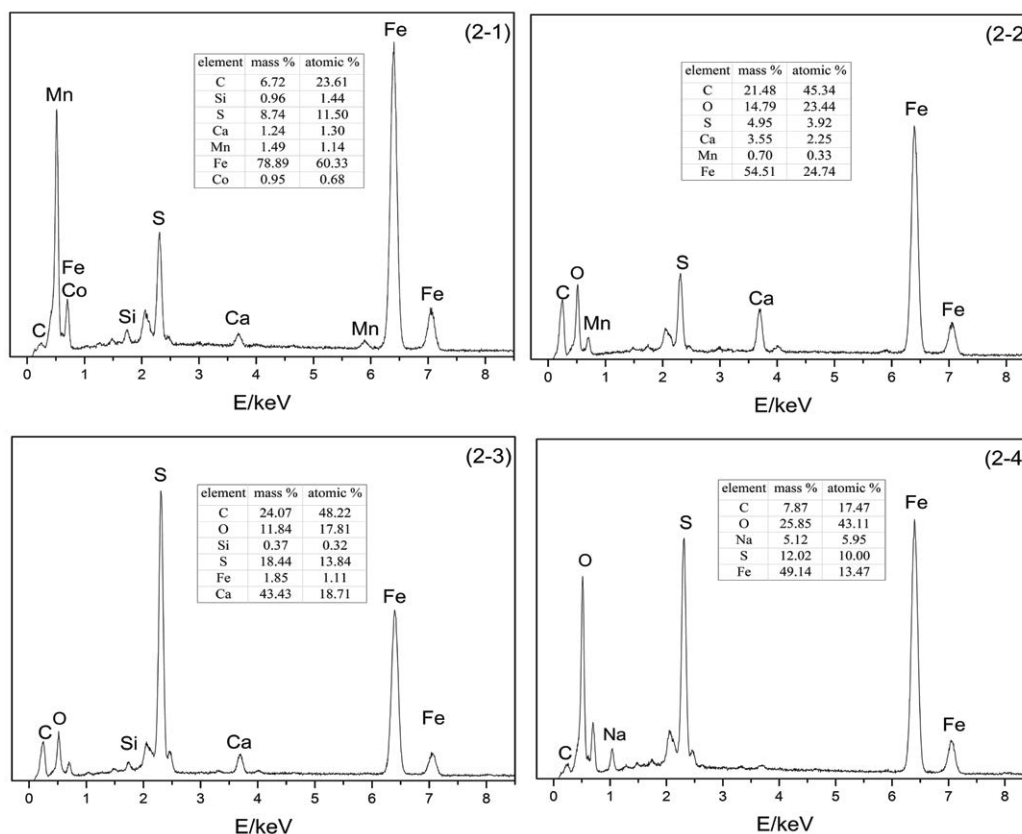
SEM-EDS analysis: The combination of SEM and EDS analysis can not only provide micromorphology of the samples, but also make qualitative and semi quantitative analysis of components. The SEM results of 2-2 are shown in Figures 17 and 18. As can be seen from the diagram (a), the surface of the sample is uneven and has many defects. With the increase of magnification, it can be observed that the surface is relatively rough, besides, the inner structure is loose and riddled with gullies and crevices. When magnification reach to 10000, the flake-shaped and massive corrosion products that remain in the surface and gaps can be clearly seen, which indicated that the strength of bonding force between corrosion product and matrix was so insufficient that cannot protect the matrix.

Figure 17: SEM images of samples.

Figure 18: EDS images of samples.
