Disaster Hit Pithoragarh District of Uttarakhand Himalaya: Causes and Implications

Sushil Khanduri*

Disaster Mitigation and Management Centre, Department of Disaster Management, Uttarakhand Secretariat, Dehradun-248001, Uttarakhand, India

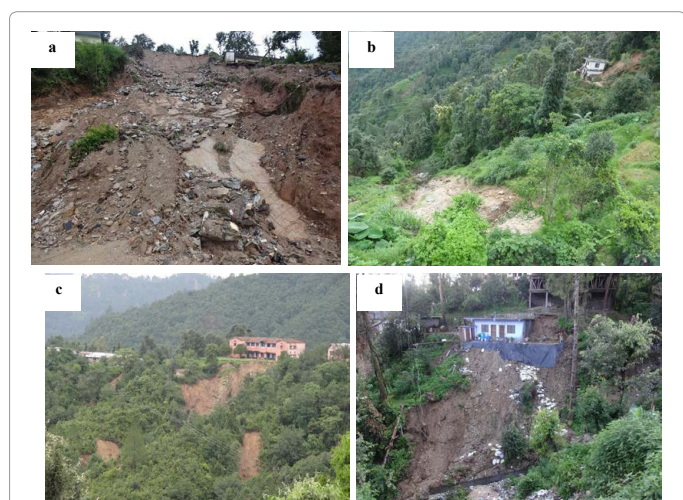
degradation and most of the slope failures have been caused due to saturation of the soft and weak weathered rock/soil materials together with heavy rainfall. Due to this, a total of 232 families are affected by the landslide incidences in the area around Didihat, out of 101 families live in GIC Ward alone. This is followed by 92 in Tehsil Ward, 32 in Ambedkar Ward and 07 in Shiv Mandir Ward (Data Source: Nagar Panchayat, Didihat). Maximum landslides incidences was observed to be occurred in GIC and Tehsil Wards while moderate in Ambedkar and less in Shiv mandir Wards.

The landslide is located just below the Didihat-Adichaura motor road that is occupied by outcrops as well as thick overburden. Due to heavy rainfall a major landslide took place in Ambedkar ward and Deendayal Park was severally damaged. This slide has partially damaged two houses on its left and right flanks and these are under severe threat (Figure 2a). Besides, some houses in Shiv Mandir and Tehsil Wards were also affected by landslide incidences (Figure 2b and 2d). Debris slide is located near District Institute of Education and Training (DIET), Didihat. Presently, Govt. polytechnic is conducted in a building of DIET, situated just above the landslide (Figure 2c).

At some places including Nain Basti in Tehsil Ward, Shiva Colony in Ambedkar Ward and Kandai village on the uphill side to Shiva colony subsidence, cracks on buildings and landslides are attributed to construction on recent material/loose soil/overburden material and poor drainage network.

Figure 2: Landslide incidences in the area around Didihat; damaged Deen Dayal Park at Ambedkar Ward (a), slope failure in back and front of some houses at Shiv Mandir Ward (b), debris slide in front portion of District Institute of Educational and Training (DIET) at GIC Ward (c) and mass movement in front part of house at New Basti area in Tehsil Ward (d).

Since, the area around Didihat town has abundance of very weak materials, lies in a high precipitation region, and already has many constructions; water management is the key to safety in this town. This should be comprehensively planned for the entire area, and should take into account the following measures, however, site specific conditions must be considered in detail while applying the measures.

- It is recommended that the drain sections sufficient, with regard to gradients, for the monsoon and seepage discharge that they are meant to carry.
- It is recommended that wear resistant drain lining in higher gradient reaches of drains to withstand abrasion.

- It is recommended that all existing or proposed retaining and other walls, and any other coverings on slopes, must have proper arrangements to allow free drainage of slope material so that harmful pore pressures do not develop in the slope.
- It is recommended that as the space between slope and house is very less, anchored concrete curtain wall must be considered at the same.
- It is recommended that the rock fill buttress or gabion wall can be provided to protect the completely weathered rock/soil slopes.
- It is recommended that the low retaining walls at different levels of the slope with free draining backfill, to support the fill around building.

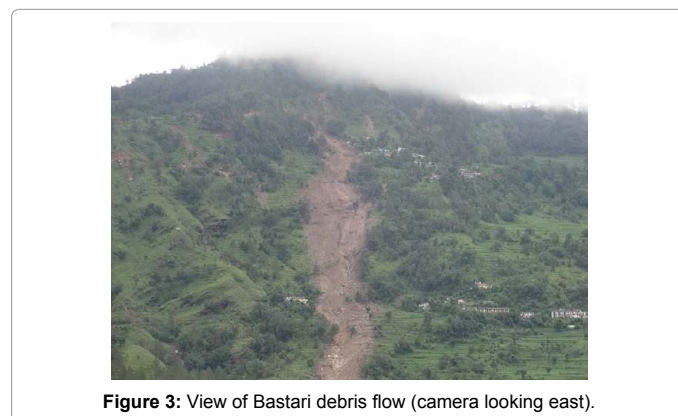
According to eyewitness accounts cloudburst like incidence took place around Bastari village on 1st July 2016 in two phases. Debris flow occurred after heavy rainfall in the morning hours (around 0430 hrs) in which one house was damaged. The inhabitants of the same were rescued by the villagers. Thereafter most people of the village (around 24) took shelter in a well-constructed house in the village that was perceived to be safe by the people. While they were still waiting for rain to stop another debris flow took place around 0600 hrs. This engulfed the very house in which people had taken shelter. All the persons were thus burried in the debris that flowed down along a 1st order drainage passing through Urma village, which is situated below Bastri village. 19 persons were killed in this incidence. Of these bodies of 08 could not be recovered. Total 16 buildings were destroyed or damaged and 174 cattle were lost.

The slope in the area is generally observed dip towards southwest at steep angles (55-60°). This has facilitated fast downslope movement of debris. A number of agricultural fields along with houses were thus damaged due to debris flows in the Bastari area (Figure 3). The thickness of the debris accumulated in the area is observed to be around 3.5 to 4.0 meters. This material is observed to comprise of hill wash and debris consisting of brown, fine grained silty-sandy matrix with rare boulders and fragments of granitic gneisses.

Figure 3: View of Bastari debris flow (camera looking east).

landslide several landslide scars are also observed on the uphill side to Bastari village. Activation of these has the potential of posing danger to the village. Geologically, the area is deduced to be in a critical state of equilibrium and the following suggestive measures are suggested:

- The hill slope around Bastari village is deduced to be highly susceptible to failure, particularly in the event of heavy or prolonged rainfall. The residents are therefore advised to keep safe distance from the vulnerable slope and vacate the area, especially during heavy or prolonged rainfall.
- It is highly important to ensure all future constructions only on firm ground. At the same time excavation on steep slope should not be allowed. The excavated slope if left untreated is sure to pose threat during heavy rainfall.

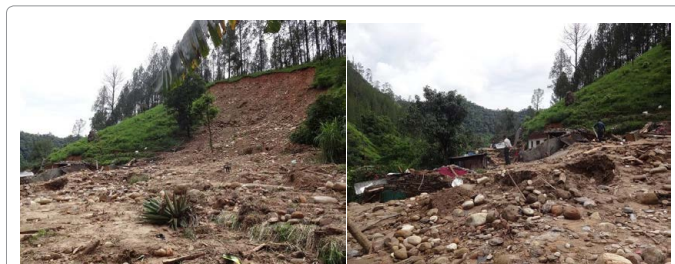
Heavy rainfall also accelerated gulley erosion on river born material (RBM) and debris flow took place at Kumalgaon (near Naulra village) as well. 3 persons were killed in this incidence while houses of 5 families were burried under the debris. Around 70 animals were lost in the incidence. 2.5-3.0 m thick pile of debris was observed at the site. Presence of river born material (RBM) is observed behind the habitation. Slope at this location is observed to dip towards east at an angle of around 40°. Indications of heavy rainfall induced gulley erosion and debris flow are observed during field investigation. RBM is always vulnerable for the slope failure due to the roundness of its constituents and poor cohesion. The debris slide is observed to have occurred on the eastern slope of N-S trending ridge. The width of the failure slope is about 50 meters along the cultivated fields and height of the crown from cultivated fields is about 30 meters.

The landslide debris that descended down from the area upslope of the village is observed to have overrun both agricultural fields and houses (Figure 4a and 4b). The thickness of the debris accumulated in the area is observed to be around 3.0 meters. This overburden material is observed to comprise of river borne material consisting of dark brown to reddish, fine grained silty-sandy matrix with rounded boulders and pebbles.

The landslide is deduced to be highly susceptible to failure, particularly in the event of heavy or prolonged rainfall. Geologically, the area is deduced to be in a critical state of equilibrium and the following suggestive measures are suggested:

Figure 4: Debris flow on slope made up of RBM at Kumalgaon near Naulra village (a) and devastation around Kumalgaon village (b).

- The residents are therefore advised to keep safe distance from the vulnerable slope and vacate the area, especially during heavy or prolonged rainfall
- During field investigation it was observed that the devastation mostly occurred along areas where Quaternary deposits were present.

Construction on RBM and old landslide debris should therefore be avoided.
