Investigation of Hydro-metrological Disaster Affected Malpa and Mangti Area, Pithoragarh District, Uttarakhand, India

Sajwan KS* and Khanduri S

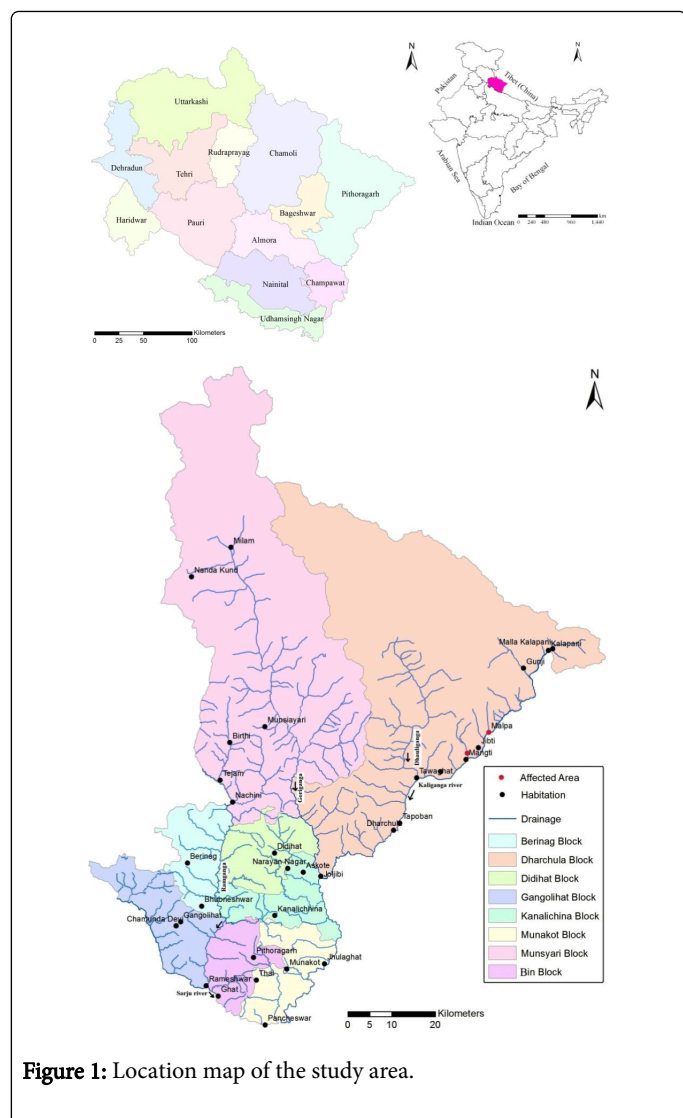
Figure 1: Location map of the study area.

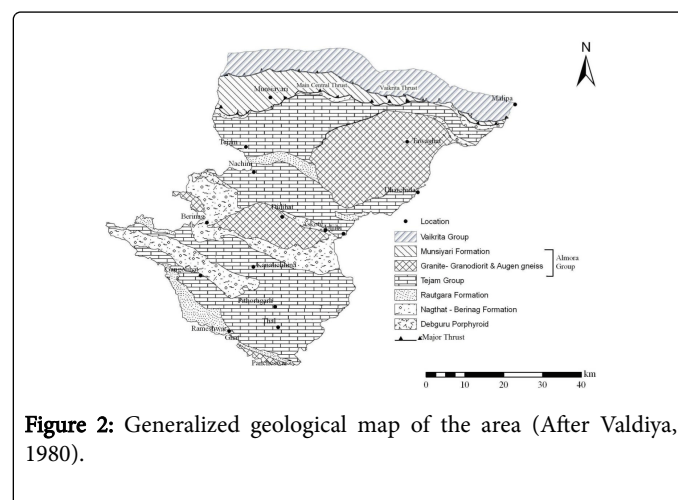
Figure 2: Generalized geological map of the area (After Valdiya, 1980).

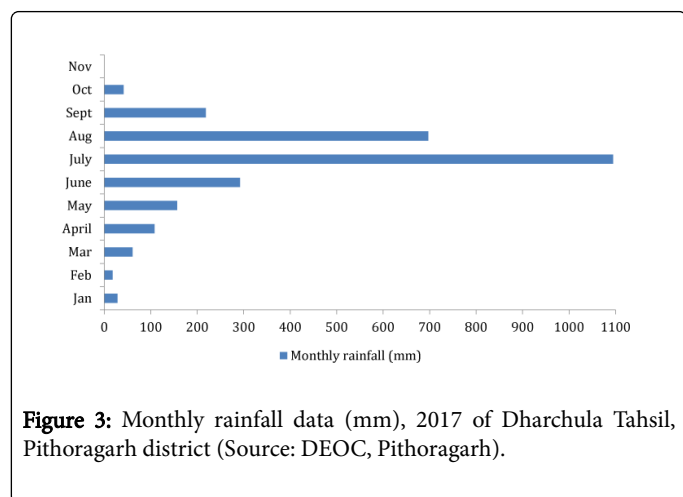
Figure 3: Monthly rainfall data (mm), 2017 of Dharchula Tahsil, Pithoragarh district (Source: DEOC, Pithoragarh).

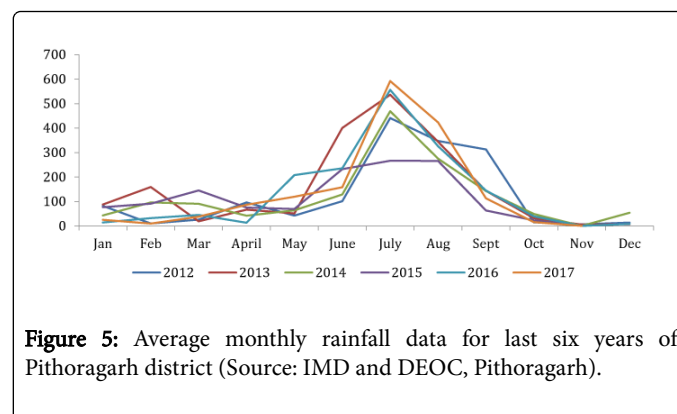
Figure 5: Average monthly rainfall data for last six years of Pithoragarh district (Source: IMD and DEOC, Pithoragarh).

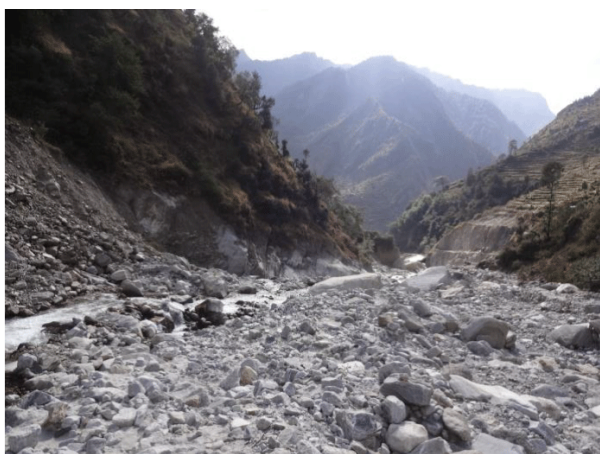
Figure 6: Inundation along Simkhola Gad after 14th August 2017.

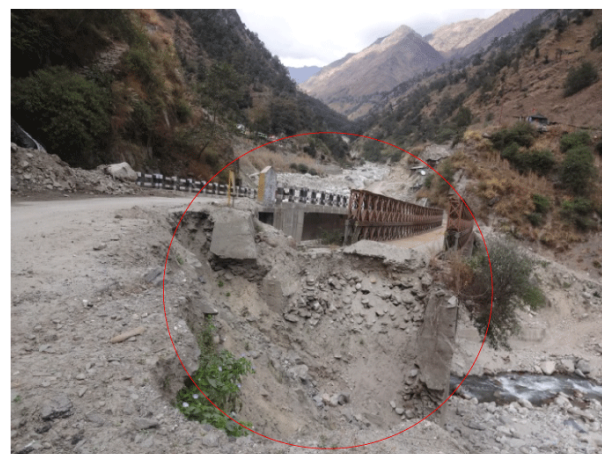
Figure 9: View of damaged right abutment of iron and RCC bridges of Kailash Mansarover Pilgrimage road.

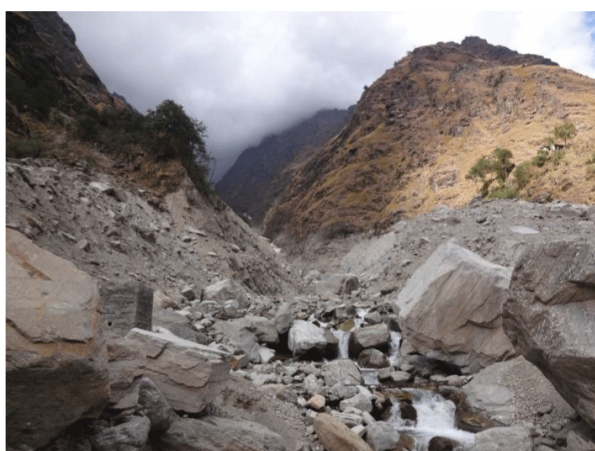
Figure 10: Inundation along Malpa Gad after 14th August 2017.

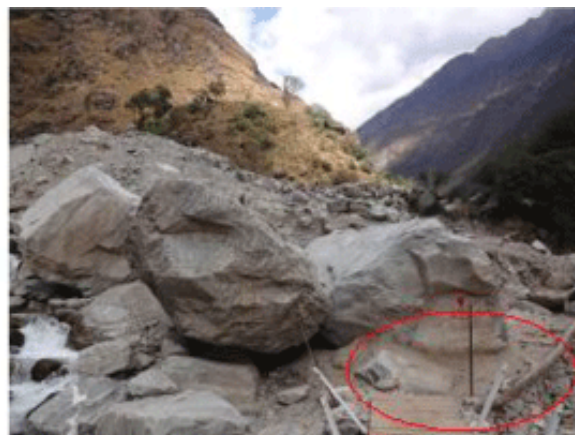
Figure 11: View of Kailash Mansarover pedestrian route, temporary wooden bridge can be observed in the red circle.

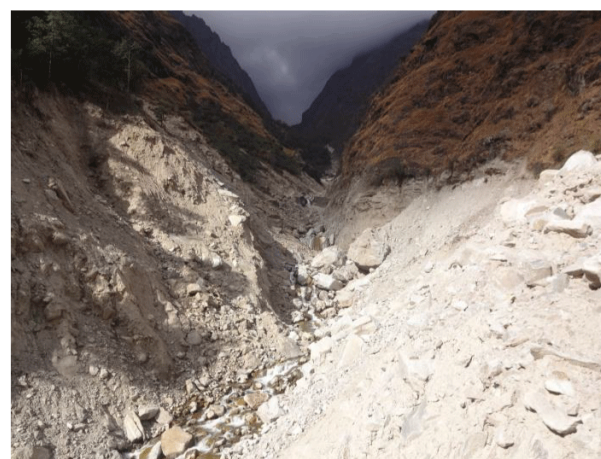
Figure 12: Upstream side view of Malpa Gad.

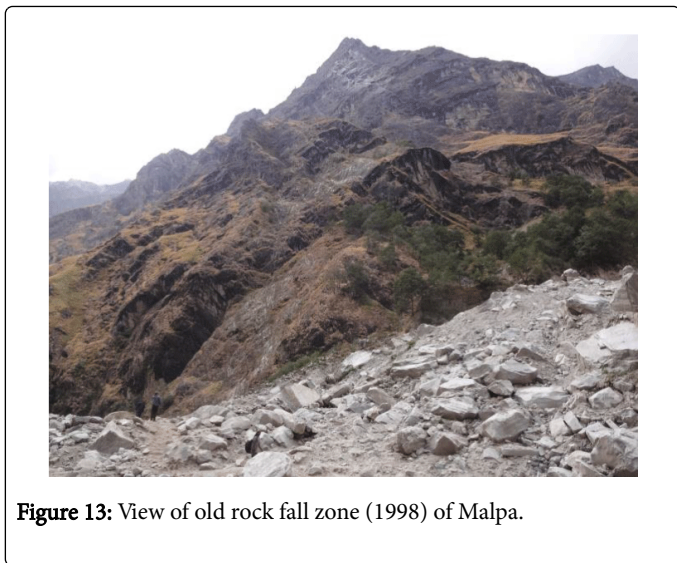
Figure 13: View of old rock fall zone (1998) of Malpa.
