## Extreme Twiddling: Unusual Presentation of an Old Foe

### Abstract

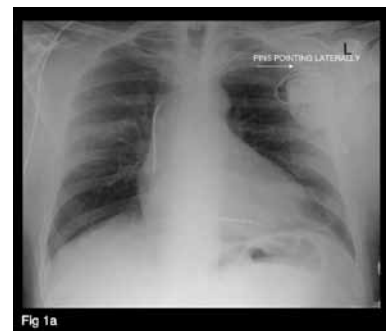
At routine device interrogation 1 month later there was complete failure to sense or capture. Again, the chest X-ray showed satisfactory lead position with no evidence of twisting or coiling and the patient denied any manipulation of the generator. At operation, the old lead was removed and a new dual coil RV lead was positioned at the RV apex [R wave 10.5mV, threshold 0.5 V, impedance 500 ohms, HV and SVC coil impedance 44 and 61 respectively] (Figure 1a).

**Figure 1a:** Post procedure chest X-ray showing clear separation between the proximal and distal coils. The pins are pointing laterally within the header.

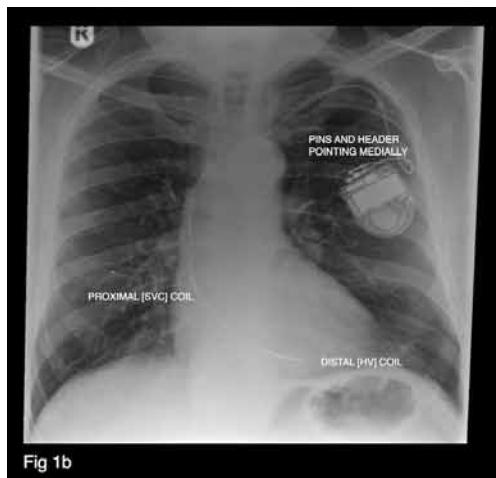
Fig 1b

1 month later HV and SVC impedances, which had always been within normal limits now both measured <20 ohms [R 9.9mV, threshold 2.75V, impedance 437 ohms]. Furthermore, chest X-ray demonstrated an abnormal lead appearance with decreased distance between the proximal and distal coils. The pins and header were orientated in the opposite direction to that seen on the post implantation X-ray (Figure 1b). Lateral chest X-ray confirmed localized intracardiac twisting of the RV lead (Figure 1c). The patient subsequently admitted to manipulating the generator. At operation the RV lead was untwisted, explanted and replaced. On this occasion a non-absorbable suture was placed through the fixation hole of the generator and fixed to the floor of the sub-pectoral pocket to help anchor the device. No further problems have since been encountered.

**Figure 1b:** 1 month later the pins are now pointing medially, the proximal coil has advanced into the heart and there is decreased distance between the 2 coils.

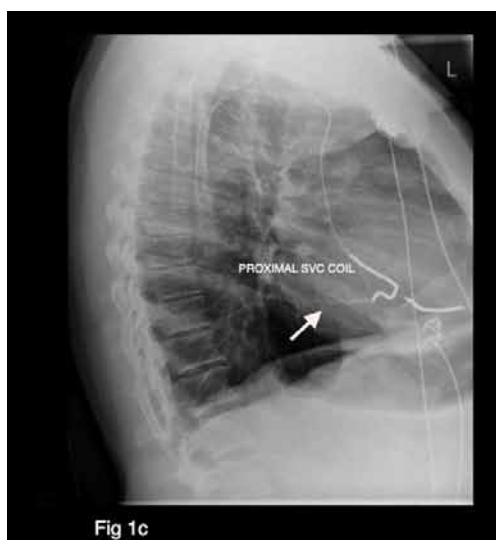
Fig 1c

**Figure 1c:** Lateral chest x-ray showing intracardiac twisting of the RV lead involving the proximal [SVC] coil.

lead damage without resulting in overt twisting or displacement of the lead. This may explain the initial 'concealed' presentation. Finally, continuous uni-directional rotation of the generator resulted in twisting of the intracardiac portion of the RV lead. This caused the 2 shock coils to move closer together and subsequent drop in HV and SVC coil impedances, which until that point had always measured within normal limits. These observations all infer that 'fulminant' twiddling did not commence until the later in the course of events when far more convincing signs of twiddling became apparent. Sub-pectoral placement of the pulse generator is described as a potential remedy for Twiddler's Syndrome. However our case demonstrates that this does not prevent a determined patient. Securing the generator with an anchoring stitch and comprehensive directives on refraining from stirring the pocket may be just as influential in reducing the incidence of this patient-induced complication.
