TIME COURSE OF THE PASSAGE OF AN INGESTED BRASS WIRE SEPARATOR THROUGH THE GASTROINTESTINAL TRACT.

**ABSTRACT:** Fixed Orthodontic Treatment involves the use of appliances with many metallic components. Some times appliance parts may go missing between appointments instead of and may be noticed during recall appointments. Ingestion of this parts is rare but if it happens it may be life threatening. Herewith a case of ingestion of metallic brass wire ligature and timely intervention is discussed.

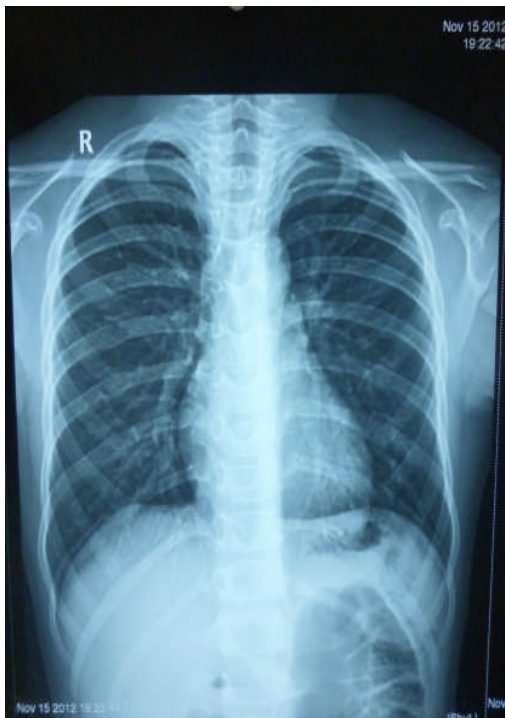
Fig.1. PA view chest does not show the separator

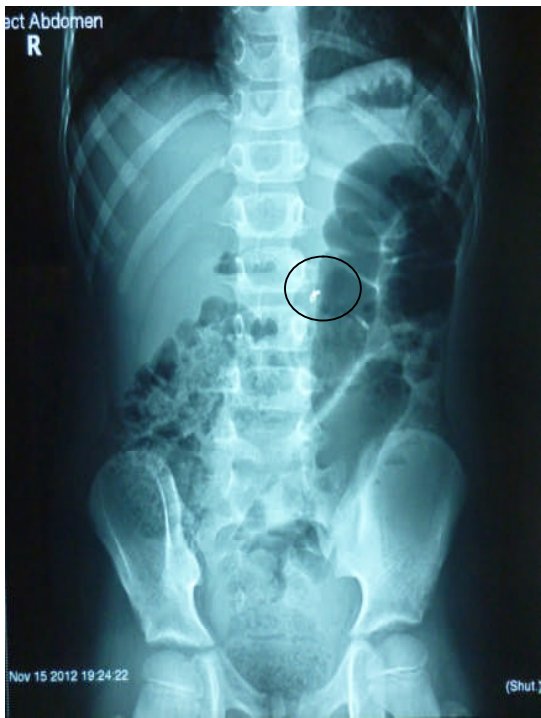
Fig.2. PA view abdomen showing the separator in the left hypochondrium

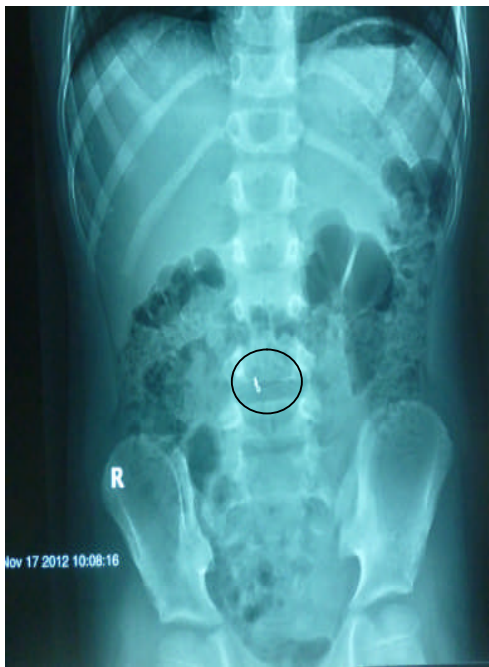
Fig.3. PA view abdomen showing the separator near the midline at L4/L5 level

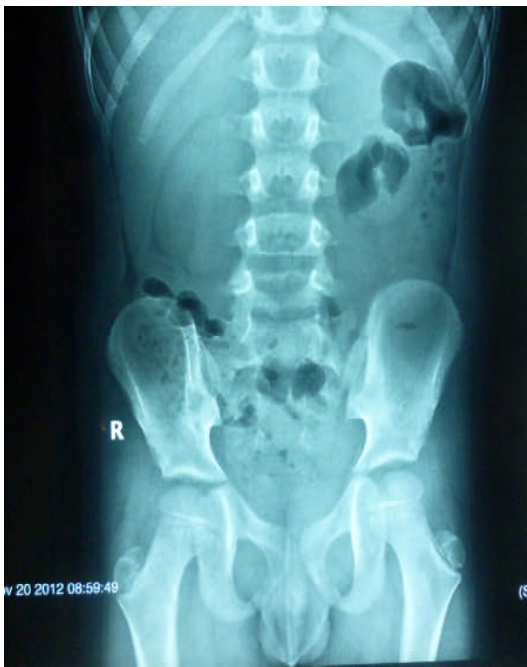
Fig.4. PA view abdomen showing no evidence of separator

appointment for removal of the wire. During this visit, it was noticed that the separator was missing. Neither the patient nor his parent was aware of this but the patient did recall feeling it with his tongue the previous day. After taking an IOPA to ascertain that the separator was not lost into the interdental area, the patient was sent for PA views of the chest and abdomen. The latter showed the presence of the separator in the left hypochondrial region at the level of L2/L3 (**Fig.1 and Fig. 2**). Since the patient had no symptoms, he was sent home with instructions to eat a lot of fibrous food and to drink a lot of water. A PA view radiograph done 36 hours later showed the separator near the midline at the level of L4/L5, probably in the small bowel intestinal loop (**Fig.3**). A further radiograph done 72 hours after the last one (5 days after the possible ingestion) did not reveal the presence of the separator suggesting that it had passed through uneventfully (**Fig.4**)
