Ceramic Femoral Head Fracture and Severe Wear of the Cone: A Case Report and Review of the Literature

Kassab Institute of Orthopaedics, Manouba, Tunisia

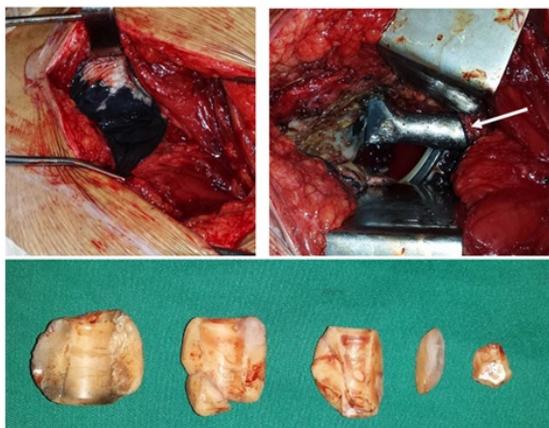
The patient underwent revision surgery. Intraoperative findings included diffuse metallosis (Figure 3), a pseudocapsule containing black metalloid fluid, excessive wear of the cone that had impacted the ceramic insert without damaging it and a multifragmented ceramic head. The uncemented stem and the acetabular component were not loose.

Figure 3: Intraoperative findings at revision operation showing diffuse metallosis, multifragmented ceramic head, notching of the cone (arrow).

Metallitic tissue was excised, ceramic debris was carefully removed, the area was well irrigated and the undamaged ceramic insert was not replaced. Although there were apparent imperfections at the taper of the stem, we decided not to replace it, as it was absolutely stable. A 28 mm small ceramic femoral head was finally placed at the existing taper.

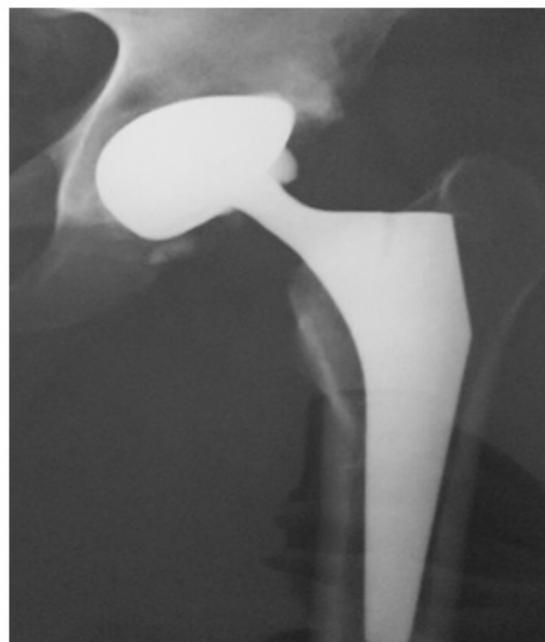
At the 3-month follow-up examination, the patient had no pain, used no walking aids and had normal activity without any signs of loosening or other implant pathology on plain radiographs (Figure 4).

Figure 4: Normal plain radiograph of the involved hip 3 months after the revision operation.
