# Landslide Environment in Pakistan after the Earthquake-2005: Information Revisited to Develop Safety Guidelines for Minimizing Future Impacts

## Abstract

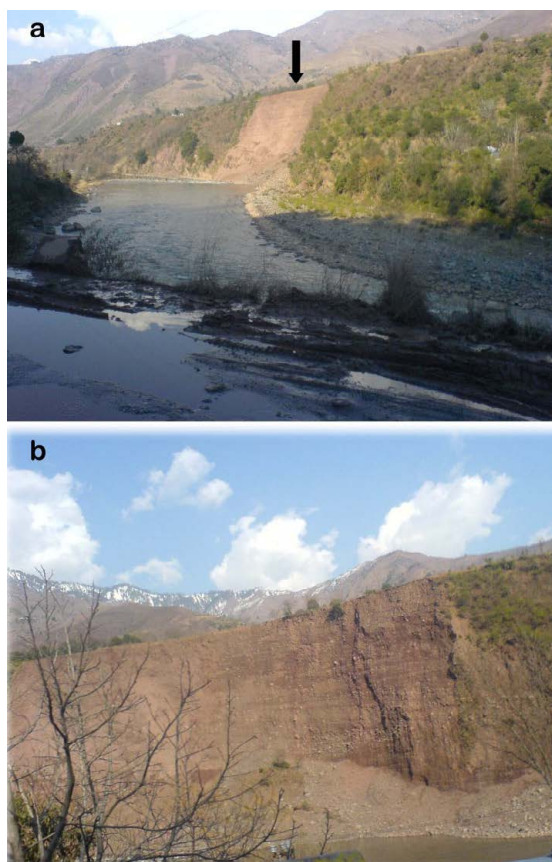
**Figure 2:** (a) Debris flow into the River Jhelum close to Muzaffarabad observed in 2008, over two years since the earthquake. The arrow shows the debris flow area which is about 500-600 m in width. (b) The landslide in a close-up view.

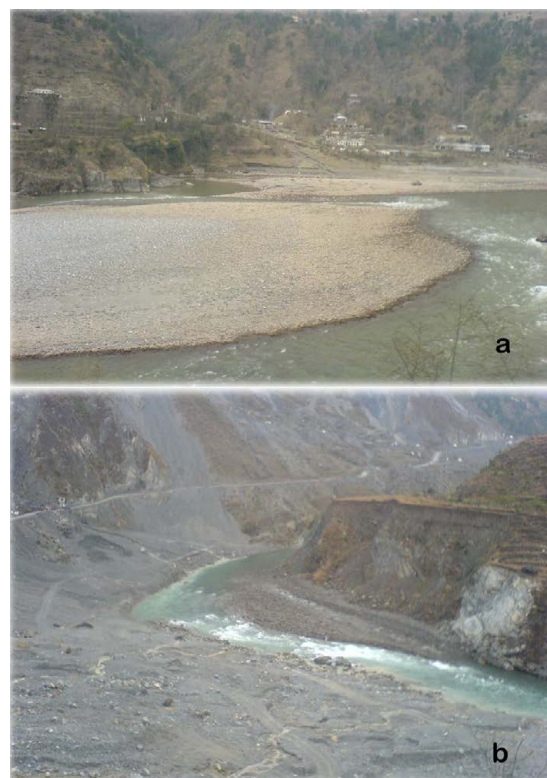
**Figure 3:** (a) Debris flow has narrowed down River Jhelum in Muzaffarabad. (b) Debris flow has narrowed down River Neelum in Muzaffarabad.

along the acute slopes as it could be observed even seven years after the earthquake-2005. The debris flows have most often narrowed the two major rivers Jhelum and Neelum that flow across the affected region. As it has been observed in 2008, slope failures in the scales of few hundred meters to few tens of kilometres in width have been recorded along the range of hills towards Muzaffarabad and Balakot. They were seen widening over the following four years. Figures 2 and 3 show such debris flow which hampered the natural flow of water in the respective rivers. The loosely bound unstable soil stratifications left by the debris flow which stands at almost  $90^\circ$  slopes (Figure 2b) hint that they may give up at any instant creating further catastrophe. The topography of the entire hill boundary along the two rivers showed this ready-to-flow feature as our observation team visited the area in 2012. The study visit made in 2008 showed that more than 75% of the hill gradients in the affected area with slope angle exceeding about  $60^\circ$  are deprived of vegetation. Even by 2012 the situation remained nearly the same in many parts while in some cases it has become worse as the light tremors and heavy rainfall has resulted further collapsing of loosely hanging soil layers that retained the vegetation. Figure 4 shows the large scale rock avalanche occurred in Hattian Bala which destroyed the vegetation in a vast area while killing over 12,000 within a period of about 10 minutes after the earthquake. The photographs in Figure 4 have been taken in 2008 after more than two years since the earthquake. Even by 2012 the vegetation did not show any signs of recovery. This may most often be due to the exposure of rock in the high elevations and covering of soil

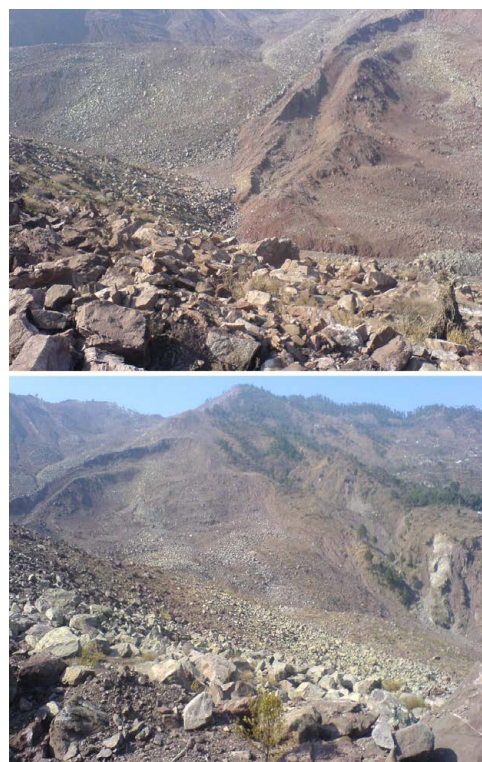
**Figure 4:** Hattian Bala rock avalanche in two directions. The vegetation in a large area has completely been destroyed by the rock flow. Estimated number of 12,000 people has been buried in the debris.

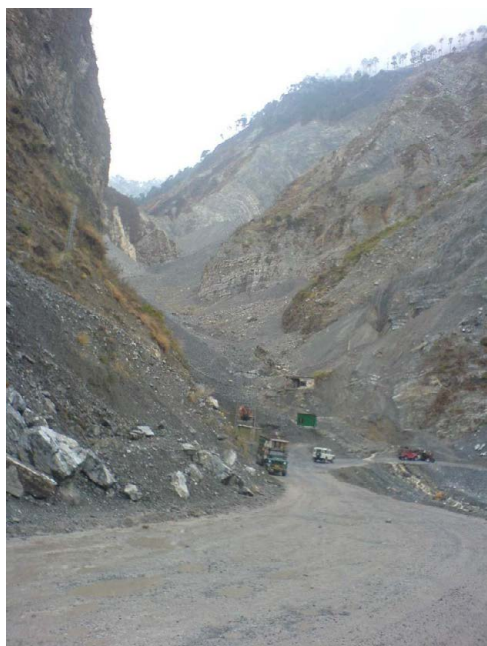
**Figure 5:** A metal quarry causing severe damage to the hills that are already stripped by the earthquake of its once beautiful lush greenery.

in the lowlands by rock debris. At several sites where the rock has been exposed due to the down flow of soil masses, metal quarries have been started further eroding the surface. Figure 5 shows hill slopes in the vicinity of River Neelum in the backdrop of a metal quarry that harvest the exposed rock.

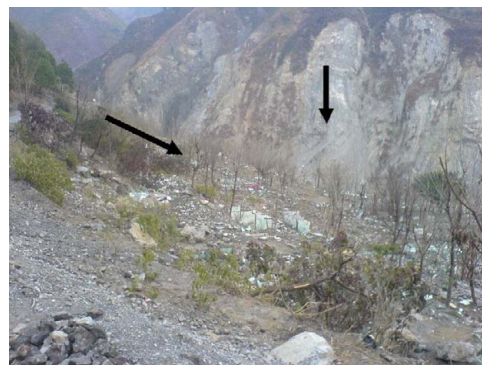
**Figure 6:** A village of over 500 houses wrecked by the tremor and the consequent boulder/debris flow. Arrows indicate the directions of material flow after the tremor.

Irrespective of the known facts of large earthquake generation potential of the India-Tibet subduction region, the building structures; commercial, industrial and domestic; in the affected region have been designed without taking any measures on the earthquake effects. Furthermore, even as recent as in 2012 it has been observed that the new structures are put up in the region that may not withstand land movement and earth tremors, despite predictions of the possible occurrence of high end earthquakes (of which the magnitude may exceed 8.0) in the future [14]. Figure 6 shows the wreckage of a once a lively community on a hill slope in Muzaffarabad about 2 years after the earthquake-2005. The picture depicts the devastating effects of the tremor and consequent boulder-flow which has totally destroyed the buildings. Eye witnesses survived, with whom the inspection team has communicated mentioned that there were even concrete structures and beams were demolished by the tremor and debris flow. Arrows indicate the direction of debris flow.

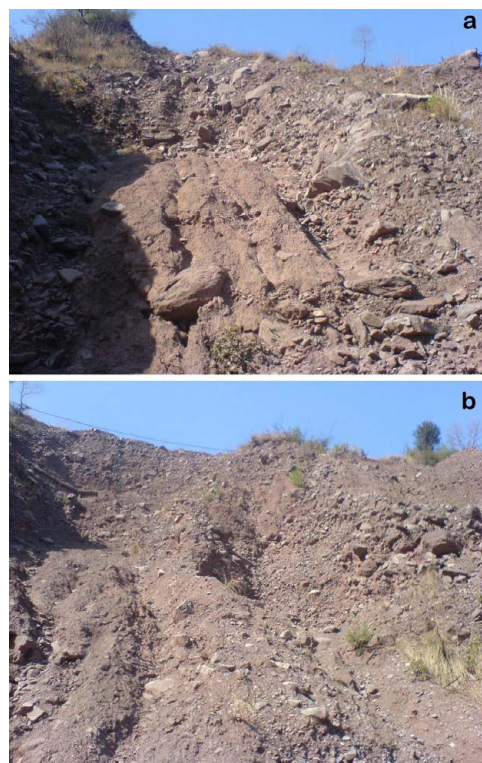
**Figure 7:** Loosely hanging soil in the earthquake affected area (in built up area close to the city limits).

Frequent minor debris flow could be observed throughout the period of study even in built up areas. Figure 7 shows such locations close to the city centre in Muzaffarabad. The exposed soil profiles are characterised by soft bedrock type structure with fragmented and weathered unconsolidated rock debris in the basal subsoil. These localised debris flows are grossly neglected due to the large scale catastrophes looming over the area. The instability of slopes over small elevations (5-10 m) may affect many small houses and dwellings which shelter a sizable number of people. This relatively small debris flows most often move considerably large boulders down slope, of which the size sometimes exceed 1 m<sup>3</sup> (Figure 8). These boulders either end up in rivers causing damn formation or in highways or by roads causing traffic block. A number of new settlements could be observed on or

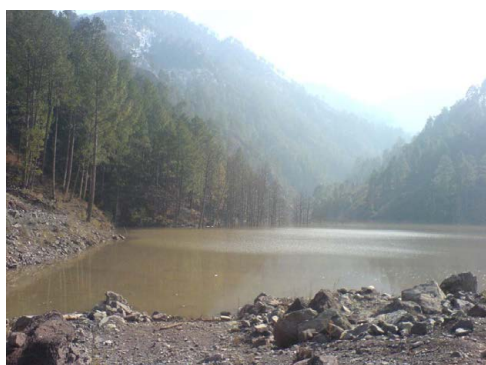
**Figure 9:** A lake formed after the earthquake close to the Hattian Bala rock avalanche.

Several lakes have also been formed in the area aftermath the earthquake. One such lake that has been formed adjacent to the Hattian Bala rock avalanche is shown in Figure 9. A majority of these earthquake generated lakes were observed at isolated location, thus there were no human settlements developed in the neighbourhood by the time of conducting the investigation. As per our knowledge, until now there are no scientific studies that have been conducted to understand the lake environment such as bank stability, lake-bed structure, water quality etc. Hence, it is better prevent human settlements forming in the lake neighbourhood until such investigations are conducted.
