## Management of Peristomal Skin Complications with Negative Pressure Wound Therapy: A Case Study

**Aim:** Estimate the effectiveness of the Negative Pressure Wound Therapy (NPWT) into managing a complex peristomal skin complication in a patient with a urostomy. The goal was to improve the conditions of the skin in order to concede stoma management with the appropriate ostomy device. The clinical condition of the patient was exasperated by her overall status: advanced neoplasia, skin deterioration and diabetes.

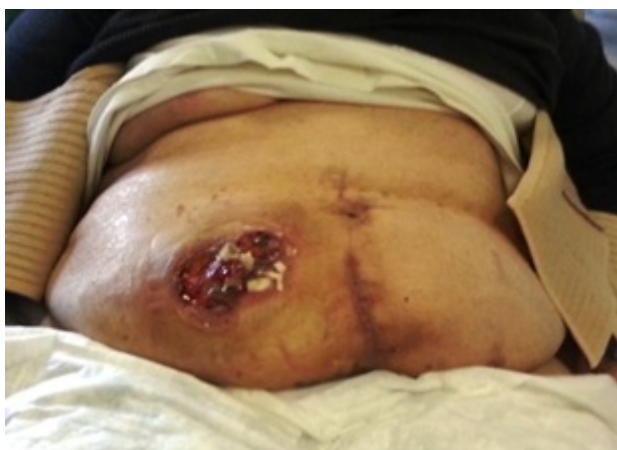
**Figure 1:** Peristomal Skin Lesion L4-TV (S.A.C.S. Classification).

The patient was an elderly woman of 72 years who suffered from a malignant metastatic bladder cancer. She had a complex medical case: urostomy (Wallace 2), overweight, arterial hypertension, diabetes, impaired mobility. The patient had a severe peristomal skin lesion L4-TV, according to the SACSTM Classification (Figure 1). Skin complications treatment was a priority in order to manage the ostomy with the appropriate medical device.

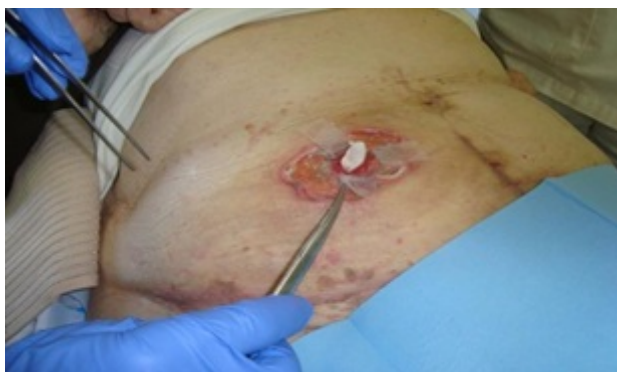
Step 1: We started protecting the periwound skin with sterile grease gauze, in order to preserve the area from Negative Pressure (Figure 2).

**Figure 2:** Positioning of the non-adherent dressing to protect the skin.

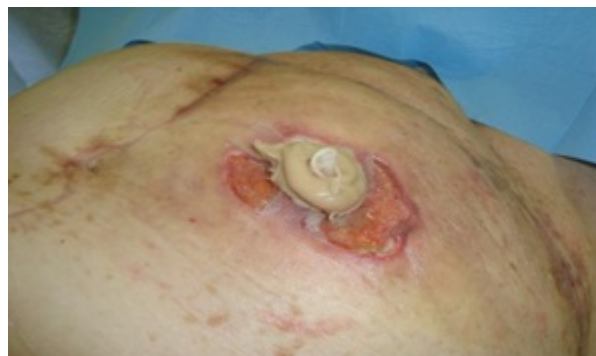
Step 2: Then we applied the Stomahesive Paste to flatten and protect peristomal skin from urine leakages (Figure 3).

**Figure 3:** Application of the Stomahesive Paste in order to protect the lesion from the urine.

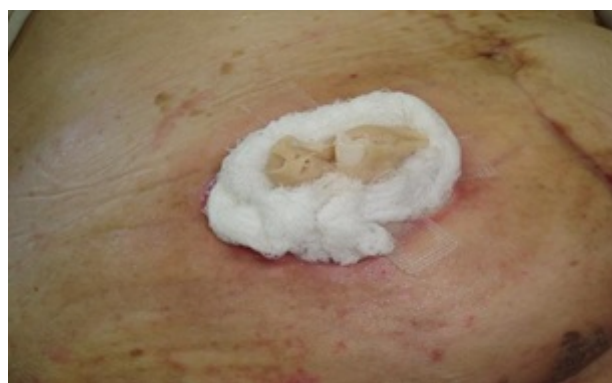
Step 3: As we experienced some challenges in adapting the Polyurethane Foam to the peristomal area, we decided to protect the skin with sterile gauze (Figure 4).

**Figure 4:** Application of the antimicrobial gauze.

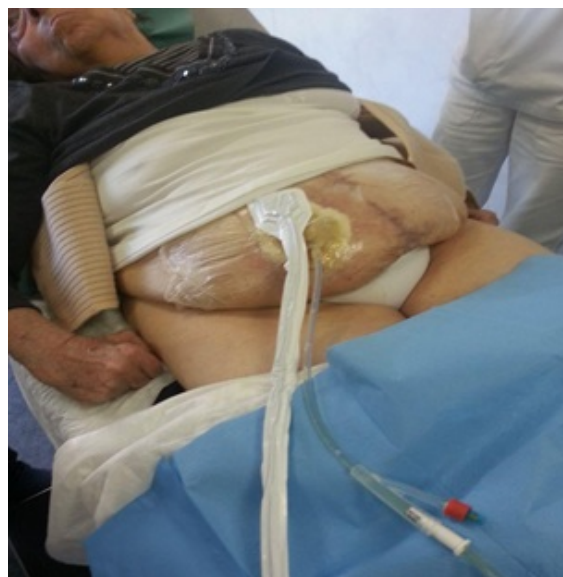
Step 4: The last step was applying the NPWT Therapy; we used a Foley Catheter in order to reduce urine leakage, placed directly inside the urinary ostomy (Figure 5). This innovative set-up allowed us to reduce significantly the risks of detaching the NPWT device.

**Figure 5:** Foley catheter and VAC Therapy application.

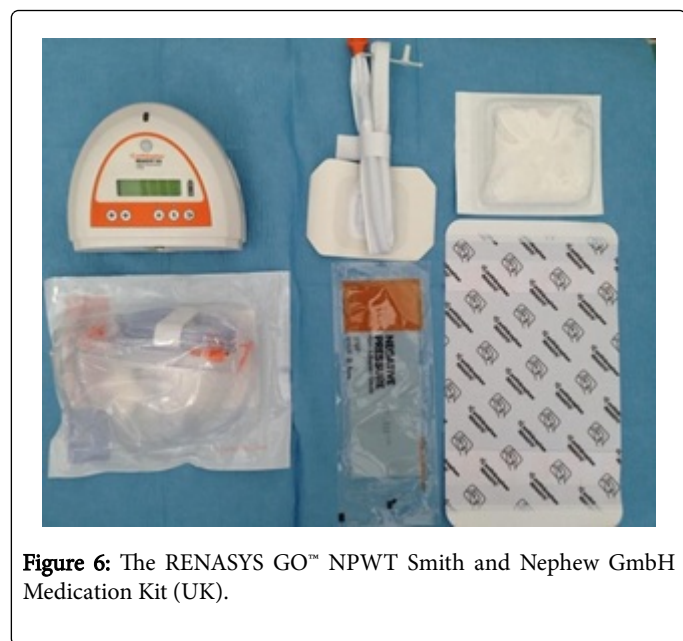
The patient was treated with a new wound dressing every 72 hours. The device used in this case study is The RENASYS GOTM, an electronic NPWT pump (Figure 6), that can offer flexibility in treating a wide variety of wounds in acute and home care settings, and it combines portability and ease of operation in order to maximize patient comfort, mobility, and convenience. This device was chosen because it allowed us to continue the treatment at the patient's home. The decision was made with the patient in order to best meet her needs.

**Figure 6:** The RENASYS GO™ NPWT Smith and Nephew GmbH Medication Kit (UK).

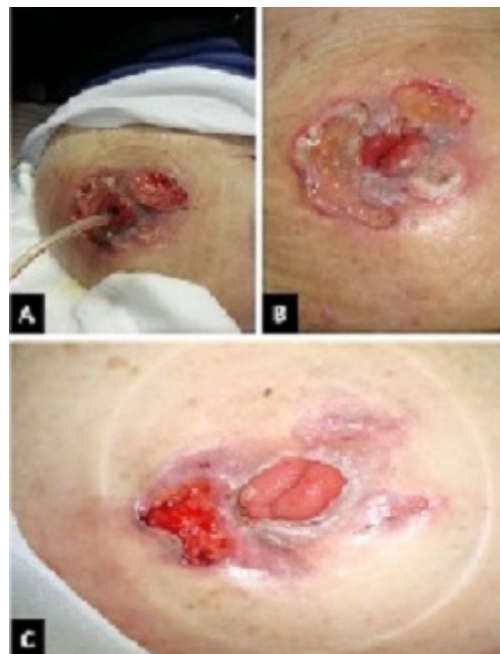
In each follow-up visit, we assessed a constantly improving condition of peristomal skin. The patient was treated with NPWT for 12 days. After this time we could already observe a significant improvement of the lesion. The skin condition, initially rated L4, improved to L3; the extension of the skin lesion also reduced from TV to TI-TIV (Figure 7).

**Figure 7:** (a) Skin lesion at Time 0 of Vac Therapy, (b) After 72 hours from the first use of the Vac Therapy, (c) After 12 days the lesion had a significant improvement to L3 / TI-TIV (S.A.C.S. Classification).
