Pacemaker Wire Perforating Colon in an Asymptomatic Patient

Clinical Image

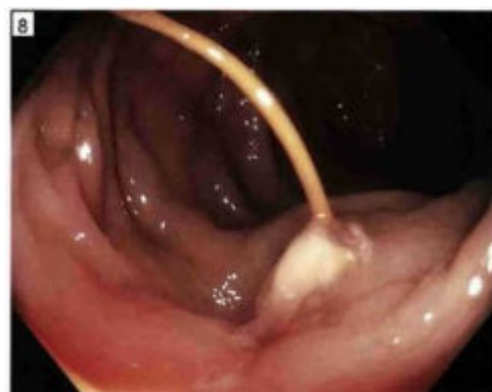
Figure 2: Point of penetration covered with granulation tissue.

Our patient is a 67-year-old gentleman with a history of Coronary Artery Bypass Graft (CABG) and Aortic Valve Replacement (AVR) and colonic villous polyps, who presented to our hospital (Monmouth Medical Center, Long Branch, New Jersey) for a follow up colonoscopy. During colonoscopy, a yellow catheter of approximately 2 mm in diameter, 10 cm long was seen emanating from the mucosa and extending freely into the lumen of the transverse colon (Figure 1). On further evaluation, our patient had an epicardial pacemaker placed during his prior cardiac surgery. Epicardial pacing is a temporary measure undertaken in open cardiothoracic surgeries especially CABG and AVR. These pacing wires are usually removed post-surgery with gentle transcutaneous traction if the patient is hemodynamically stable. However, when the wires are difficult to be pulled out, they are cut flush with the chest skin surface (Figure 2), which was likely the case in our patient. The redundant wire made an indolent tract to the colon, perforating the diaphragm (Figure 3). Because of the lack of symptoms and to avoid creating a fistulous tract, no intervention was done. In accordance with the expert opinion offered, our patient will have periodic CT imaging of the colon to monitor the position of the wire.

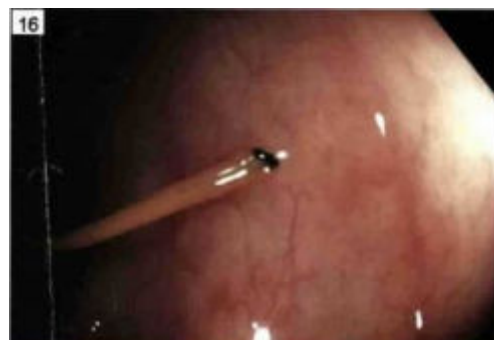
Figure 3: Tip of the wire-bevel cut.
