The Existing Challenges of Heritage Management in Gondar World Heritage Sites: A Case Study on Fasil Ghebbi and the Baths

Shegalem Fekadu Mengstie*

Department of History and Heritage Management, University of Gondar, Gondar, Ethiopia

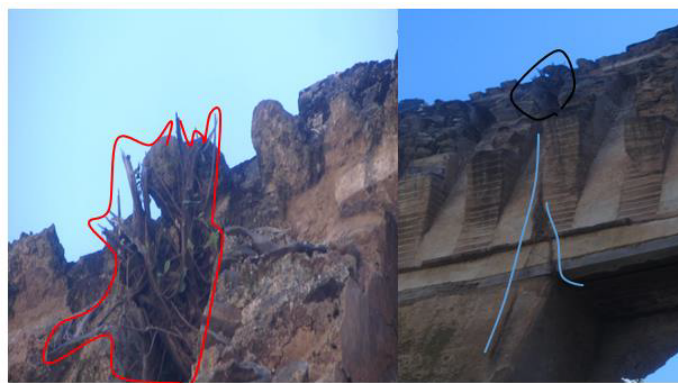
Likewise in Gondar town heritages are the victim of this kind of problem. Large and small trees (shrubs) are grown over historic structures and practically it leads to the destruction of the structures. The small trees and grasses are affecting the structures by creating algae and fungi (Biological agents). These parasites on the structure decayed the wooden materials in the structure. Whereas the large trees grown on the structure became strong trough time and their root is go down and then tauten the structure by force when it get strong. This problem is extremely affecting at the enclosure of *Fasil's* bath and palace's of Adiam Seged Eyasu (Figures 1 and 2).

Figure 1: A shows the tree grown on the upper and internal wall of the structure at the south-eastern facade of Adiam Seged Eyasu's Palace and B shows how much the root of the tree (shown at A) go down externally and we can estimate the other part of the root is go deep inside the structure to this much.

The small trees and grasses grown on the historic structures should be cleaned and better to have a permanent solution. The solution might be the culture and tourism office shall recruit a person who specializes in heritage conservation to clean and control the heritages permanently. In regarding to the big trees, the researcher strongly recommended to cut the trees before damaging the other part of the structure. Then after reconstruct or restore the structures already damaged through this case.

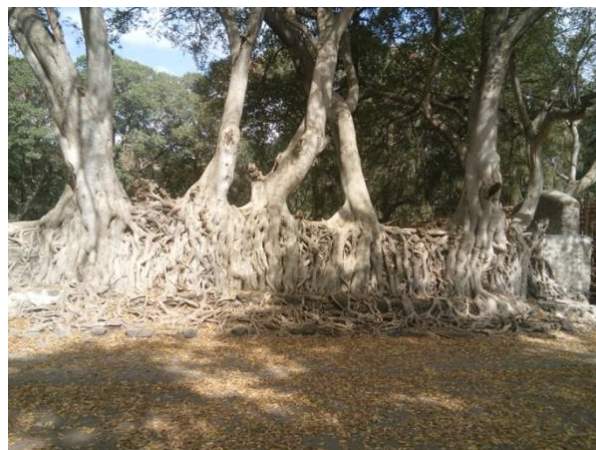
As we can see on the above image which is the western part of the main bath of *Fasil*, approximately 5m of the historic building is totally demolished by plants grown over it. This means ~5m structure is fully lost by the root of the trees. First it was grown like as the small trees displayed in Adiam Seged Eyasu's palace (Figure 3).

Figure 2: The western external part of the façade of the main bath.

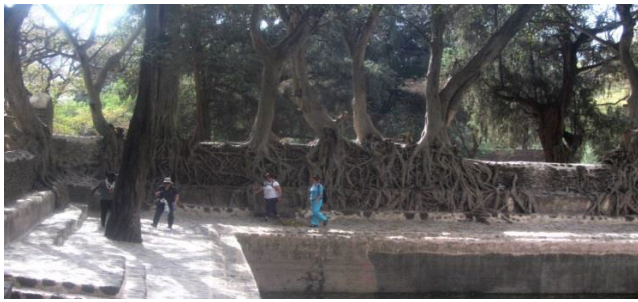
In the external part of the structure the building is totally covered with the root of the trees. Whereas, in the eternal part of the structure (Figure 3) indicates how the roots are tauten the structure;

Figure 3: The western eternal part of façade of the main bath.

because the original building is displayed under the roots. In general, plant overgrowth is a common and serious problem of heritages in Gondar town and specifically on heritages in *Fasil Ghebbi* and the baths. There are shrubs, grasses and large trees are grown over the structures almost on every built heritages of Gondar town.

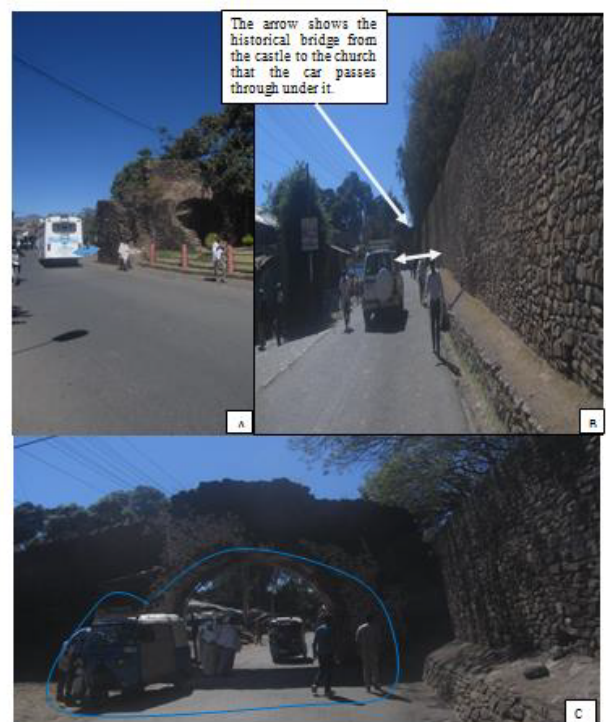
Vibrations resulting from the movement of vehicles around the palace leading to the collapse of the foundations and that needs maintenance and repair [4]. Similarly, in Gondar town, since the roads pass through almost by touching the core area of the site or the enclosure, it makes a vibration when a van passes through the road. And even there is a road under the bridge. This is a serious problem and even the case will make the site under endangered list. As we have seen above there is no specified place for parking. So, in most sites for example in the baths of *Fasil* and *Fasil Ghebbi* the parking is near the structure (Figure 6).

Figure 6: A large bus passes near the historic structure (A), a car that will pass through the historic bridge displayed below there (B) and the bridge over the road and activities under it.

In regarding to roads, squares, parking and other human activities near the site, all the concerned bodies including heritage professionals, municipality and construction offices and culture and tourism office should work together on the this problem. The flow of vans, events on the square, parking almost on the site and cars pass through the historic bridge must be urgently stopped. The settlements almost on the site or nearby and the craps disposed on heritages also needs urgent intervention and stop it. So, the aforementioned stakeholders must introduce a new legislation or law to restrict and stop the human activities that affects the heritage resources.

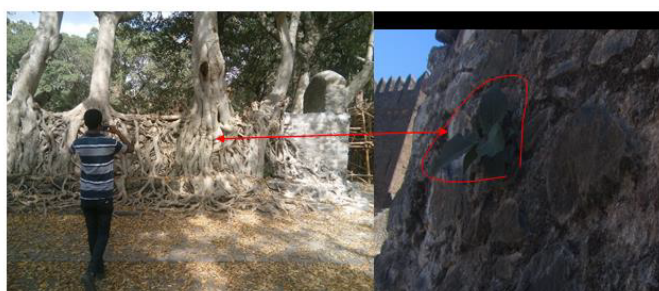
Even, the growing of large trees on the structure is the result of carelessness or negligence. As we can see the Figure 8 below (the readers' right side) trees on the structure grown like that and through time it destruct like the image below displayed on the left side. It is simple to avoid the small trees before they get strong except carelessness/ lack of due attention towards the heritage site.

Figure 8: The structure destructed by big trees at *Fasil* bath and a small tree growing on the left side of the stair goes to the second floor of *Fasil* palace.

Professionals and concerned institutions must give a due attention for the neglected heritages. The researcher believes that, the public bath located above the *Fasil* bath needs archaeological excavation and the institutions should work in relocation of settlements over the baths.

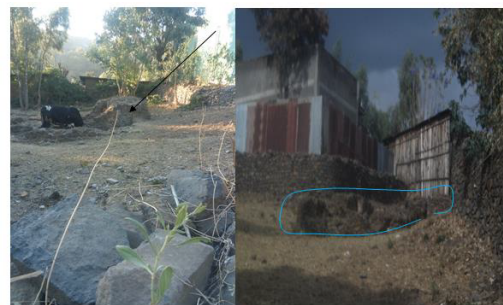
In the case of abandoned structures over the *Fasil* bath which were a public bath constructed by *Fasilare* severely neglected. The structures are destructing and almost buried with craps. The peoples living there are damping sweepings/dusts on the historic structures. Plants overgrown, herding animals and settlement inside the enclosure of the sites are destructing the heritages. The following Figures 9 and 10 shows the ruins of the public baths which was used as hen breeding during the Italian occupation period (1935-1941).

Figure 9: A circle of ruined structure buried through the accumulation of craps and now a cow is eating a grass in the circle of the structure. This shows how much the historic structure is neglected (reader's left). And the other ruin of a structure which was a public bath and now a new house is constructed over it. The new settlement almost covered the site.

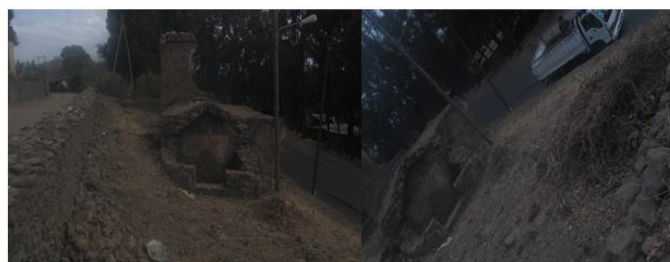
Figure 10: It is also the ruin which was the public bath during the reign of emperor *Fasil*. And as we can see on the image, it is almost destruct and the compound is full of craps. Roads also encircle the structure in two directions (reader's left). And the right image also shows when the big van passes almost close to the site (reader's right).

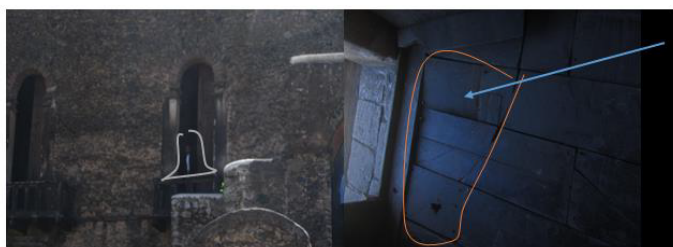
The following image is the second example for how mass tourism challenging heritages in Gondar town. The left photo (A) shows as a person standing for photo on the space at the back side of *Fasil* palace made out of wood. During the frequent visit of the researchers they saw this trend of having photo on this place. So, this trend on the wooden historical structure is a treat for its destruction. The Figure 12 on the right side; (B) also shows the defect of wooden floor of *Fasil* palace through the impact of overcrowded visitors.

Figure 12: (A) A person standing on the historical wooden structure to have a photo at the back side of the castle of *Fasil* and (B) The wooden floor of *Fasil* palace and the circle show the defect of the floor.

A number of visitors in a time should be specified or restricted. As it is stated in the main body, the domestic tourism including number of visitors during wedding should be restrict. During epiphany and other events, it is better to have a way that accommodates the visitors without affecting the site.

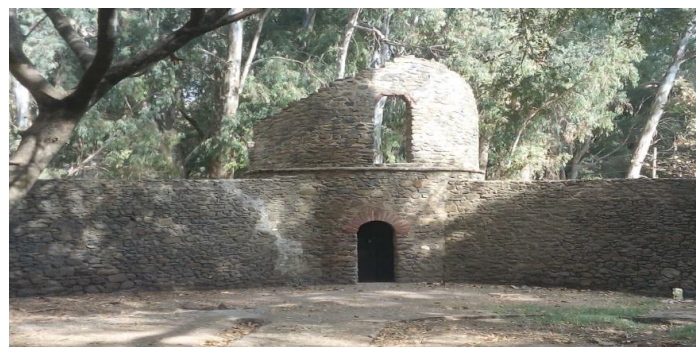
Conservation is a problem if we are falling to do it properly. And if we are doing faults in conservation it is dangerous for the heritages; because heritages are irreplaceable human resources once we have lost them. There should not be try and error on heritages during conservation work. Having with this fact, the researcher has tried to assess the conservation work done on Gondar castles and the baths of world heritage sites. Accordingly, the *Fasil* bath has four gourd houses located in four directions. Originally, the purpose of these houses was for guarding. Now they (the conservator) have conserved and returned to its original nature physically. However, they tried to adapt and reuse the one guard house for toilet. The researcher believes as this way of adapt and reuse (conservation) is not fair and it is out of the science of conservation or it is improper and destructive (Figure 14).

The above displayed guard house was constructed in the south of the *Fasil* bath for guarding purpose and it is attached with the external fence of the bath. But now it is changed in to toilet. During the researcher's survey it was locked (as the arrow showed on the image) and according to the guard, it is locked due to the lack of water. And he further stated that, every facility is prepared for the toilet and it was started its function for the aforementioned purpose. So, having with this fact let us see the principle of adaptive reuse from a quote "Adaptive Reuse: Preserving our past, building our future (2004)" Commonwealth of Australia, Department of Environment and Heritage [7]:

According to the above argument, adaptive reuse is self-defeating if it fails to protect the building's heritage values. This means the developer should not disturb or change the heritage value of the historic structure. It is also advisable when adaptive reuse of a building is the only way to sustain the building and should not be a problem for the environmental settings. However, in the case of *Fasil's* bath guard house is now changed to toilet. That means the original value of the guard house is totally changed. And the new function of the house by itself is destructive for the heritage

Figure 14: The guard house found on the south of the bath.

and disturbs the surrounding environment. So, the work is done in contradict with the principle of adaptive reuse.

or should not be destructive. Conservators shall consult the professionals in the area. In the case of the adaptive re-use at *Fasil* bath all the materials for the installation of toilet in a historic structure should out and make it free or better to adapt and reuse for non-destructive purpose.

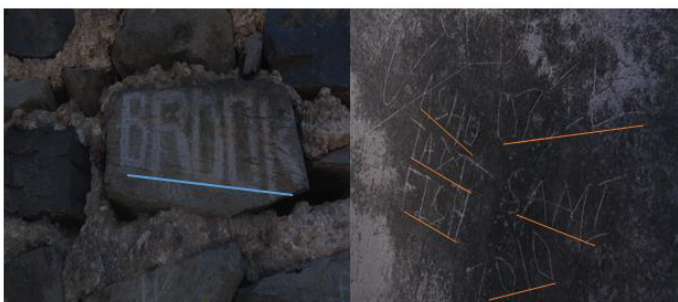
In the case of heritages in Gondar town, except selling of tickets at the entrances; no follow up of tourists after they enter to the enclosure. Particularly in the castles, no body follow-up the visitors; what they are doing inside. Due to this problem visitors made a graffiti (strike and incise) on the wall and write their name and sign their signature on the wall. As we can see on the Figure 15 and 16 below, the names written with strike strongly spoiled/damaged the surface of the wall. The image shown at “C” is the name written on

the wooden part of the wall. So, this problem is affecting not only on the plastering wall, but also on the wooden part of the structure.

Figure 15: (A) Strike and written name (BROOK) on the external wall of the then archival center (B) Strike and names (ASHU, OZIL, TADI, SAMI, FISH and ZOLO) of the visitors on the plastering of eternal wall of the Fasil bath.

Tourist-follow up system also mandatory and it might be in the form of installing a hidden camera or follow up the visitors in person. In doing so, we can minimize or avoid illegal activities inside the sites by the visitors who visit the site without guide.

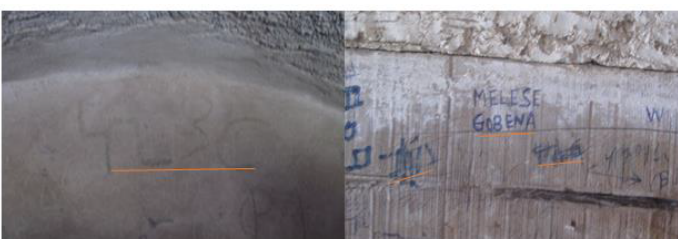
Figure 16: (A) shows written name (h,PC) by striking on the plastering ceiling of the bathe of Fasil Gehebbi and (B) shows again strike, written names (MELESE GOBENA) and signatures on the eternal ceiling of Emperor Bakafa’s castle.
