# The Spatio-Temporal Dynamics of the Gully Since 1986-2017 on Roads and Adjacent Lands: Case of Ouzera, Medea, Algeria

In Algeria, roads necessarily cut land and divert the flow of water from their natural ways. Thus in our study area: Ouzera, before the installation of the agricultural village, the area was covered with vineyards which maintained and protected the soil cover. Currently, thinning of the surface and intensive and unsuitable cultivation practices to the severity of the landscape contribute to increased erosivity that irreversibly damages the soil. The road-level civil works, carried out in 1986-1987, created a large ravine. The effects of runoff from underground drains installed in 2000-2001 resulted in the formation of six (6) other gullies parallel to the ravine which was itself a gully. These devastate cultivated land and increase the cost of maintaining the road. Also, the evolution of the slope, densely populated (agricultural village) raises more and more questions about the future of these environments and these societies. The curbs of the road rightly worry the residents who see their fields cultivated or their meadows little by little nibbled by the flows.

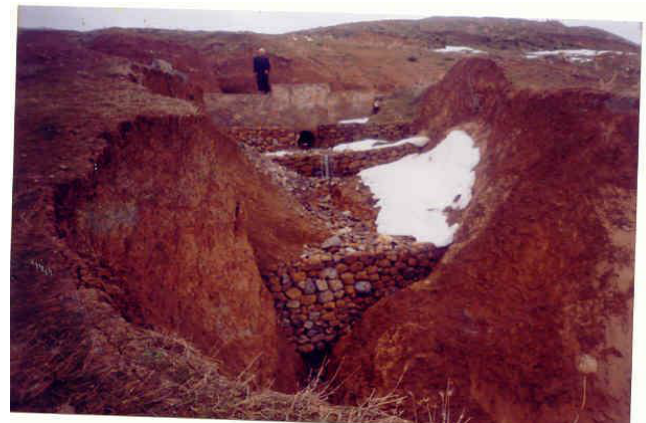
to grow. The ravine widens and widens, encroaching on cultivable land. The road perpendicular to the ravine (Figure 1) is more and more deteriorated. This deterioration is amplified over the years and takes alarming dimensions. The inhabitants are worried about the future of their land and the whole village. Faced with this problem, the local authorities tried to limit erosion at the head of the ravine (Figure 2) using the superimposed gabion thresholds on 01/11/1998 [1]. Three months later, on 10/02/1999, there were torrential rains with an intensity of 57 mm. After these torrential rains, 60 cm of snow were recorded in 48 hours. At that time all the conditions are together to

Figure 1: Thresholding of gabion thresholds: HAOUCH ZEGAA-OUZERA.

On November 16, 1999, a heavy rainfall (int=28 mm) fell on this gully from which soil soaked in water. The head of the ravine has evolved a lot: sections of the flanks of this ravine break and slide along the walls partially clogging the bottom of the ravine. Since 1988, this ravine has become an outlet for the surplus water of the fields, inhabitants (roofs) of the agricultural village. Over the years, following the increase in population and land use, the flow that runs through the gully, gradually increases from its source (at the top of the village) until its discharge into the wadi. The widening of this ravine began in 1987 and has continued to the present day (according to the testimony of the peasants). This ravine has become a ravine. The monitoring of the spatio-temporal evolution of the latter began since the year 2004. In 2005, a development was carried out by the civil engineering (gabion threshold at the head of the ravine) (Figure 1) [3,4].

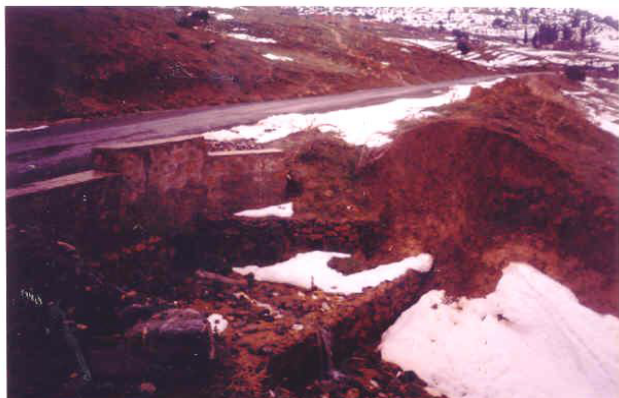
**Figure 2:** Des pluies diluviennes se sont abattues sur la région de Ouzera. Durant 24 h, les 4, 5, 6, 7 seuils en gabion ont basculé vers l'aval après ce déluge.

The collapse of gabion thresholds (Figure 2) is mainly due to torrential rains, which had previously fallen. All the sediments coming from upstream have moved downstream from where widening of the ravine: between the flank of the right ravine and the threshold in gabion=40 cm, and between the side of the left ravine and the threshold in gabion=20 cm. The gabion thresholds have dropped by 37 cm. At the level of the first gabion threshold, there is a platform that could stall. On the other hand under the two thresholds (gabion), there exists a drain in the form of tunnel (2 m 70 cm long). Clean water from this drain pushed the sediments and large blocks below the gabion thresholds downstream. Eight months later, all the sediments left in the bottom of the ravine.

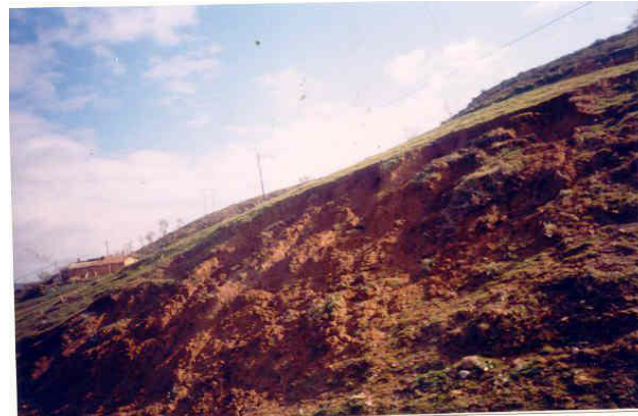
**Figure 3:** Landslide.

This slip is located below the agricultural village on the road to Kef Bou Khélil (Figure 3). The slope is constituted by marl passing to clays in certain places. Heavy rains occurred during this slip period. Part of this slope was completely overhauled on 10/03/2007 by a movement of superficial formations that slid along the slope. In this area, there are

many sources. At the base of this detachment, it is probably necessary to invoke some deformations that have prepared the ground, and also may be some withdrawals having opened crevasses where water engulfed during heavy rains of 08/03/2007. At first sight, this slope shows us a slip in packets [5]. Almost all the trees or shrubs on this slope are tilted, indicating that it is a sudden movement. Thus, in the agricultural village, the road linking Ouzera to Kef Bou Khélil poses a problem for DTP services, which have to recharge it almost every year as a result of subsidence.

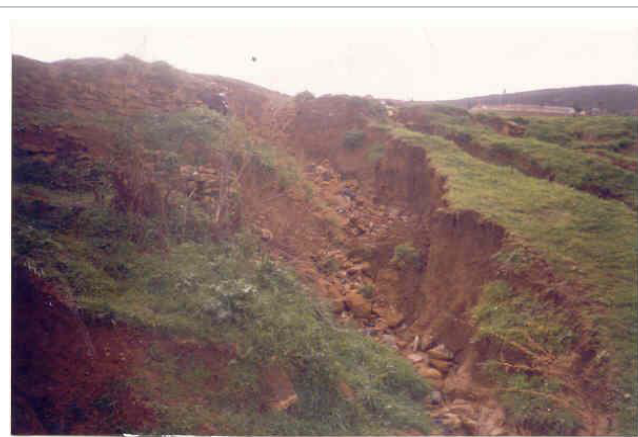
**Figure 4:** Ravines parallel to the ravine: Houch Zegaa Ouzera.

The ditch along the road from Ouzera to El Djouahria has not been rebuilt in 40 years. The location of the underground drains caused this gully and deteriorated the road that is loaded each year. Thus, this ravine appeared perpendicular to the road and also other gullies parallel to the latter already studied (Figure 4). This is largely due to civil engineering works along the road. Erosion debris from this ditch along this road is deposited on good arable land [6]. Water flowing from the underground drains and the road, has dug ravines. These gullies are formed perpendicular to the road following the work done by civil engineering.

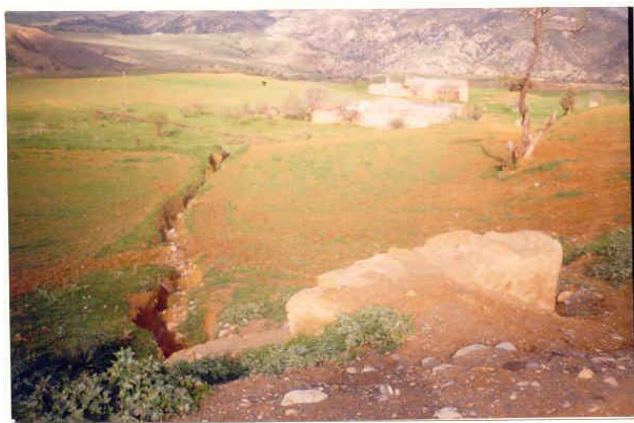
Figure 5: Gully from underground drains all along the road is entering the field.

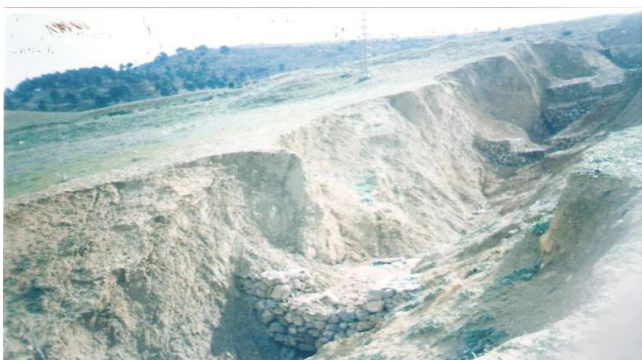
A development was carried out by the Forest Conservation of the Wilaya of Medea inside the ravine (Figure 6).

Figure 6: Torrential correction: gabion thresholds Haouch Zegaa - Ouzera shooting 27/03/2007 and at the slope.

The foresters placed 09 gabion thresholds in the ravine (Figure 6) and a dry stone retaining wall (Figure 7) to support the landslide:  $L=120$  m,  $h=1$  m,  $l=80$  cm. This torrential correction was negative. The last three years 2015-2017: all gabions have sunk into the bottom of the ravine bed. The latter has been filled during these last years by sediments coming from the banks of this ravine. We noticed that the surface of this ravine became uniform. In the middle of this ravine natural vegetation grew during this period (Figure 8).

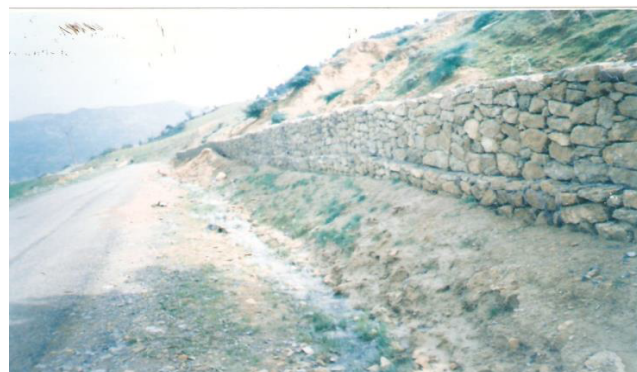
Figure 7: Natural drainage ditch along the road.

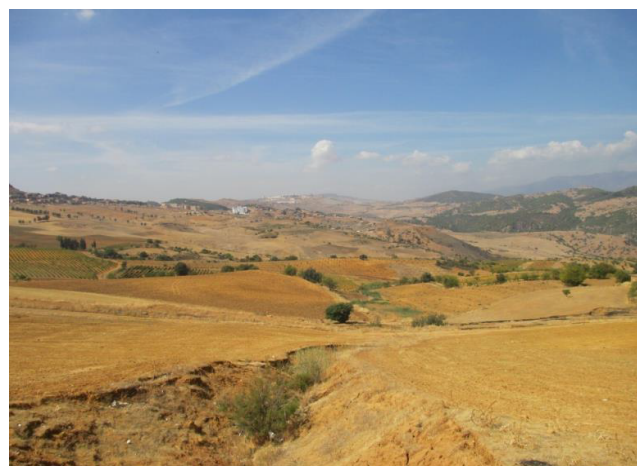
Figure 8: The ravine of Haouch Zegaa: Ouzera.

This vegetative cover was reconstituted spontaneously as soon as the factors of degradation and destruction ceased to act (after Benchetrit, 1955). This vegetation has provided greater soil regeneration than erosion ablation, and there is therefore a parallel regeneration of soil and vegetation to the initial stage without any human intervention. This ravine through which vegetation is installed. It is a true biological wound dressing that had opened soil erosion since 1986 to date 2017. It is urgent to remove all the underground drains under the road, to make the biological correction and finally to let the water that comes from upstream flow into the natural moat.
