Understanding, Interpreting and Reporting a Total Hip Arthroplasty Radiograph

Jonathan Chan*, Al-Achraf Khoriaty, Chu-Hao Chiang and Nawfal Al-Hadithy

Department of Orthopaedics, Waikato Hospital, New Zealand

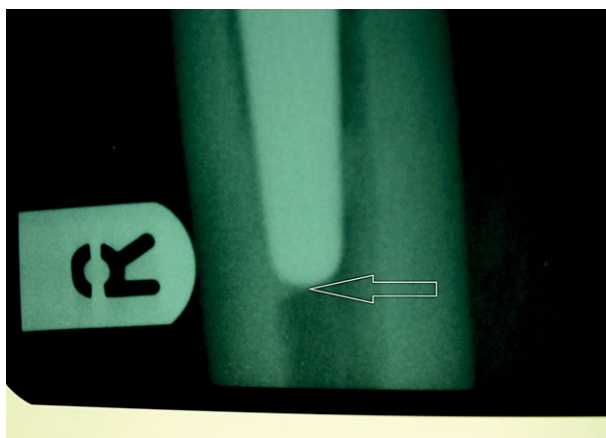
Figure 4: A bone pedestal is noted at the distal tip of the implant.

A transverse sclerotic line lying below the tip of uncemented stems

may also be detected. This is known as a *bone pedestal* (Figure 4). Although it may be associated with tip stability, it is also encountered just as frequently in unstable implants [11]. Cautious further evaluation and sequential radiographic follow-up is therefore advisable when this sign is encountered as well as observation for other signs of stability or instability.

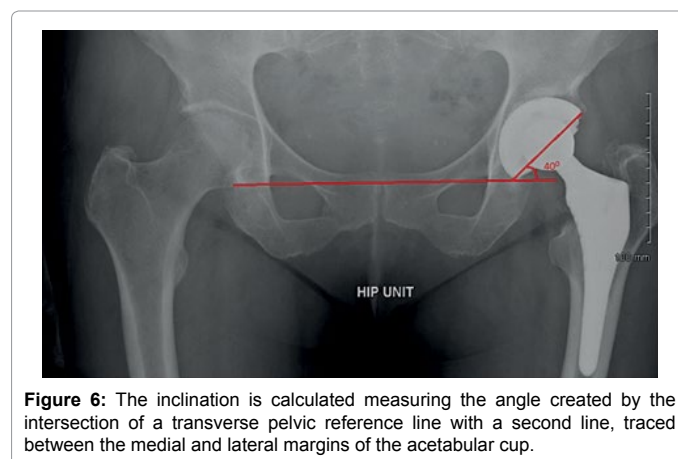
Figure 6: The inclination is calculated measuring the angle created by the intersection of a transverse pelvic reference line with a second line, traced between the medial and lateral margins of the acetabular cup.

The inclination is calculated measuring the angle created by the intersection of a transverse pelvic reference line with a second line, traced between the medial and lateral margins of the acetabular cup [34] (Figure 6). It is also possible to use the longitudinal axis to measure the angle of inclination. The acceptable angle of lateral inclination is said to be between 30 and 50 degrees [34]. An angle of 45-55 degrees is thought to confer the best range of motion [35].

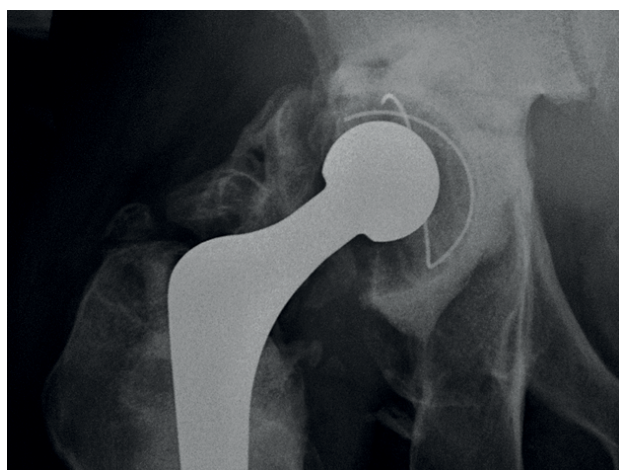
Figure 8: The difference between D1 and D2 can clearly be seen on this film. Type 3 heterotopic ossification is also noted.

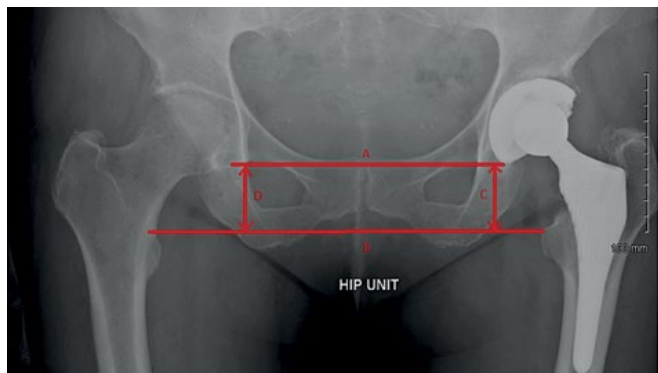
Figure 9: A reference line (A) is drawn between the inferior acetabular teardrops and compared with an equivalent line connecting the lesser trochanters (B). The difference between the perpendicular lines connecting the two is calculated (C-D) and this indicates the difference in leg length.

Leg length: Leg length discrepancy is a well-recognised postoperative complication in THAs. Its incidence has been found to be as high as 27% in studies [40]. Any discrepancies in leg length should be noted by the reporting physician. A discrepancy of 1 cm is usually acceptable and should not cause clinical symptoms. It is however well documented that even such a small change in leg length may give a patient an unsatisfactory outcome [48]. It is therefore important to report any significant discrepancy in leg length.

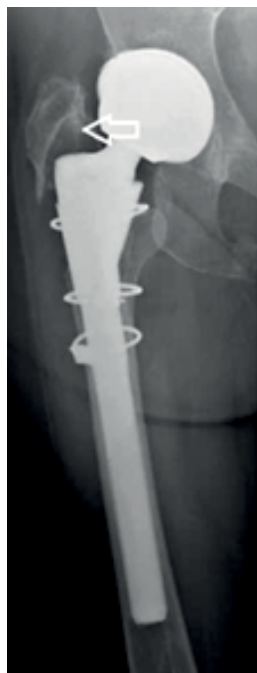
Figure 13: An A(G) periprosthetic fracture involving the greater trochanter.
