Total Hip Arthroplasty in Severe Osteoporosis - Technical Tips to Avert Complications Prophylactic Locked Plating Along With Total Hip Arthroplasty for Severe Osteoporosis with Intramedullary Nail *In Situ*

Rajesh Malhotra and Deepak Gautam*

Department of Orthopedics, All India Institute of Medical Sciences (AIIMS), New Delhi, India

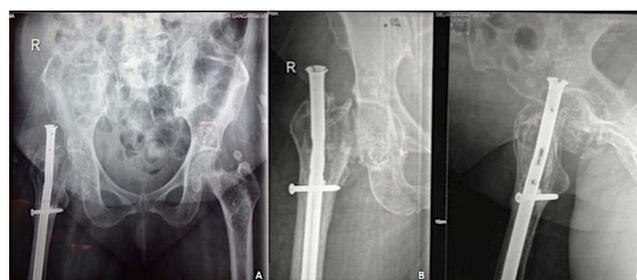
Figure 1: (A) Antero-posterior roentgenograph of both hips with pelvis showing fracture neck of the right femur (B) Antero-posterior roentgenograph of right hip in internal rotation (C) Antero-posterior roentgenograph of right hip in external rotation showing un-united fracture neck of femur.

On radiographic evaluation, she had fracture neck of the femur. The fracture margins were sclerotic with slight resorption of femoral neck on both sides suggestive of old fracture (Figure 1). The roentgenograph also showed severely osteoporotic bones and a malunited fracture of the lower third of the femur with interlocking nail *in situ* and localized pronounced osteopenia at the fractured site. The distal end of the nail was perforating the anterior femoral cortex (Figure 2). This stress riser was a risk factor for fracture following nail removal.

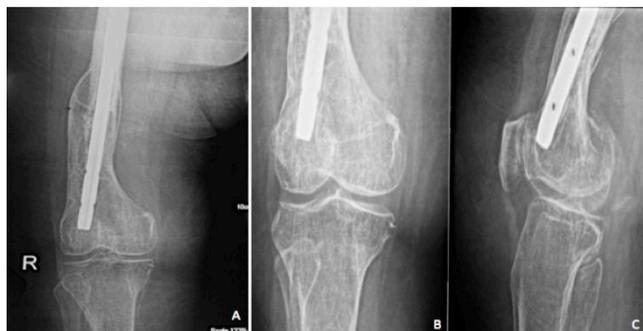
Figure 2: (A) Antero-posterior roentgenograph of the right knee with lower end of thigh showing the malunion and the distal end of nail (B) Antero-posterior roentgenograph of the right knee with lower end of thigh showing the lower end of nail (C) lateral roentgenograph showing the lower end of nail piercing the distal anterior femoral cortex.

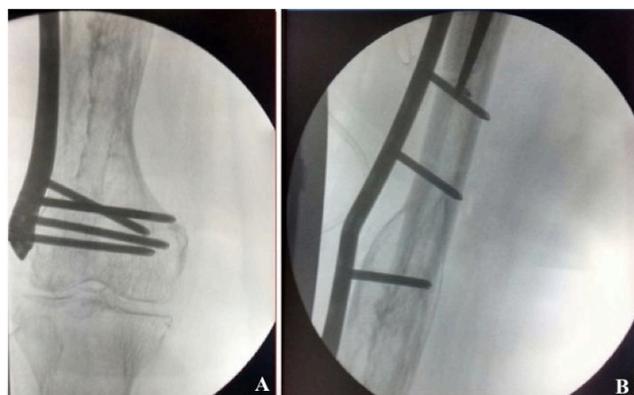
Figure 3: (A) Intraoperative roentgenograph showing distal femoral locking plate fixed to distal femur. Note the track of intramedullary nail, which was removed (B) Contouring of the plate at malunion site.

- The plate was then fixed with locking screws under the image guidance (Figure 3). A hole was drilled for the use of a unicortical

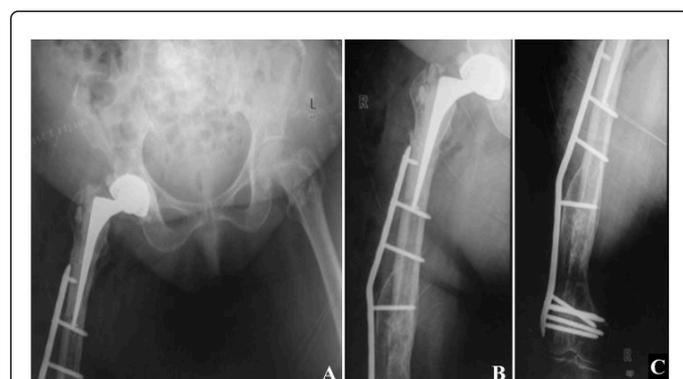
Figure 4: Immediate post-operative roentgenograph showing (A) Cemented total hip arthroplasty in right hip (B & C) Distal femoral locking plate applied prophylactically.

Postoperatively, the patient was made to sit by the side of the bed with legs dangling down on the evening of the surgery. She was mobilized and made to walk with the help of walker on the next day of surgery under the supervision of a physiotherapist. At the latest follow up of two years, the patient is walking well without any support, which she left after 6 weeks of surgery. The implants are well positioned *in situ* with no signs of migration or failure (Figure 4 and 5). However, she is continuing her anti-osteoporotic therapy.

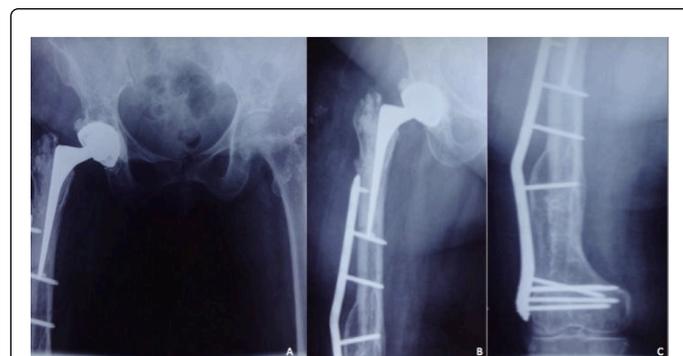
Figure 5: Roentgenograph at two years follow up (A) Antero-posterior view of both hips with pelvis (B) Antero-posterior view of right hip with upper thigh. (C) Antero-posterior view of right knee with lower end of thigh showing the plate protecting the malunited site.
