A Traumatic Dislocation of a Unicondylar Knee Replacement: A Case Report

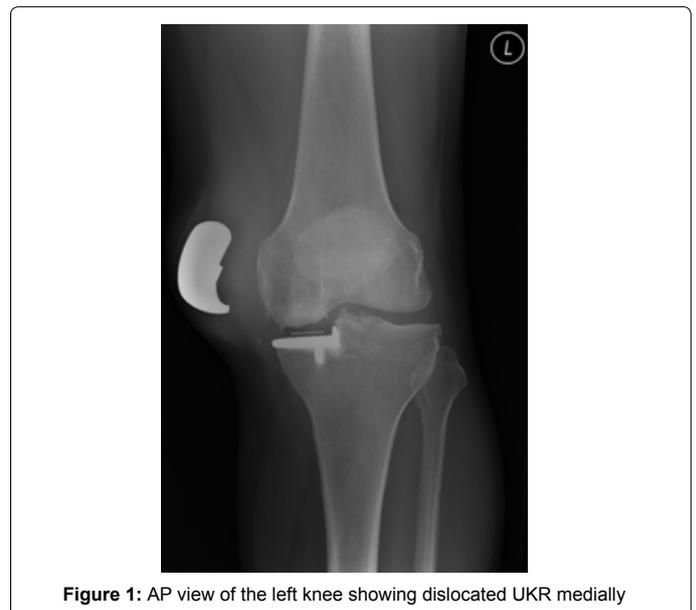
Figure 1: AP view of the left knee showing dislocated UKR medially

A 68 year old farmer presented to the emergency department with a swollen left knee. He was crushed between a young calf and a wall as the calf kicked back onto him. He felt immediate pain in the left knee and was unable to stand on the leg as the knee collapsed under him. This knee had in situ a medial Oxford Uni-compartmental replacement (UKR) since 2006 for osteoarthritis. On examination, he had a grossly swollen left knee joint with a large medial haematoma and healthy intact skin overlying the joint. There was no obvious deformity of the left leg and it was neurovascularly intact. It was an isolated injury and plain knee radiographs showed the femoral component of the UKR completely dislocated and displaced medially to the joint line (Figures 1 and 2).

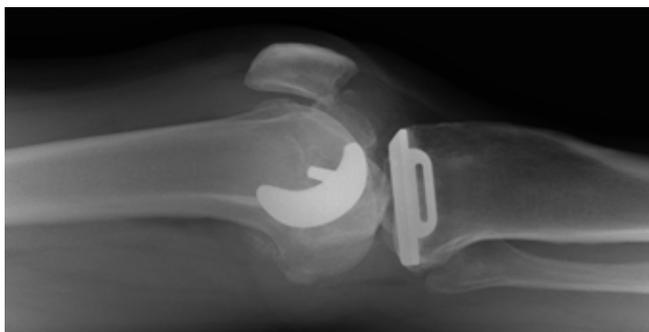
Figure 2: Lateral view of the left knee with medially dislocated UKR femoral component

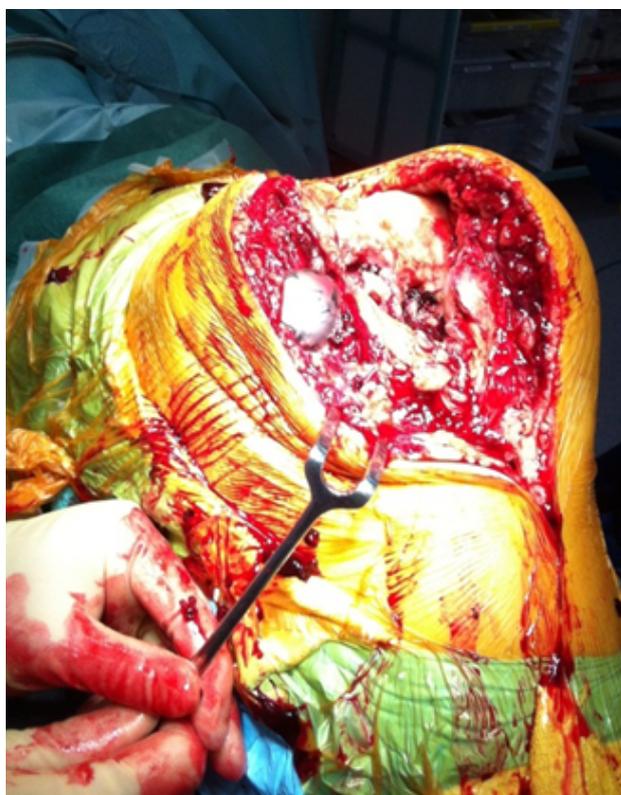
Figure 3: Intraoperative exposure of the knee with the metal femoral component floating in the soft tissue and tip of torn ACL inferiorly

Examination under anaesthesia revealed medial instability of the knee with a maximum valgus deformity of 30 degrees suggesting damage to the medial collateral ligament (MCL) and possibly the cruciate ligaments. Through an extended medial parapatellar incision and approach the knee joint was exposed (Figures 3 and 4) revealing the dislocated femoral component in the medial subcutaneous tissue. There was a large defect in the medial joint capsule and avulsion of the MCL off its femoral attachment. The anterior cruciate ligament was

completely torn (Figure 3) whilst the posterior cruciate ligament had 20% of its body intact. The tibial component of the UKR including its fixed bearing was secure. This was removed and the MCL repaired with 2 Mitek bone anchors with repair of the capsule using number 2 Vicryl sutures. A posterior stabilised PFC (DePuy) TKR was then performed. Post operatively the knee was placed in a hinged knee brace with unrestricted range of movement for six weeks. The patient currently

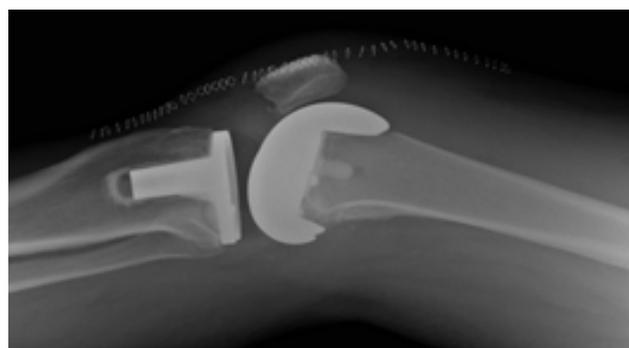
Figure 5: Lateral view of the left knee postoperatively after revision to TKR

A definitive management plan was made to revise the UKR to a Total Knee Replacement (TKR) (Figures 5).
