## The Artificial Urinary Sphincter Infection that Occurred 10 Years Later from Implantation

### Abstract

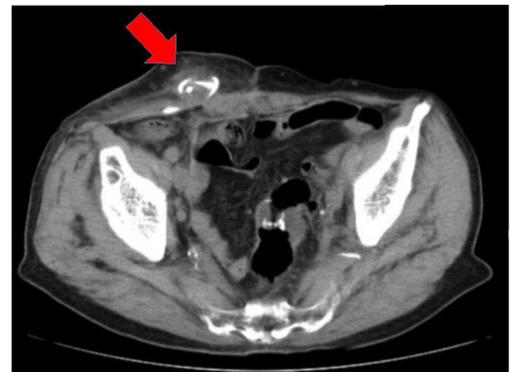
**Figure 1:** Computed tomography image. Inflammatory change around the tube of AUS were shown.

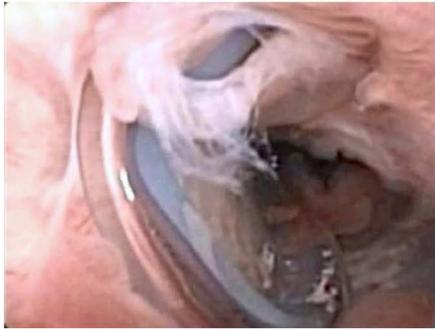
**Figure 2:** Bulbar urethra observed by urethroscopy. Urethral cuff erosion on the surface and bulge of the cuff into the lumen of urethra were seen.

In this case, Cuff erosion was observed after urethral catheter indwelling for abdominal surgery. Late erosion will occur at any time after insertion. So, the cause of infection is thought to be inserting urethral catheter. It is difficult to be thought that infection was introduced by surgical incision. The reason why the cause of infection is not surgery because there was no report about infection of AUS in association with abdominal incision so far, and if the infection were

Treatment for infection is recommended to remove the device [6]. We have planned to conduct removal of the device, however, the patient was treated effectively with only administration of antibiotics and recurrence of infection has not been observed for 6 months with cystostomy. Cystostomy was placed to cope with urinary incontinence due to malfunction of AUS, and to prevent reinfection. We finally took out the device except the cuff to treat the infections when the device tube became exposed with pus discharge. We did not remove the cuff that dent into the lumen of urethra, because urethrectomy would be needed, but it thought to be invasive procedure for the aged patient. If reinfection of the cuff will occur, urethrectomy may be taken into consideration.

What is critical is to prevent occurring of urethral erosion and infection of AUS. While indwelling urethral catheter, adequate procedure to deflate the cuff is needed with meticulous attention in particular.

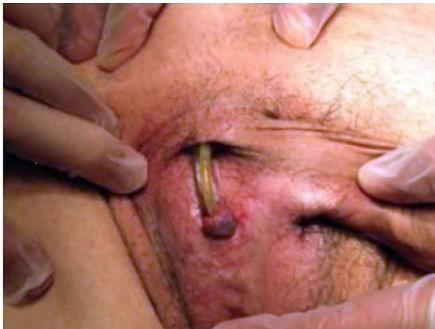
**Figure 3:** The tube of AUS exposed on the outside of right scrotum skin.

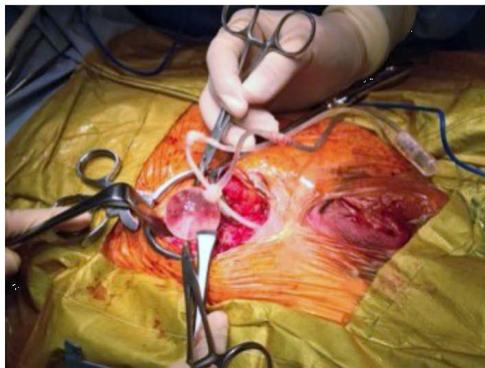
**Figure 4:** Removal of AUS unit except the cuff.
