Disaster in Rudraprayag District of Uttarakhand Himalaya: A Special Emphasis on Geomorphic Changes and Slope Instability

Abstract

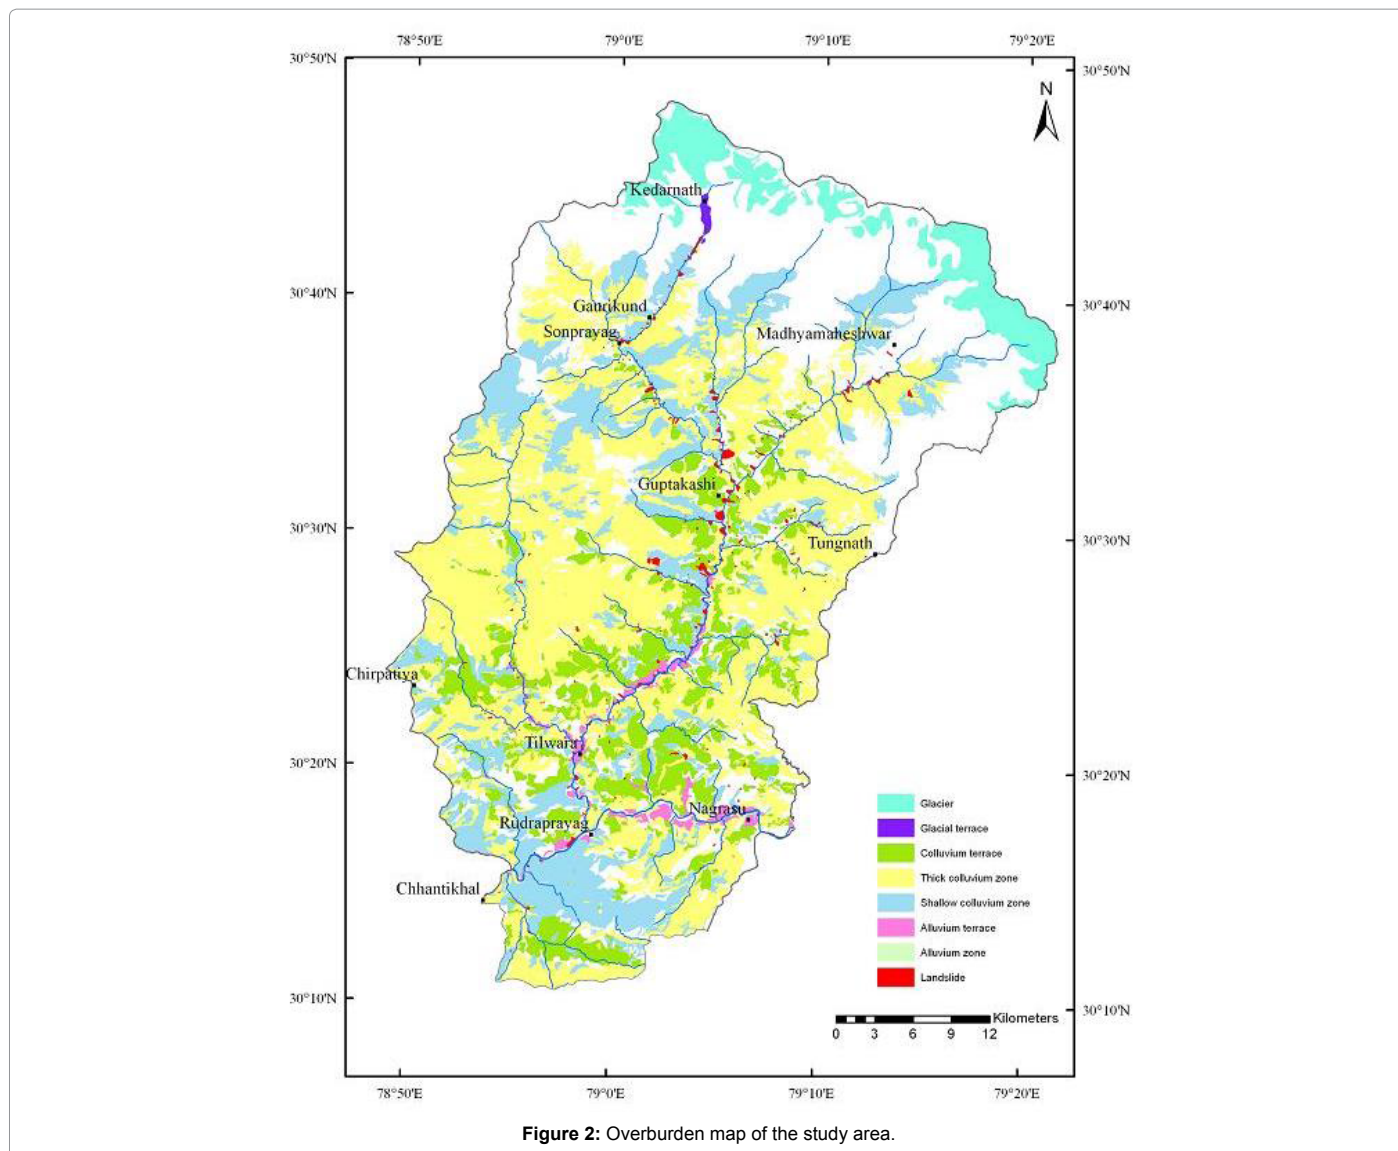
Figure 2: Overburden map of the study area.

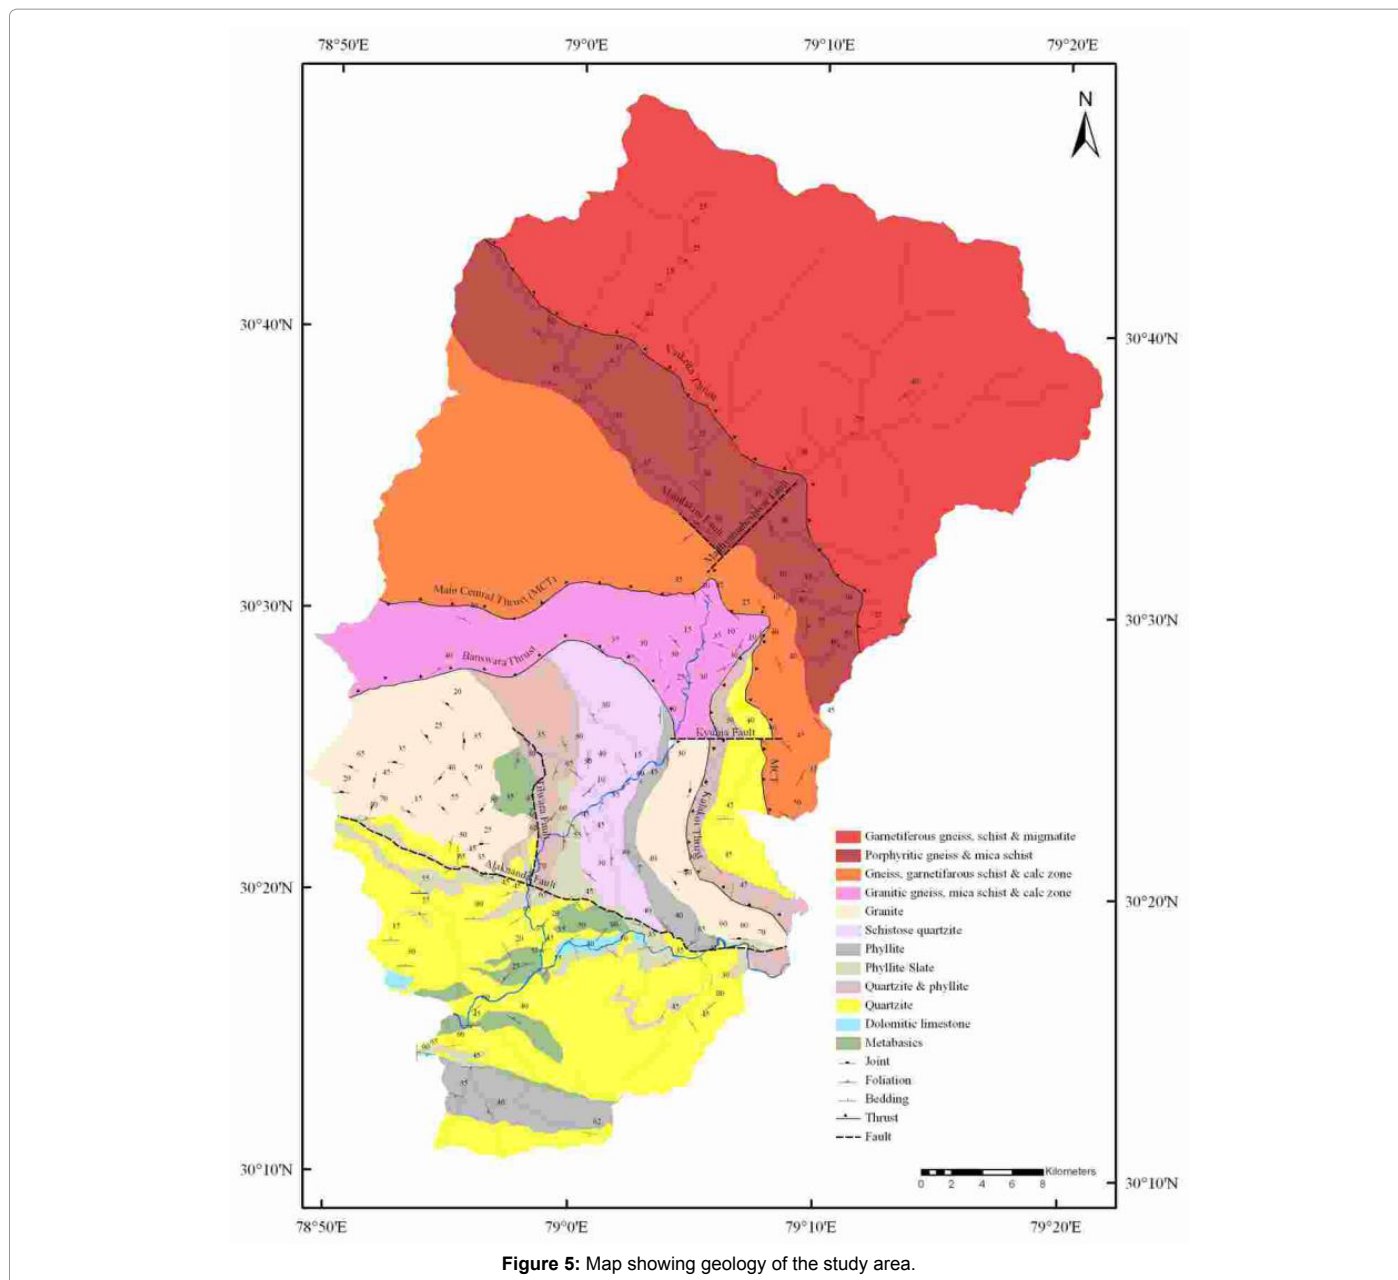
In the study area Central Crystalline rocks are thrust over rocks of Lesser Himalaya along Main Central thrust (MCT) which is a northerly dipping major tectonic discontinuity exposed across the Mandakini river at Kund near Okhimath (Figure 5). The rocks of Lesser Himalaya are observed to comprise of low grade metasediments that are intruded by acidic and basic igneous rocks. The lithological units have been refolded, faulted during various phases of the tectonic activity [27]. These consist of thick succession of low grade metasediments made up of quartzite along with penecontemporaneous metabasics and carbonate rocks. The main rocks observed in the area include phyllite, quartzite, limestone, slate, granite and metabasics [28,29].

Figure 5: Map showing geology of the study area.
