## Landslide Distribution and Damages during 2013 Deluge: A Case Study of Chamoli District, Uttarakhand

Khanduri S\*

Department of Disaster Management, Disaster Mitigation and Management Centre, Rajpur Road, Uttarakhand Secretariat, Dehradun, Uttarakhand 248001, India

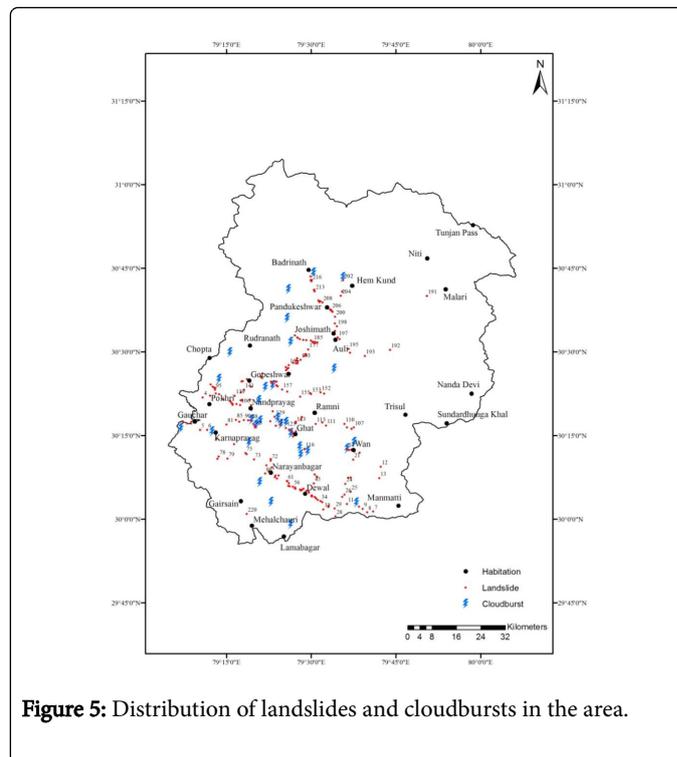
**Figure 5:** Distribution of landslides and cloudbursts in the area.

In June, 2013 rainfall in the area was relatively higher and large number of landslides are observed to have been triggered at various places, mostly along the streams and roads. A total of 220 landslides are identified through field investigations in Chamoli district (Figure 5). Catchment wise distribution of landslide is given in Figure 6. The observations make it clear that maximum landslide incidences have taken place along the Alaknanda and Pinder rivers.

On the basis of movement and rigidity of material comprising the slide mass, bed rock, debris and earth, these are classified as debris/bouldery debris slide, rock cum debris slide and rock slide / fall. Total 158 debris slides, 58 rock cum debris slides and 4 rock slides/falls are to be observed in the area. Of these, 72 percent are observed to be debris/bouldery debris slide. This makes it amply clear that saturation of overburden or debris material by prolonged heavy rainfall is responsible for the initiation of most slides of the study area.
