Mapping Spontaneous Ground Fissures using Seismic Refraction, Reflection, and Ground Penetrating Radar in the Letlhakeng Area, Kweneng District, Botswana

Abstract

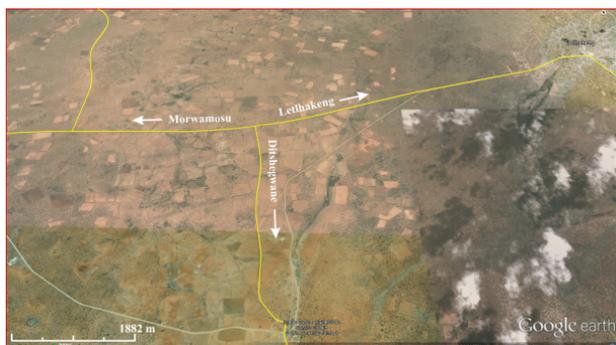
Figure 3: GoogleEarth™ image showing the location of Letlhakeng Village, the small settlements of Ditshegwane and Sesung, and the main paved highway through the area which has been severely damaged by ground fissures.

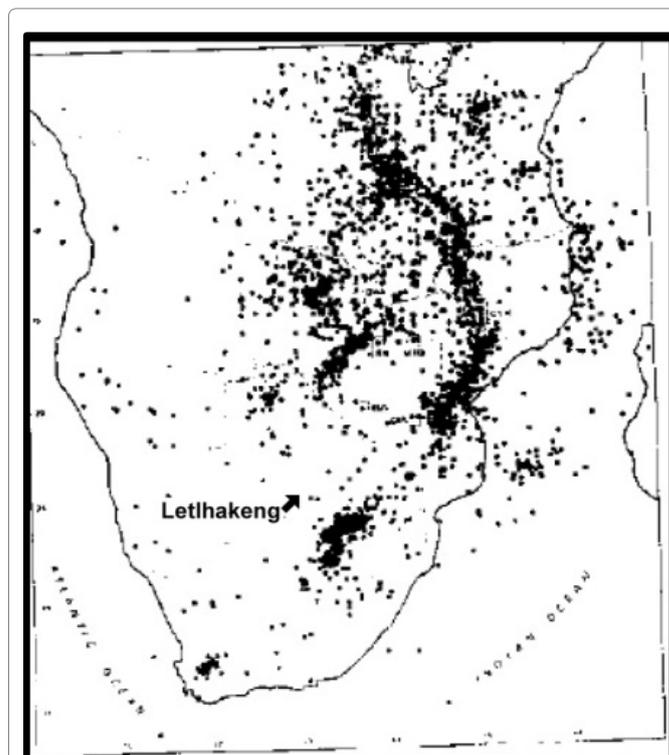
The seismicity of Southern Africa is discussed in Uzoegbo et al. [3] and shown in Figure 4. The seismicity recorded within the Republic of South Africa comprises mainly mining-induced earth tremors which are high frequency and of a shallow origin. Such seismicity poses a danger to single storey buildings since it is high frequency, but its energy is attenuated within 10 km from the source [3]. As such mine-induced seismicity is of concern only within the townships of the mining area.

High density earthquake seismicity is observed on the East African Rift System, which extends into Zimbabwe and northern Botswana. A good amount of both earthquake and reservoir-induced seismicity caused by the Kariba Dam is reported in western Zimbabwe along the Deka Fault which possibly extends into the Makgadikgadi Pans area of Botswana [4]. Similarly, the wall impounding of the Mahale Dam in Lesotho has led to a significant amount of seismicity [3]. The Mahale Dam wall-impounding seismicity is reported to have caused damage to property in settlements downstream of the dam. It can be seen in Figure 4 that the Letlhakeng area shows no previous record of seismicity, partially because of lack of coverage by the local seismic recording station network but also because no active faulting is known to occur in the area. Ground fissures are common in areas of active tectonics, volcanism, subsidence related to aquifer depletion, and mine-induced seismicity. In tectonically active areas, the ground fissures are a precursor to rock failure and are expected to occur. Geng et al. & Carpenter et al. [5,6] examined the distribution and development of ground fissures in mainland China and the USA respectively. Kenny et al. [7] gave an interesting perspective on the development and perceived causes of earth fissures in the USA, including an eye witness account of a developing earth fissure in Arizona. The ground fissures in southwestern USA such as Arizona and Utah can be large enough to be visible on Google Earth™ images [8,9]. Most studies in the USA conclude that the occurrence of a seismic ground fissures is induced by over-pumping of ground fluids leading to differential stress and eventually failure. In some cases, ground fissuring was observed to be related to monsoon flash flooding [5]. After concerted efforts aimed at mitigation of property destruction caused by seemingly a seismic ground fissure development in Riverside County, California, [10] concluded that the fissures were caused by hydro-consolidation and differential settlement related to rapid fluctuations of the groundwater table.

Figure 4: Distribution of active seismicity in southern Africa [3].

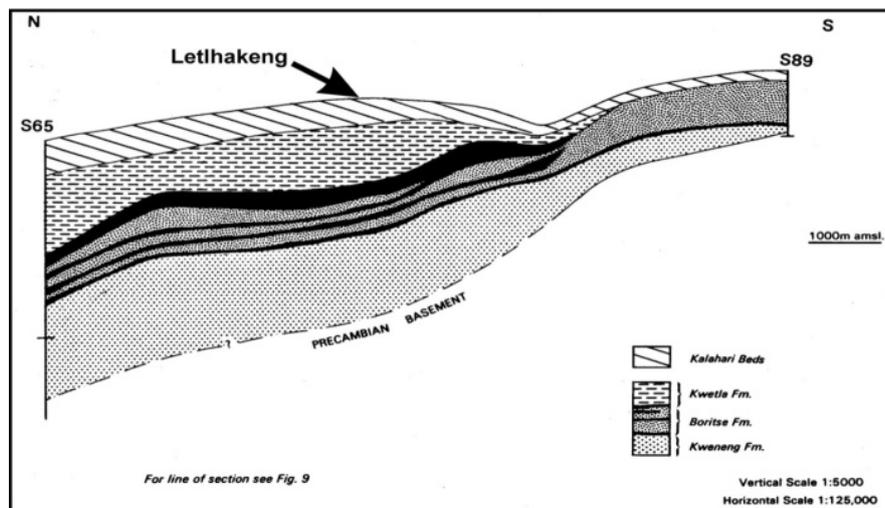
Figure 5: A N-S cross-section through the southeast Karoo sub-basin. The section shows formations of the Ecca Group resting un-conformably on Precambrian basement [11].

The Karoo Supergroup comprises three Groups; namely Dwyka, Ecca, and Beaufort, deposited in an epicontinental basin under conditions varying from glacial to aeolian. The Karoo stratigraphic column is incomplete in Letlhakeng area because it occurs on the edge of the main Karoo basin (Figure 5). Here, the topmost unit of the Karoo Supergroup intercepted by water and exploration wells is the Lower
