Corrosion Failure Analysis of Elbow in LPG Desulfurization Unit

Jianwen Z¹, Guoqing S^{1*}, Chuansheng W²

ABSTRACT

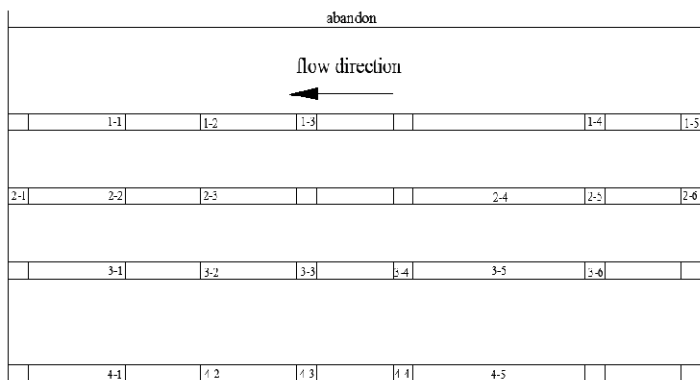
Figure 12: Sketch map of sampling.

Analysis of thinning law: Regional sampling of the inner wall was carried out to obtained corrosion thinning laws of the elbow; the initial scheme was shown in Figure 8. Taking the thief hole as center, the wall was divided into 5 rows, numbered 1~5 from top to bottom. The interval of each row of adjacent samples was 15 cm, numbered 1~8 from left to right. However, samples cannot be removed completely since the edge area was too thick in actual sampling process. Therefore, the following adjustments were made: the 1st row was abandoned, the 2nd and 5th row were moved 5 cm upwards, and 5~6 samples are taken in each row, and the rest remained unchanged, as shown in Figure 12. Firstly, the inner wall

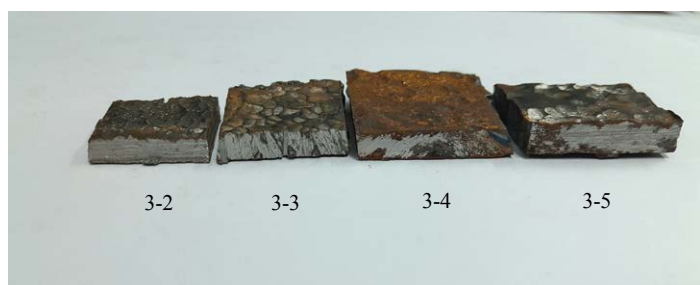
Figure 13: Samples.

removed completely using cutting machine. Then, subsequent sampling process was performed using a chainsaw; plasma cutting and hand saw to ensure physical and chemical properties of samples stably. As shown in Figure 13, the physical map of 3-2 ~ 3-5 showed that there was a significant difference in thickness between samples. Each sample was measured 4 times from different angles and averaged, as shown in Figure 14. The 1st and 2nd rows passed through complete failure zone, for the integrity of the image, the thickness of these area was 0, and corrosion thickness was 10 mm.
