Application of Geophysics in Post Foundation Study: A Case Study of the Faculty of Social Science Building, Phase I, Federal University, Oye-Ekiti, Southwestern, Nigeria

Aroyehun M Tope¹ and Akintorinwa O James²

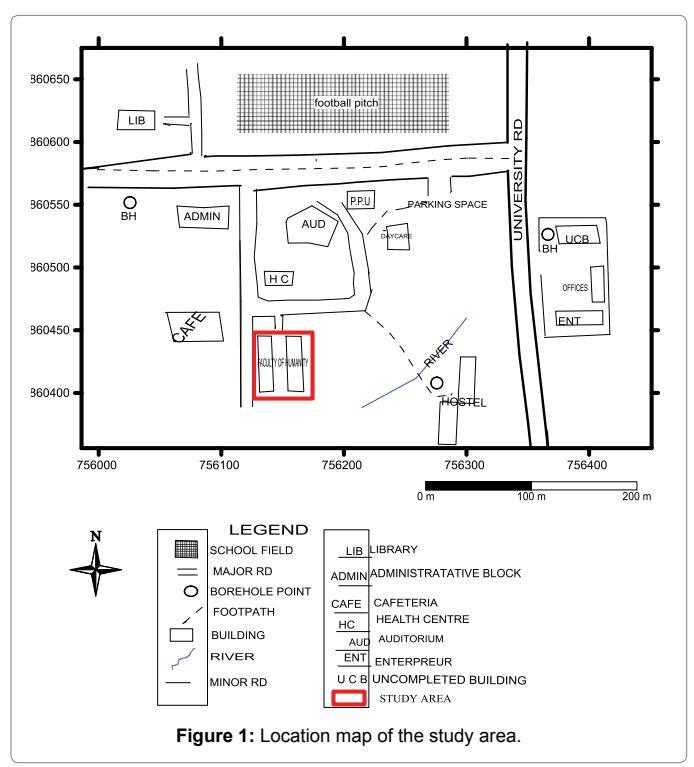
The Federal University Oye-Ekiti campus is underlain by crystalline rock of the Precambrian Basement Complex of the South-western Nigerian [4,5]. The lithologic units include migmatite gneiss complex, granitic gneiss and charnokites (Figure 2). Outcrops of biotite gneiss and granite gneiss occur in some locations around the study area.

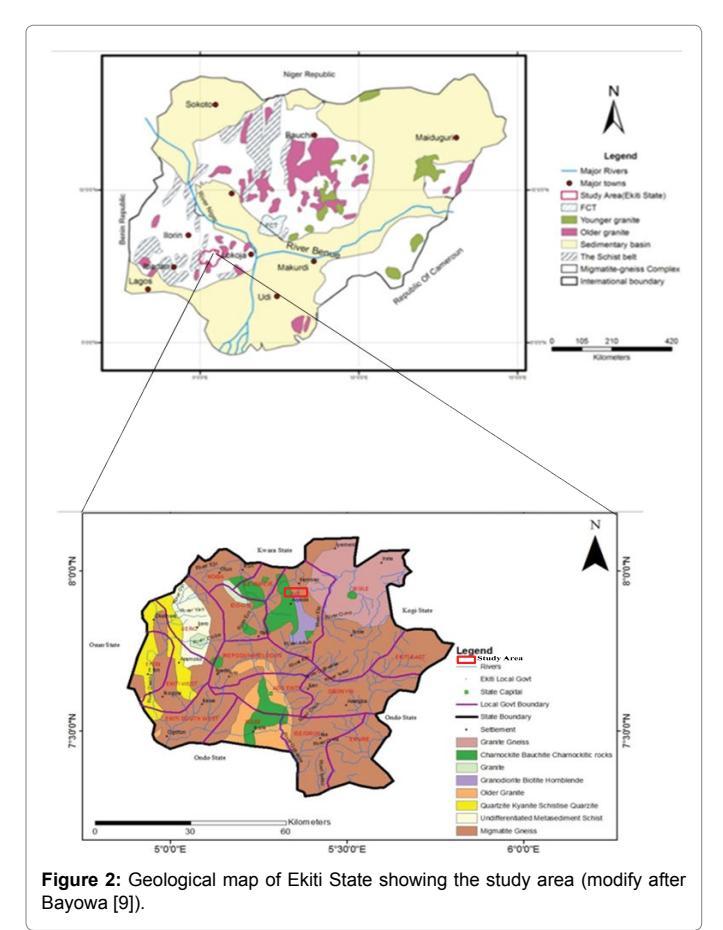
Three traverses were established approximately in the North-South direction (Figure 3). Magnetic measurements were taken at 5 m interval along the traverses. Measurements were made with the GM 8 Proton Precession Magnetometer (PPM). To increase the accuracy, two magnetic measurements with the sensor height well above the ground were taken per station together with the time. The mean of the magnetic measurement was adopted as the raw data for each observed station. A set of readings was taken at an established base station before and after data acquisition. The base station values were plotted against time of taking the reading on a linear graph, with this; diurnal and offset corrections was carried out. The 1-D Euler deconvolution software was used for magnetic interpretation [6].

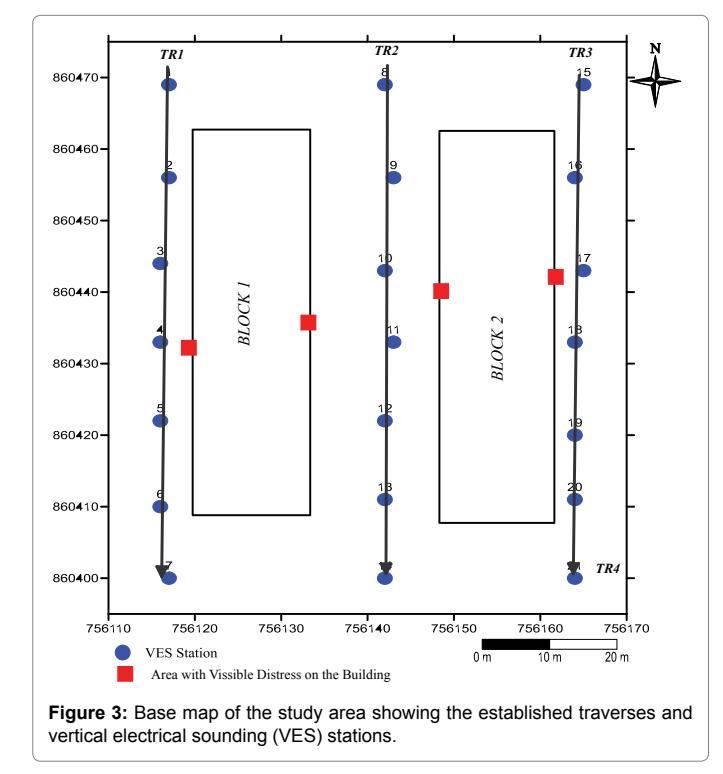
The Magnetic profile and geomagnetic section along Traverse TR1 (Figure 4) show that the traverse is characterized by relatively flat magnetic anomaly except between distance 10 and 30 m where a thin dyke magnetic anomaly was identified with the top around distance of 20 m. The anomaly is striking northeast – southwest (NE – SW). The 1-D Euler deconvolution software using vertical gradient estimates depth to the inclined body at about 5 m. This anomaly is a typical geological feature suspected to be fracture and/or fault/lithological contact.

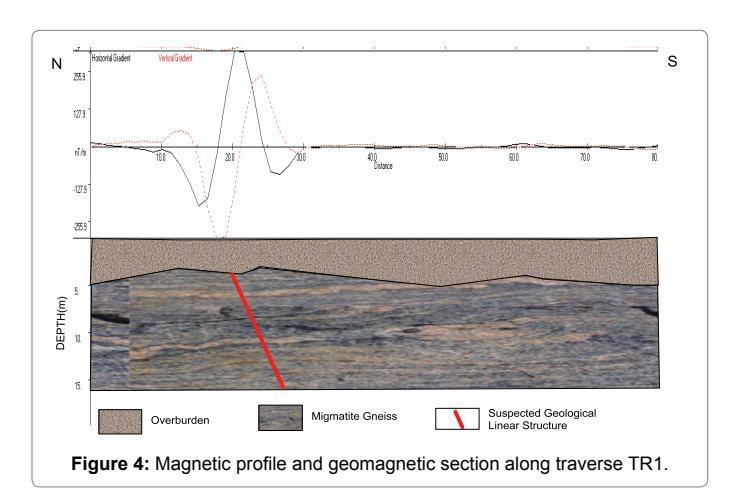
The Magnetic profile along traverse TR2 shows two major magnetic anomalies between distances 20-40 m and 55 -77 m (Figure 5). The corresponding geomagnetic section reveals a relatively thin overburden ranging from 2-6 m. The 1-D Euler deconvolution estimates depth to the identified inclined linear feature at distances 25 and 62.5 m to be 2.5 and 4 m respectively. The structure at 25 striking northeast – southwest (NE–SW) while the suspected structure at 62.5 m is relatively vertical.

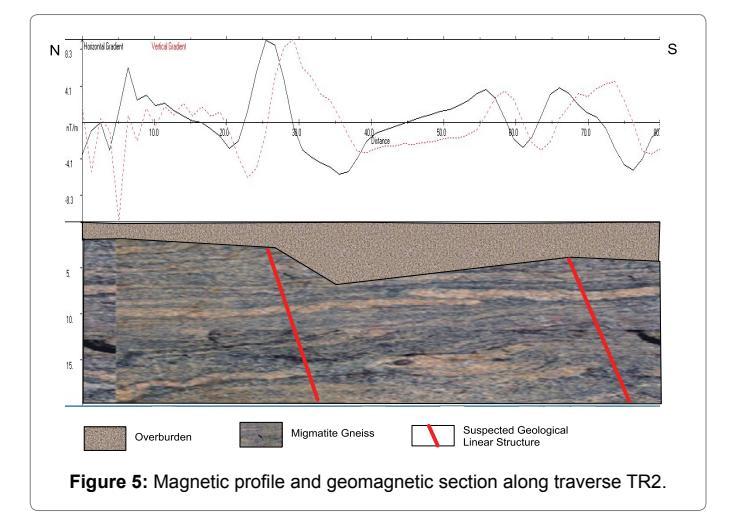
The Magnetic profile and geomagnetic section along traverse TR3 is as shown in Figure 6. The magnetic profile shows one major anomaly at a distance between 10 and 30 m. The causative body is actually located at distance of about 17.5 m and striking northeast – southwest (NE – SW). It is typical of linear geological structure suspected to be fracture

or fault. The estimated depth to the top of the body is about 4 m.

The Magnetic anomalous zones suspected to be fracture/fault/ lithological contact are all striking northeast – southwest (NE – SW). These are weak zones that could be inimical to the stability of foundation of any civil structures. This may have contributed to the distress witness on the investigated structure.

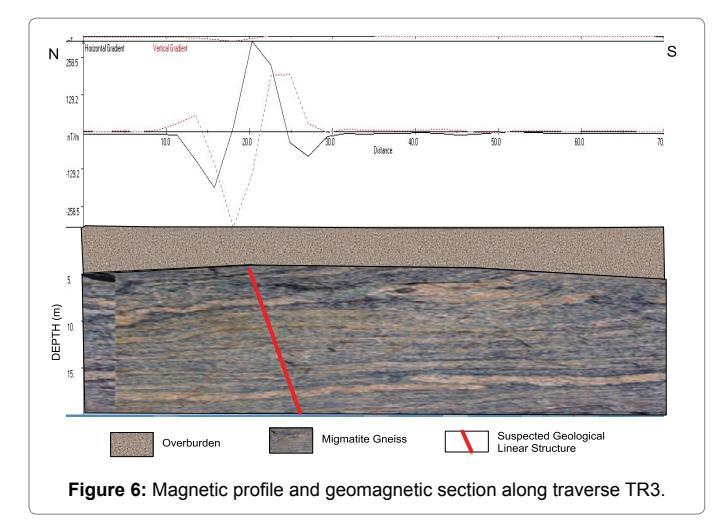
The resistivity sounding curves obtained from the study area vary from 3-layer (H and A) to four layer (HA) and five layer (HKH) type as shown in the Table 1. Figure 7 shows that H curve types is the predominant curve in the area. In order to evolve a geological model along each traverse, the VES interpretation results (Table 1) were used to prepare the 2-D geoelectric sections. These sections give respective layer resistivity values and thicknesses.

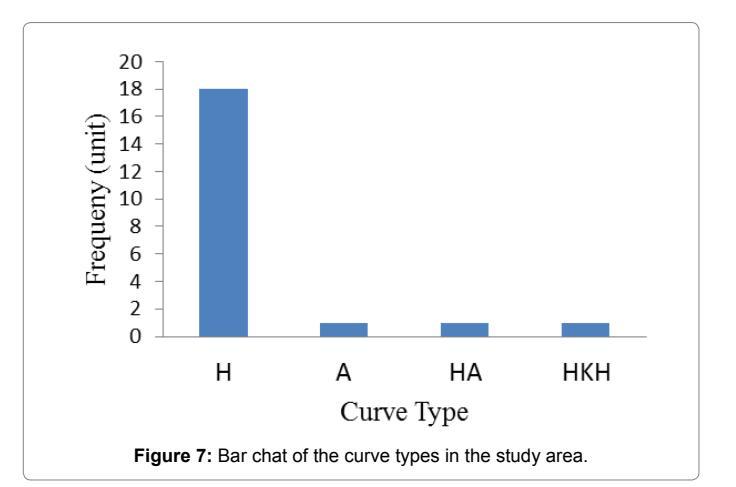
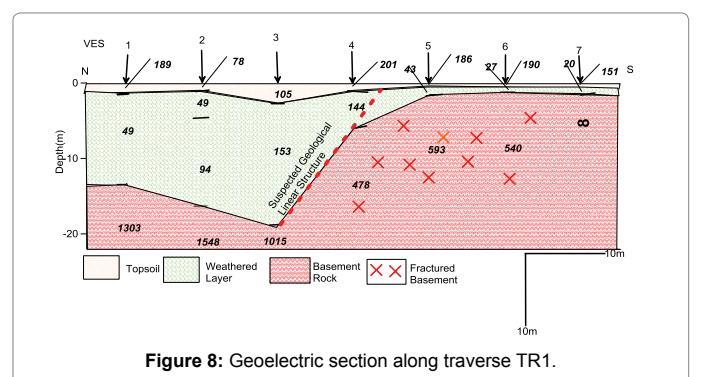
Figures 8-10 shows the geoelectric sections along each traverse. The sections identified three geoelectric/geological subsurface layers comprising the topsoil, weathered layer and fractured/fresh Basement rock. The geoelectric characteristics are as following:

Traverse 1 and 2 displays significant variable depths to the competent basal Basement rock with the thickest overburden beneath the northern segments (Figures 8 and 10). It is suspected that the Basement rock

along these traverses may have been faulted with the down thrown side on the northern segment. In the alternative, the profiles may be located on a lithological boundary (or contact) between the biotite gneiss and granite gneiss. Either way, it could be inferred that the

resistivity value of the topsoil and weathered layer is not significantly different from that of the Basement rock. The uneven nature of the Basement bedrock was revealed by the 2-D resistivity structures (Figures 15-17) which correlated with the geoelectric sections (Figure 8-10).

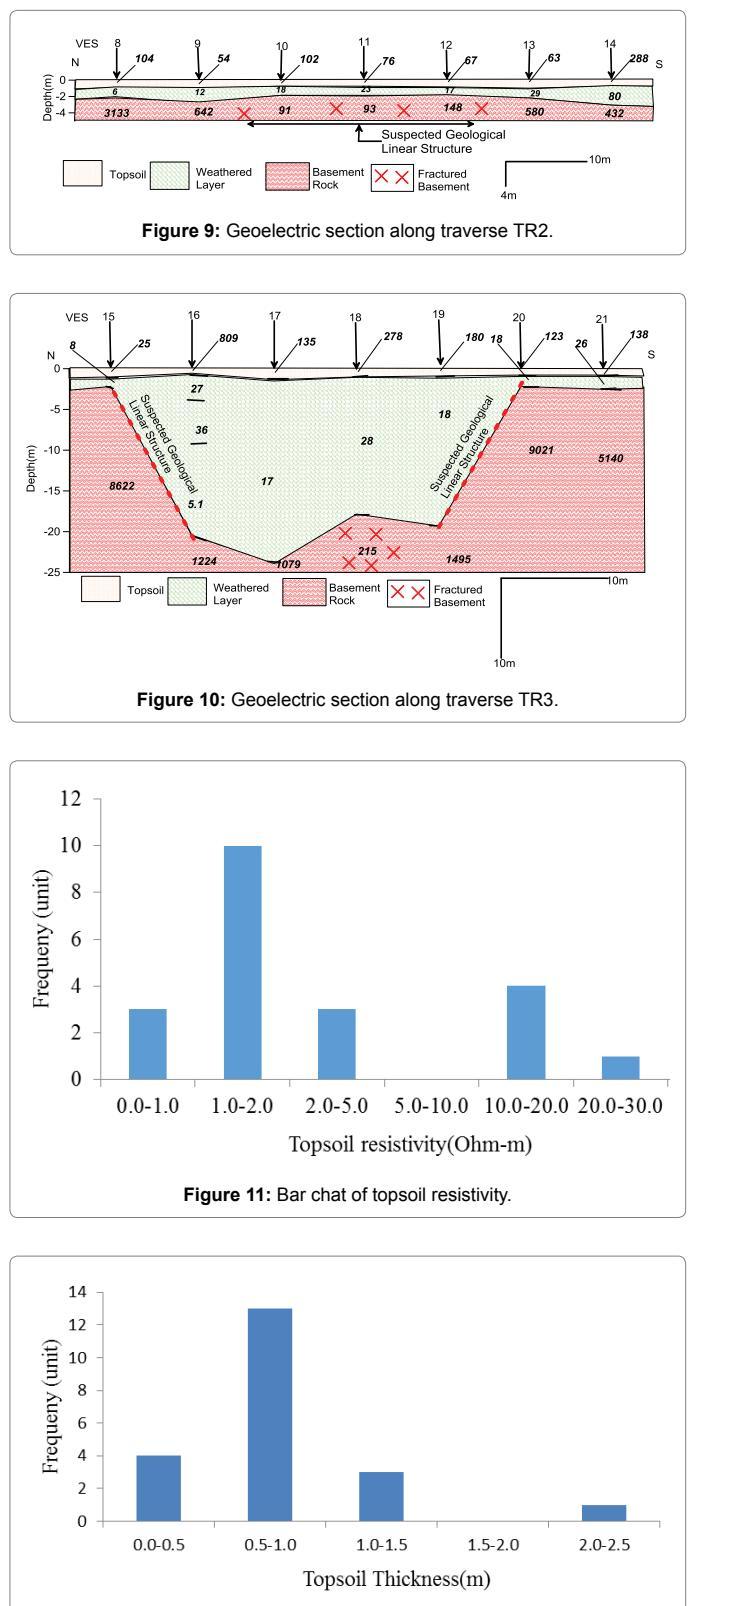
Figure 12: Bar chat of topsoil thickness.

Topsoil: The topsoil varies in composition from clay to sandy clay with resistivity varying from 25 to 288 Ω -m and generally less than 200 Ω -m (Figure 11). The thickness of the topsoil varies from 0.4 to 2.5 m but generally less than 1.0 m (Figure 12).

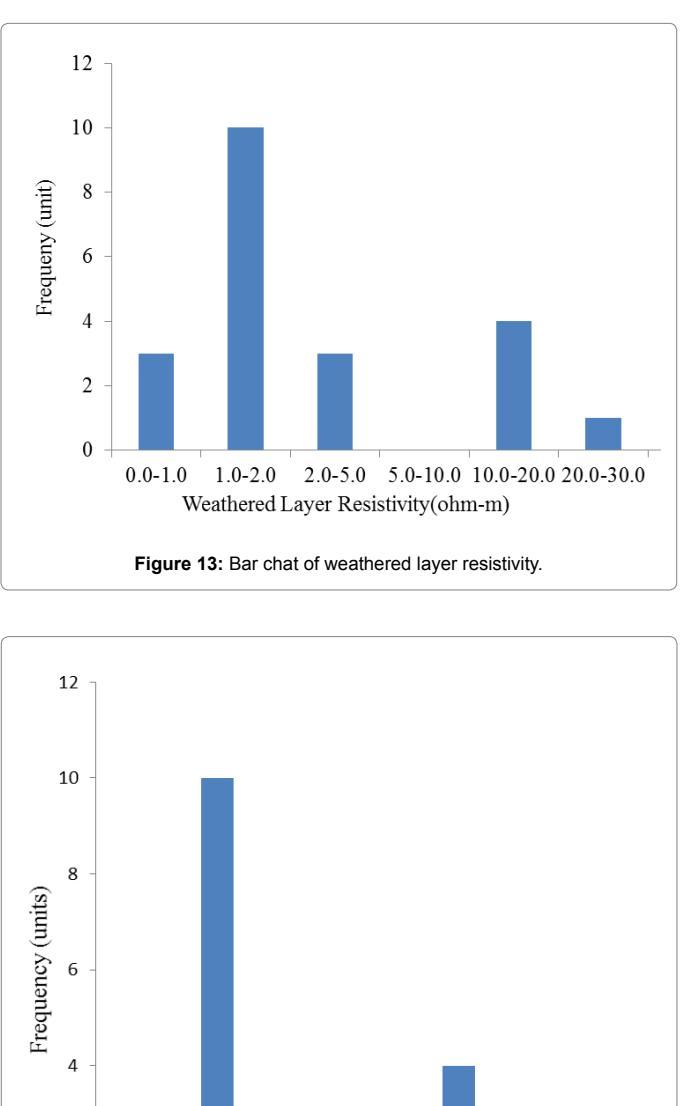
Figure 14: Bar chat of weathered layer thickness.

Weathered Layer: The weathered layer varies in composition from clay to sandy clay with resistivity varying from 20 to 153 Ω -m but generally less than 50 Ω -m (Figure 13). The thickness of the weathered layer varies from 0.9 to 23 m (Figure 14).

The foundation depth of the investigated civil structure is not known but it is suspected to have been hosted within the weathered layer. This layer is predominantly composed of clayey formation which is of high swelling potential with tendency for structure subsidence.

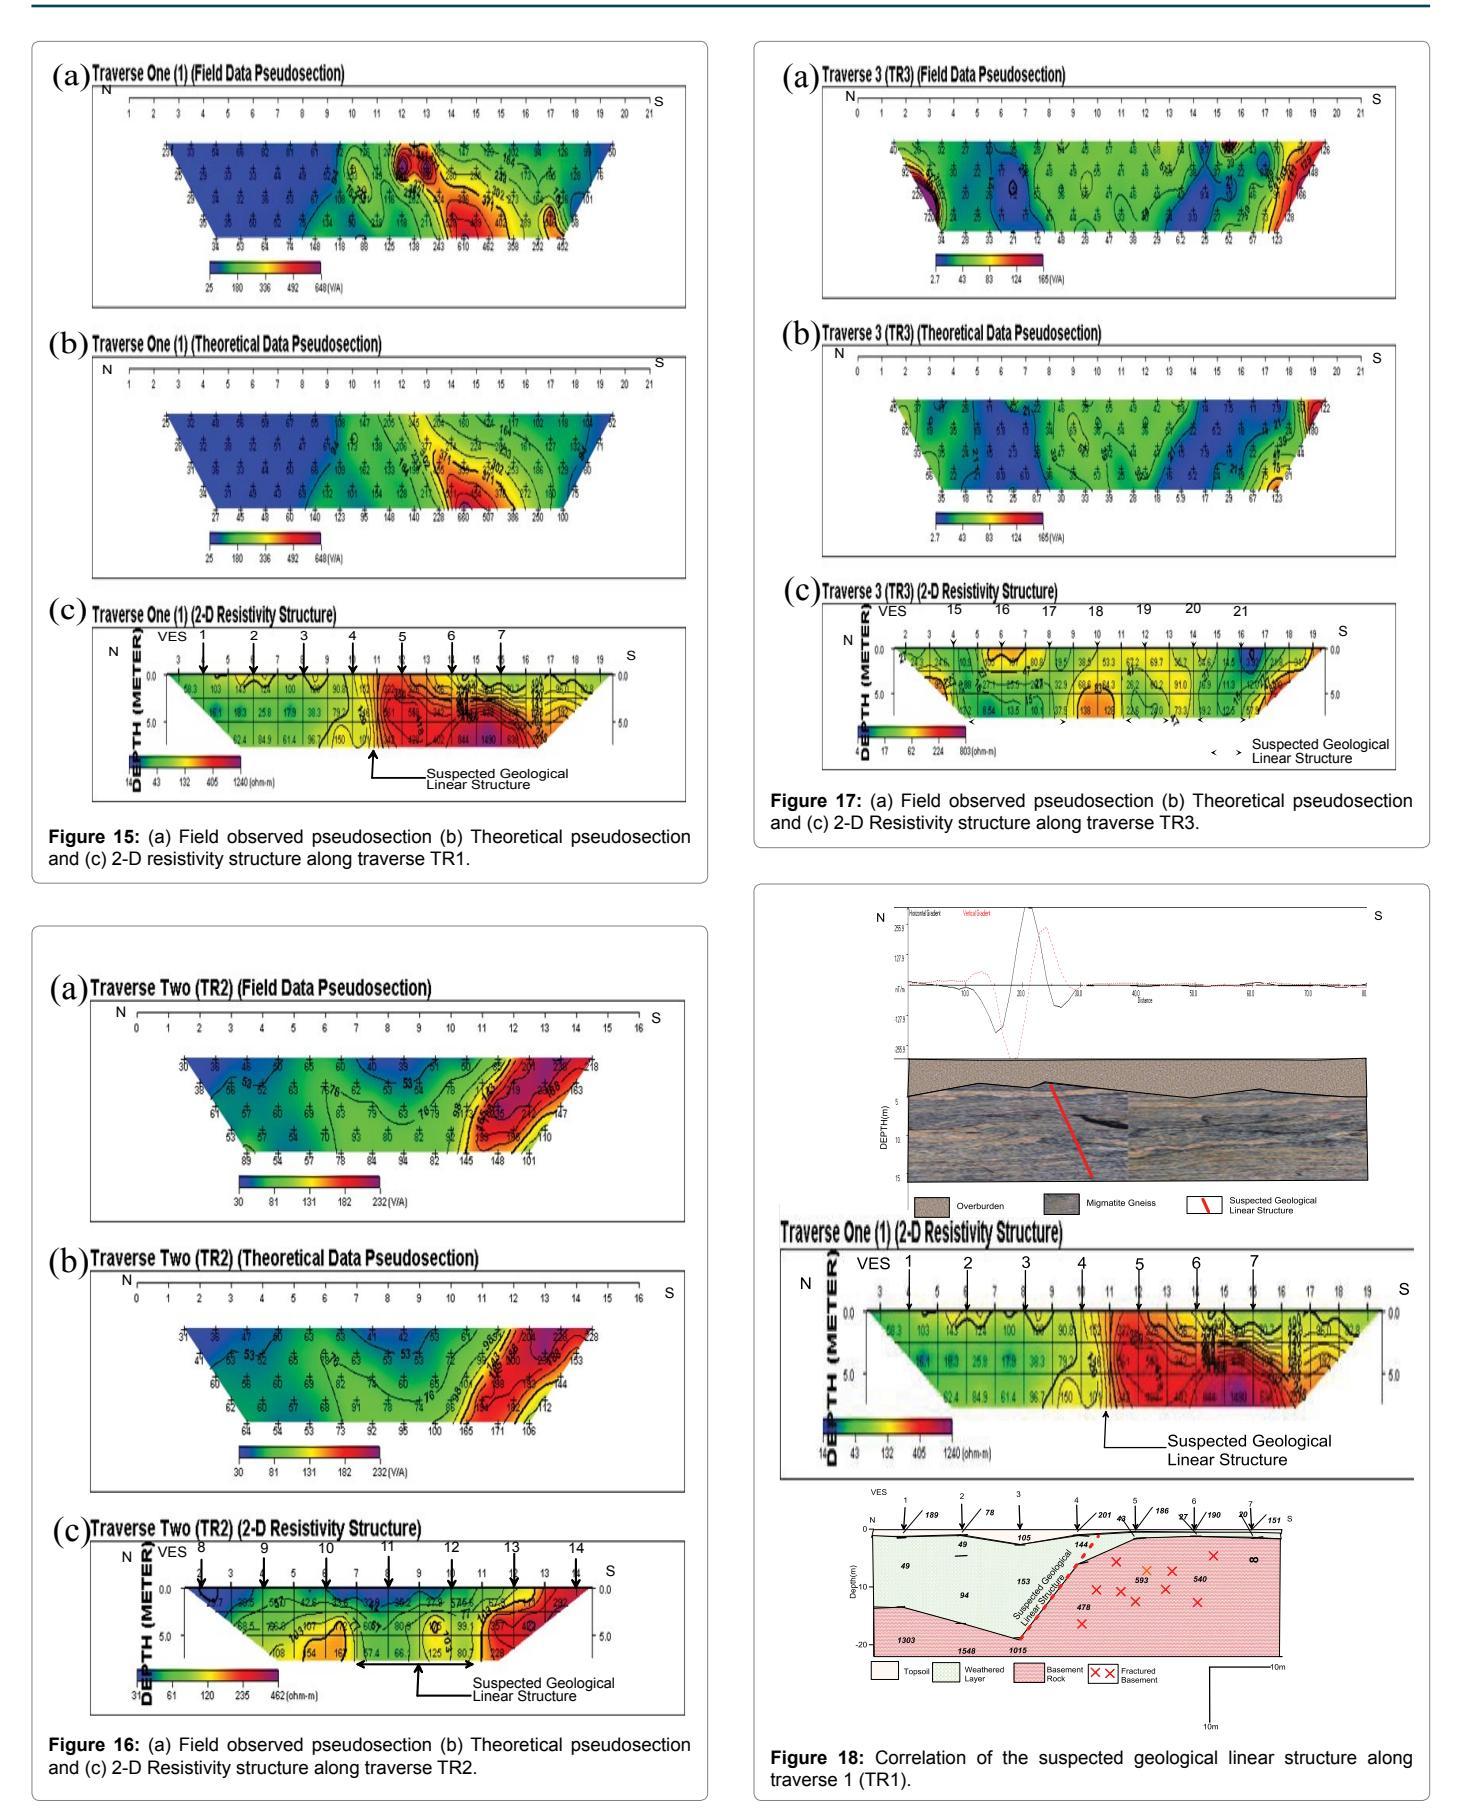
The pseudosections and 2-D resistivity structures along Traverses are shown in Figures 15-17. The 2-D resistivity structure depicts three geoelectrical/geological layers. These include thin topsoil, weathered layer and the partly weathered layer/Basement rock. The topsoil and the weathered layer have virtually merged together due to thinness of the topsoil and non-significantly contrast. They are represented by blue and green colours. The yellow colour within these layers occurs when the

The bedrock shows several vertical discontinuities typical of linear structures (fracture/fault/lithological contact) along the traverses. These linear structures are located at different distances and are steeply dipping with significant depth extent (>5 m). The delineated linear structures on the magnetic profiles (Figures 4-6) and geoelectric sections (Figure 8-10) coincide with the suspected linear geological structures on the 2-D resistivity structures (Figure 18-20). Figure 21 is the structural map of the study area generated from the magnetic profiles (Figures 4-6), geoelectric sections (Figures 8 and 10) and 2-D resistivity structures (Figures 15-17). It displays the location of the suspected linear structure (fracture/fault and/or geological boundaries) within the study area. The distressed segment of the building is located within the zone. This may have significantly influence the structural failure observed on the buildings.
