Flood Hazard Mapping of Sagar Island during Cyclone 'YAAS' Using Remote Sensing and GIS

ABSTRACT

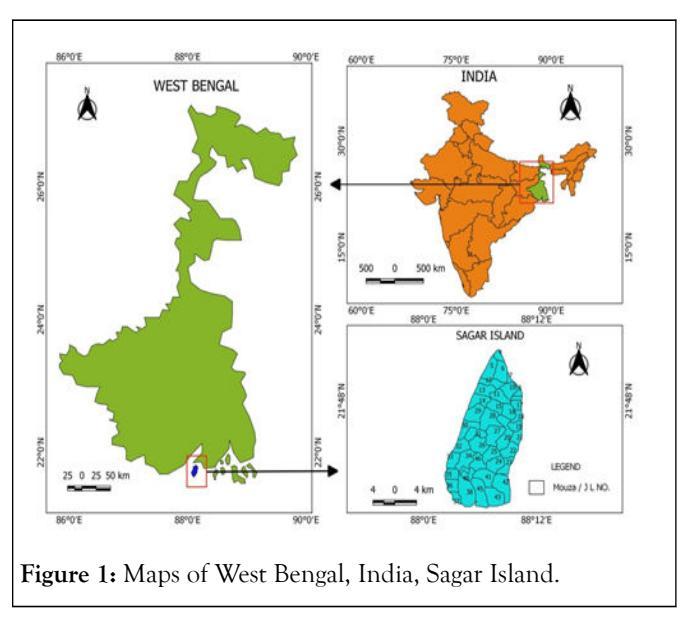
of thatched houses/extensive damage to kutcha houses, damage to standing crops, plantations and vegetation. Earthen embankments were also severely damaged (Figure 1).

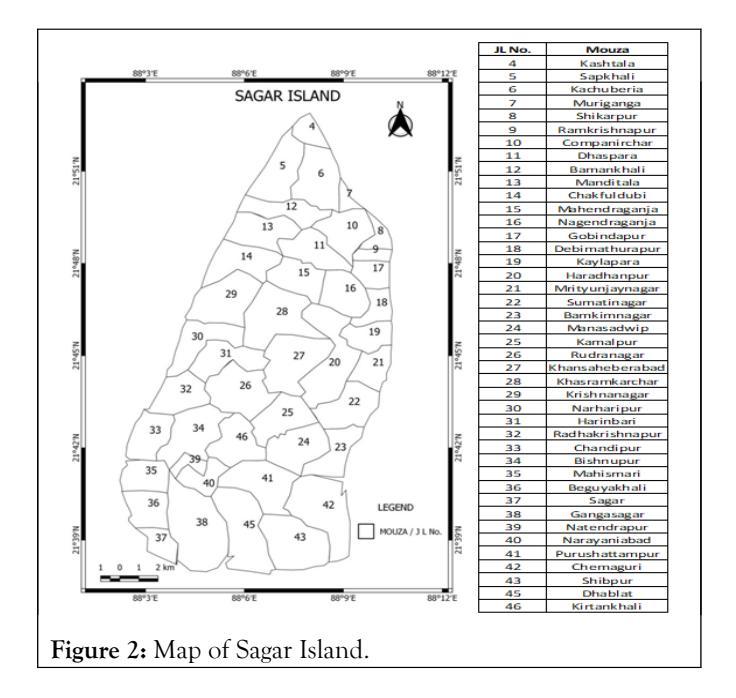
For this study Landsat 8 OLI and TIRS (free data source-USGS earth explorer) data have been used for flood mapping. For carrying out the change analysis, both pre and post flood event images have been utilized (Figure 2).

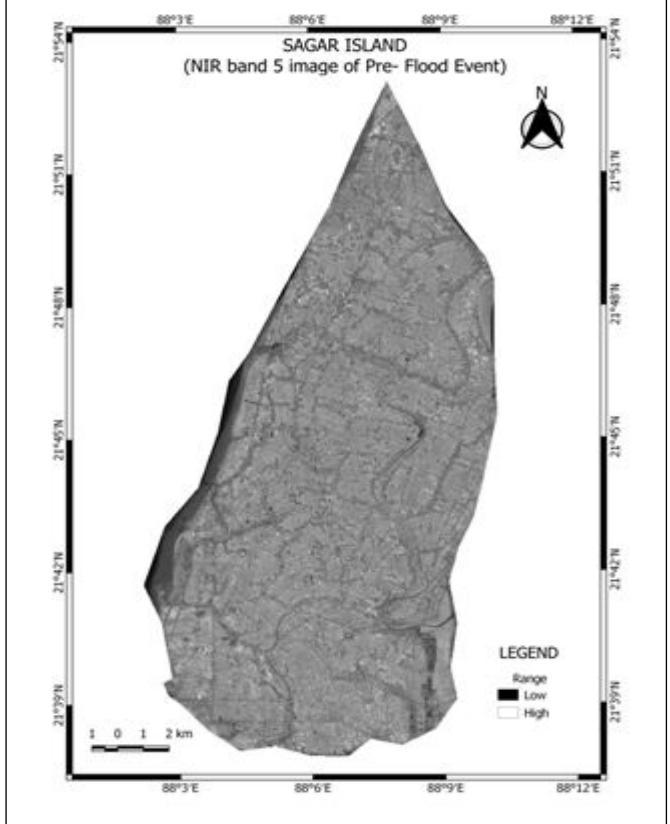
Figure 3: The rules for deciding flooded and non-flooded pixels.

Water is characterised by low reflectance in Near-Infrared (NIR) region of the spectrum and high reflectance in lower wavelengths. So water bodies can be delineated using Normalized Difference Water Index (NDWI) and thresholding on NIR (band 5 for Landsat 8) [4]. In the final step, pixel to pixel comparison is carried out for both pre and post event of cyclone YAAS to derive the extension of flooding. The rules for deciding flooded and non-flooded pixels can be summarised as following (Figures 3 and 4).

Water-water: If a pixel is classified as water on the pre-flood image and post flood image, the pixel will not be considered as flooded. Those pixels would help to identify the regular water bodies.

Non-water-water: If a pixel is classified as non-water in pre flood image and water in the post flood image, the pixel should be considered as flooded.

Non-water-non-water: If a pixel is classified as non-water on both pre and post flood images, the pixel will be considered as non-flooded [5].

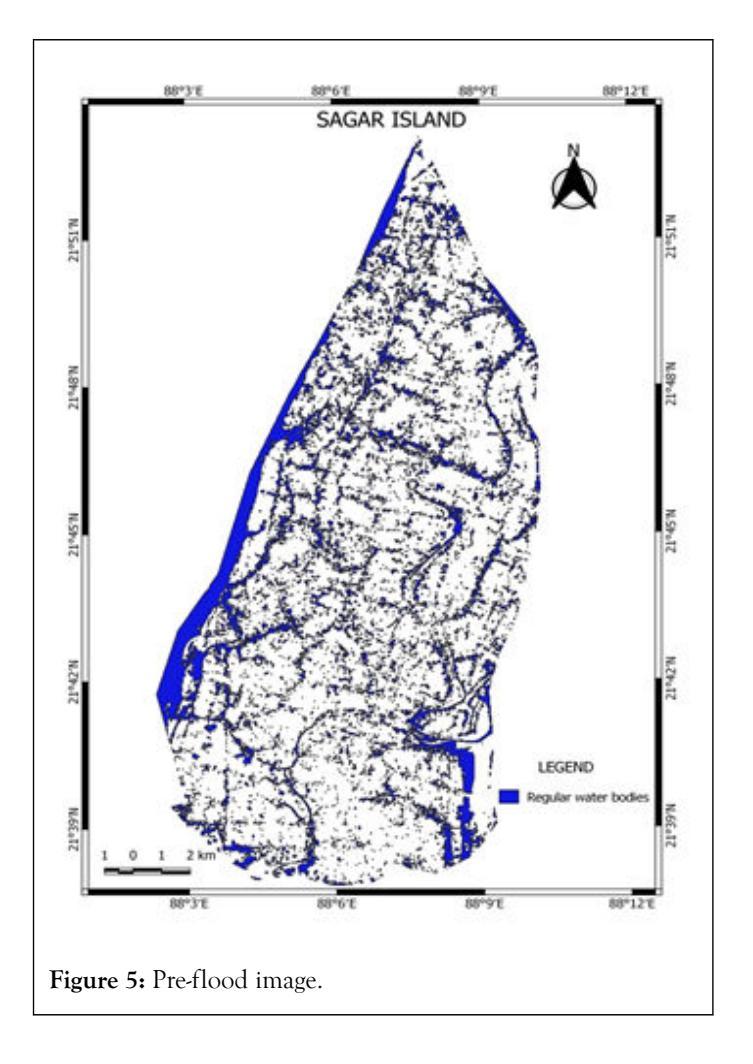
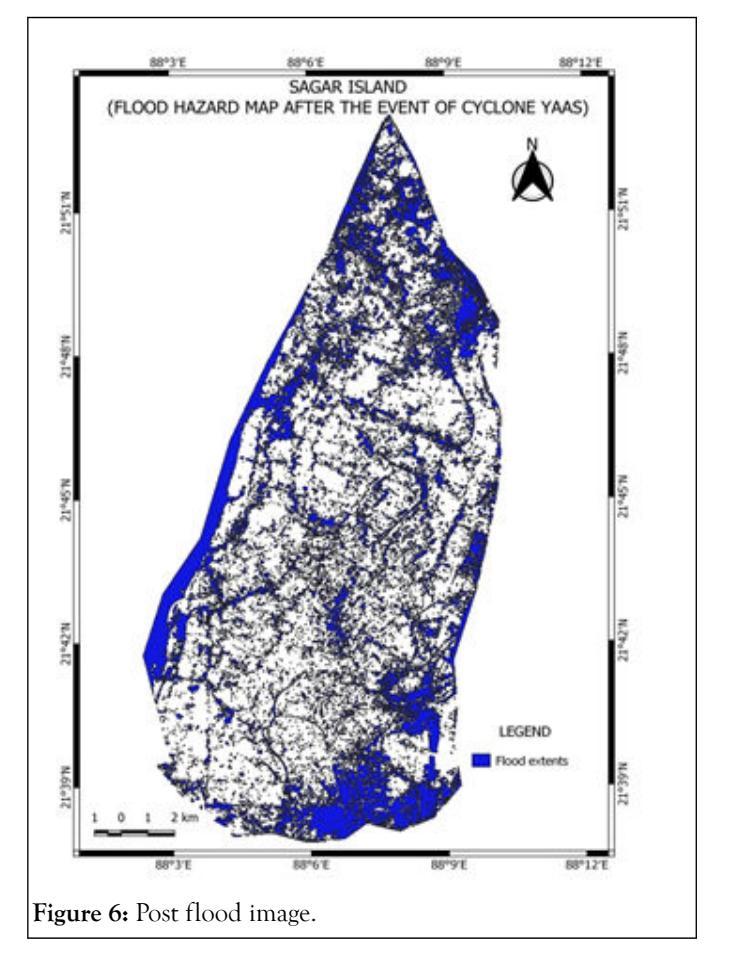
Water-non-water: If a pixel found is classified as water on the pre-flood image but non-water in post flood image, the pixel will be considered as changes in land use or due to the presence of cloud cover (Figures 5 and 6).

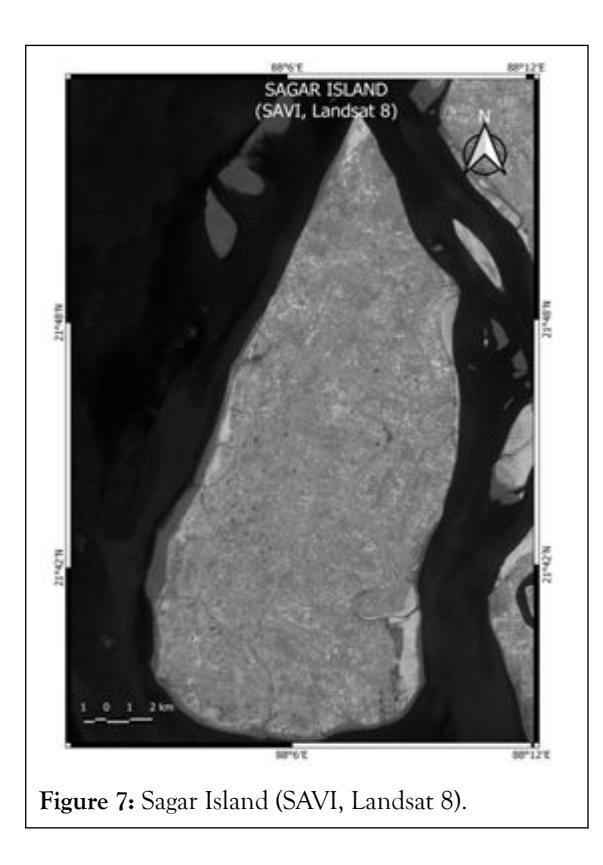
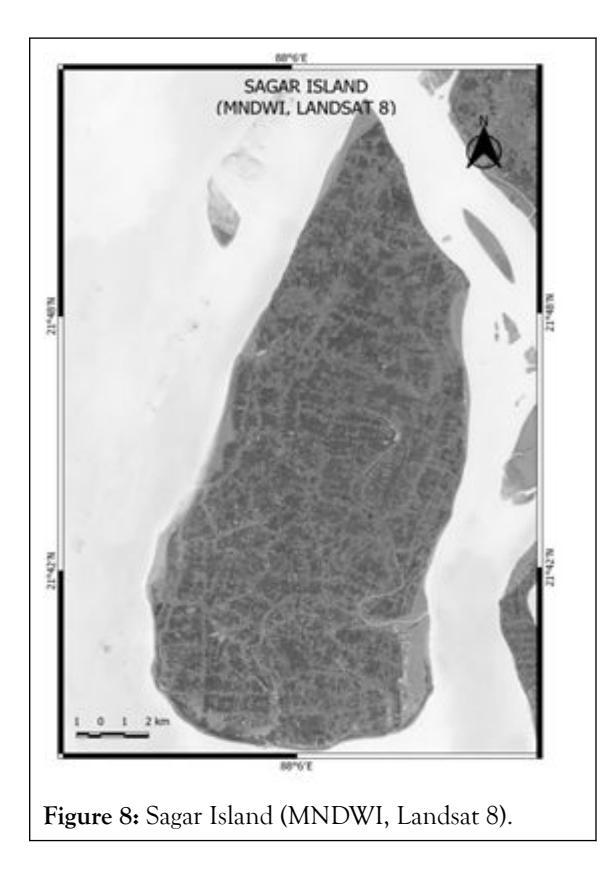
This study utilises approach proposed by Xu. This approach involves transformation of landsat data to a 3 band index using Soil Adjusted Vegetation Index (SAVI) (equation 1), NDBI (equation 2) and Modified Normalized Difference Water Index (MNDWI) (equation 3). These transformation would help to identify major urban land cover type generally present in the study area *i.e.* vegetation, built-up area and open water. The three images produced from these indexes are then combined to form a new image (Figures 7 to 9) [6].

SAVI, MNDWI and NDBI images highlight vegetation, water and built-up area in bright tones. These images make classes more separable and help to facilitates classification procedure.

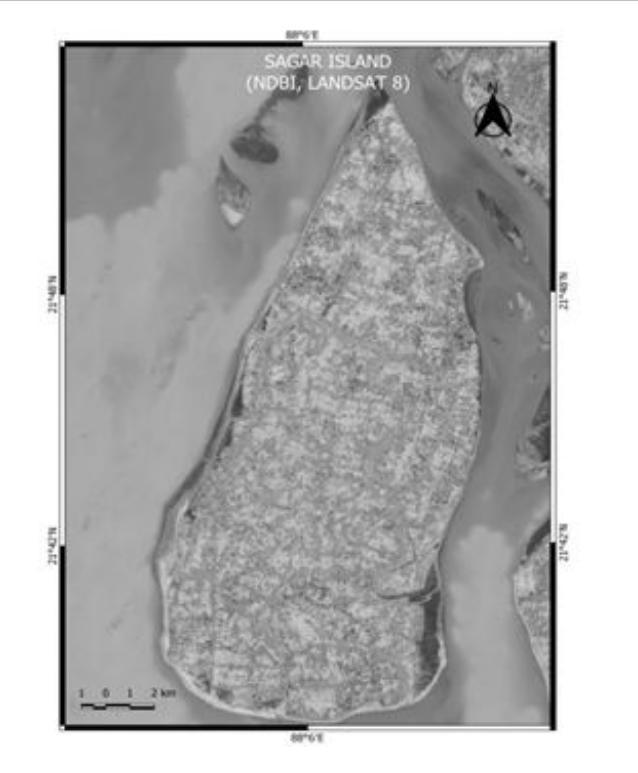
Figure 9: Sagar Island (NDBI, Landsat 8).

$$NDBI = \frac{(MIR - NIR)}{(MIR + NIR)}$$
(2)

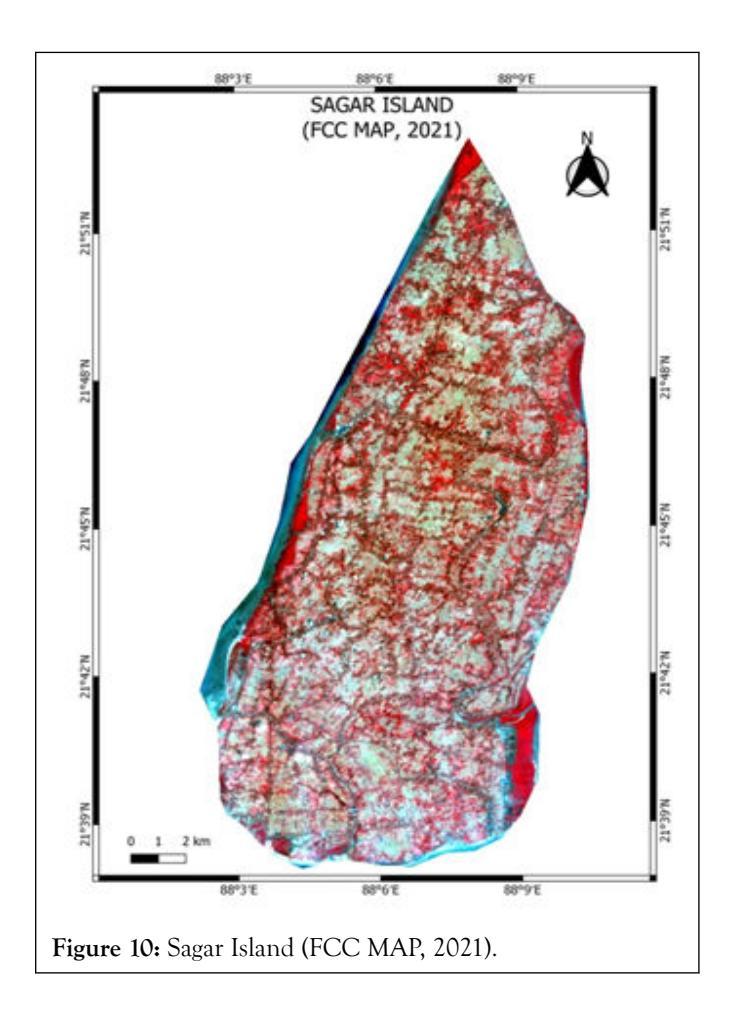
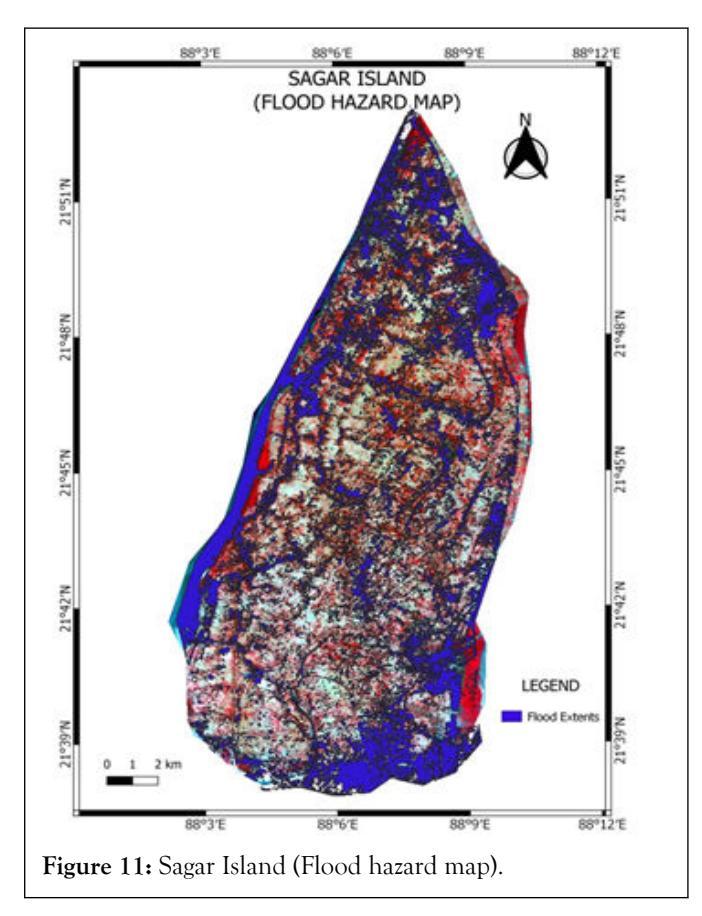
The overlay analysis of the flood hazard map and the exposure map has been carried out to delineate the build-up area under flood hazard. The overlay analysis of flood hazard map and exposure map helps to delineate the built-up area under flood hazard. This map marks up the areas which are flooded post YAAS event [7]. It is also important to keep in mind that actually risk due to hazard varies depending upon the type of exposure present within the hazard extent. Life risk would be higher if the hazard covers a residential region and economic risk would be higher if the hazard covers an industrial region (Figures 10 and 11).

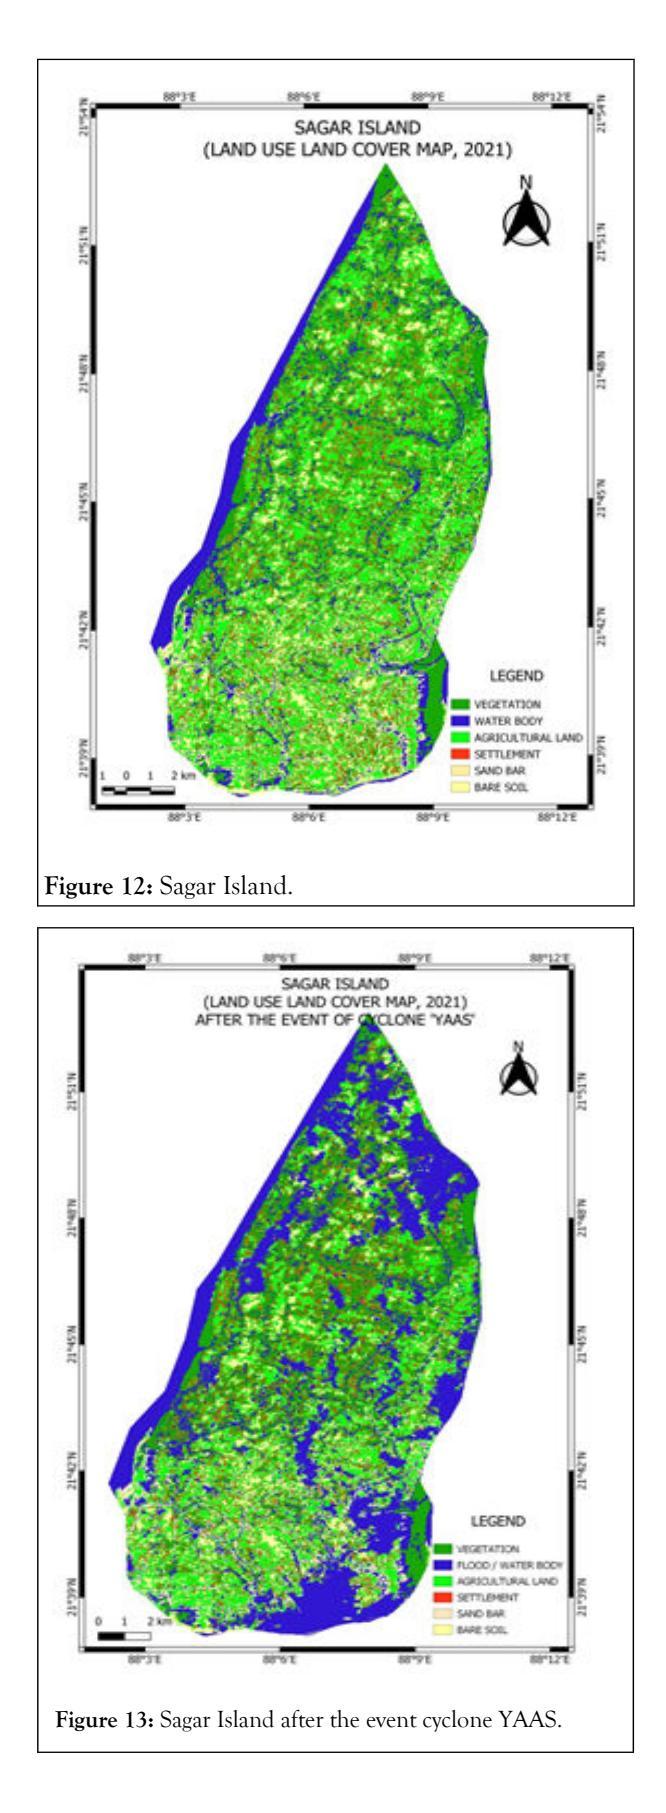
The unsupervised classification of the landsat image before the event cyclone YAAS yielded the LULC classes shown in Figure 12. The classification of land area of vegetation is 69.35 sq km, representing 28.76% of the total area. This is basically South found in the Eastern part (Chemaguri and Bamkimnagar Mangrove forest area) with the highest concentration. Likewise, regular water bodies and agricultural land covers 31.10 sq km (12.90%) and 76.73 sq km (31.82%) respectively, and are mostly scattered throughout the island. The settlement covers an area 26.22 sq km (10.87%) and is located mainly within patches around the tidal creeks [9]. Sand bar and bare soil cover an area 18.34 sq km (7.61%) and 19.41 sq km (8.05%) respectively (Table 1).

An overall classification accuracy of 71.35% and a kappa coefficient (overall kappa statistics) of 0.6692 was achieved [10]. None of the LULC classes recorded accuracy below 50% (Figures 12 and 13).

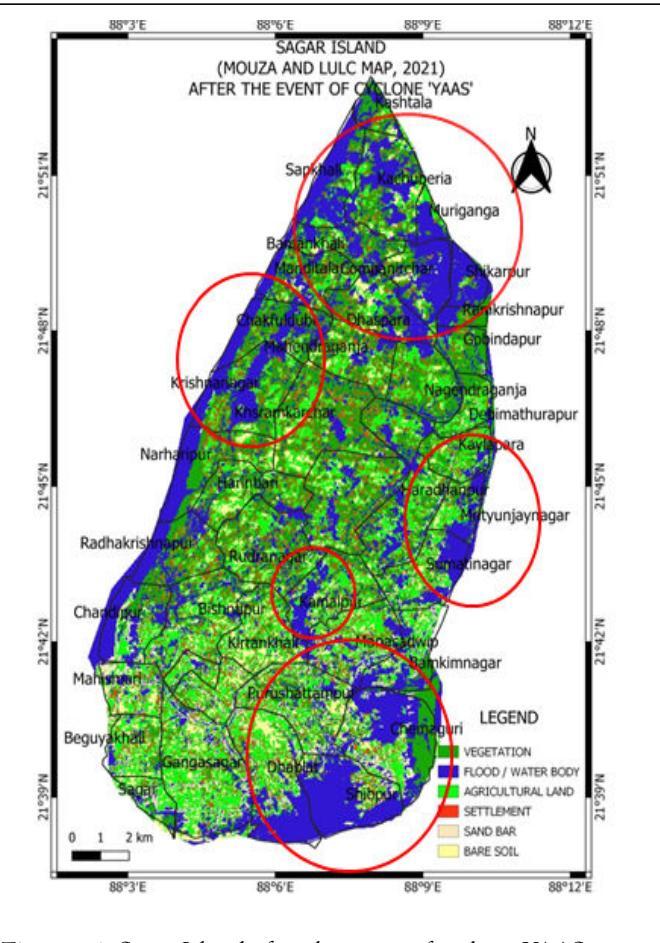
Figure 14: Sagar Island after the event of cyclone YAAS.

Vegetation, agricultural land and settlement are severely affected by the cyclone YAAS. 13.69 sq km of vegetation area gets inundated due to the flood occurred during the cyclone. Similarly 13.16 sq km of agricultural land and 4.40 sq km area of settlement get flooded after the event of cyclone YAAS. The mouzas which are severely affected by flood occurred during the cyclone are as following; Dhablat, Shibpur at South; Chemaguri, Sumatinagar at South-East; Mritunjaynagar, Shikarpur at East; Muriganga, Companirchar, Kachuberia at North; Sapkhali, Krishnanagar, Chakfuldubi at West and Kamalpur at central part of sagar Island. Areas are shown with red circles in the (Figure 14 and Table 3).

The unsupervised classification of the Landsat image after the event cyclone YAAS yielded the LULC classes shown in Figure 13. The classification of land area of vegetation is 55.65 sq km, representing 23.08% of the total area. Likewise, water bodies/flood water and agricultural land covers 69.09 sq km
