Landslides in Ghoin Valley District Poonch AJK

A number of landslide occurred in Ghoin valley when huge flood in 1992 hit the area. These landslides were complex and very sever and caused number of damages to house, land use and peoples of the area. There were number of slides reported each year in the Ghoin valley but among them two very important slides are discussing in this paper. Ghoin is an important valley eroded by Ghoin nala tributary of the Jhelum river. Geologically it is composed of Siwalik formation. In the valley the two main slides have been selected for study, Nariola-Androt and Soon slide.

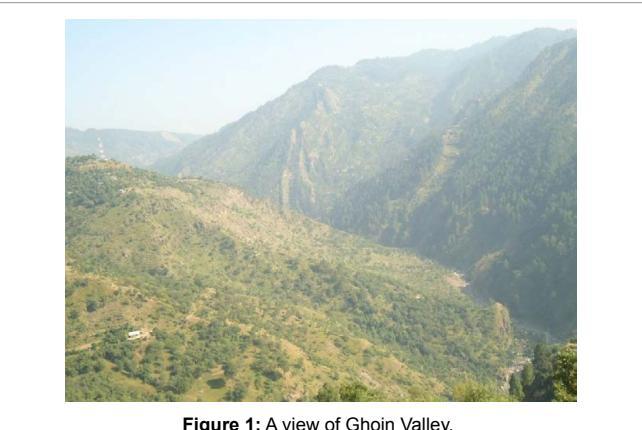
Figure 1: A view of Ghoin Valley.

Ghoin valley with the stream of the same name is one of the important valleys of the Poonch district, as it is one of the shortest routes from Rawalpindi to Rawalakot and other parts of Azad Kashmir. Ghoin stream has its origin at Dokhaddi near Rawalakot at a height of 975.meter from Jhelum river, and flowing about 35 kilometers from northeast to southwest drains into the Jhelum river at Azad Pattan. The mountain ranges are high, with an average height of about 3000 meter, and the highest points of Topa (2010 m), and Rehara (1559 m). The slopes of the mountains are very steep, with forest on the high slopes, while large parts of the lower slopes have been cleared of vegetation and occupied by the human settlements, where they practice agriculture and graze their sheep and goats. Marked and conspicuous terraces have developed in the bedrock as well as loose material, at different height, usually in the inaccessible parts, that can be observed with the help of binocular or telescope [2]. The steep slopes and terraces reveal that the valley has a highly complicated geomorphic history of its development during the Pleistocene period. Weak rock formation, steep slopes devoid of natural vegetation and plenty of water from monsoon rainfall and melting snow cover made the valley an ideal place for all the types of mass movements, which are often have hazardous to human life, property and infrastructure (Figure 1) [3].

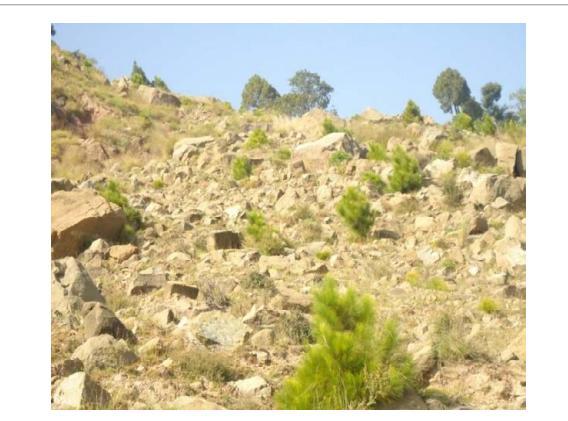
Figure 3: Debris of the Nariola-Androt slide, where huge boulders can be seen along with the fine material.

During the slide, hundreds of pine trees were destroyed, that further worsen the situation. The rock and debris were exposed to the precipitation, and during the monsoon season the processes of creep, slide and flow were noted to be more intensive as compared to dry season. During the survey of the area in October 2010, the sparse regrowth of the vegetation cover particularly pine trees, has began on the material. The area is known for fruit trees and crops. The fruit grown in the area include apple, apricot, plumps, pears, etc. where the crops included wheat and maize [10]. During the slide 32 kanal of fertile land with all the crops, washed away, while about 400 fruit trees were destroyed. About 200 meter long section of the road and a number of houses of the local people were fully or partially damaged. According to the effectees of nearby villages, the surveys of the damages were carried out by several government departments, and promises of the compensation were made, but no practical steps were taken in this regard (Figures 3-5).

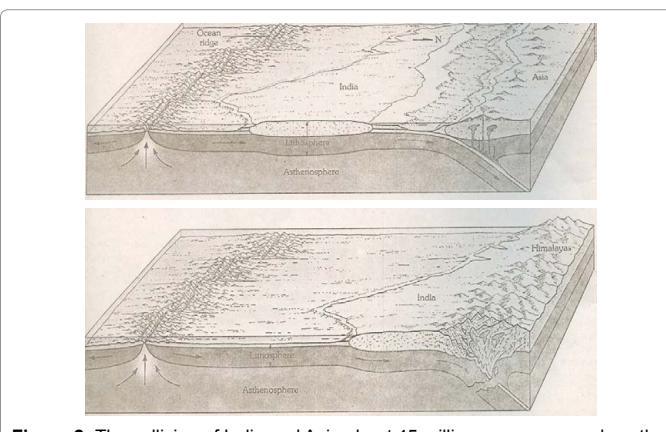
Figure 2: The collision of India and Asia about 45 million years ago produce the majestic Himalayas.

about 5 millimeter annually. This means that the Himalayas are still geologically active and structurally unstable. On the basis of geology and structure, the area of Poonch and Bagh districts falls into two broad zones, i.e. Central Himalaya Zone and Sub Himalaya Zone [5]. The northeastern part of district Bagh falls in the central Himalayas. The rock formation is directly in contact with Panjal Formations and is separated from oldest rocks by a thrust fault. Among the oldest rock units are included Salkhala formation, Dogra formation, Panjal volcanic series and Godwana formation. The younger rocks comprise Margala hill limestone, the Murree formation and the Siwalik (Figure 2).

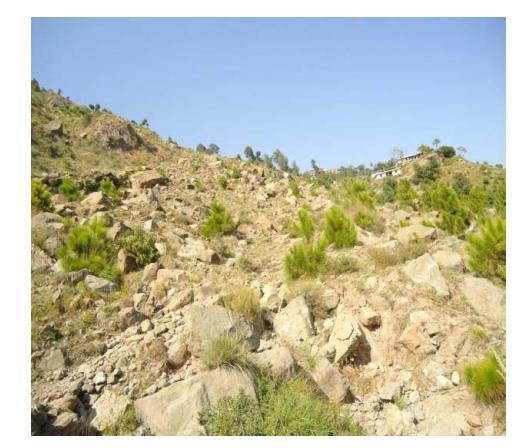
Figure 4: Debris of Nariola-Androt Slide, moved downslope.

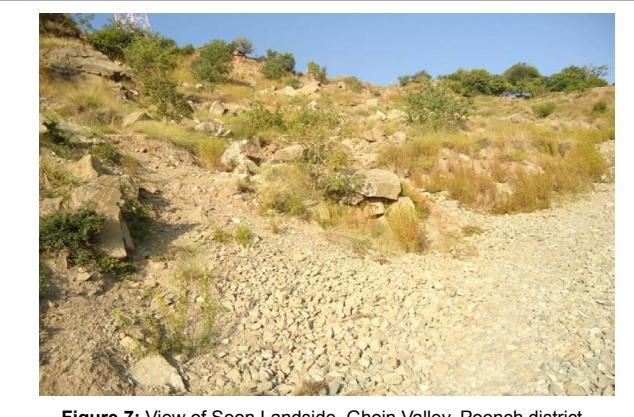
Figure 7: View of Soon Landside, Ghoin Valley, Poonch district.

Apart from the cutting of trees, another very important factor that triggered the mass-wasting processes is the construction of new roads or the widening of the already existing roads in the area. The newly constructed 35 kilometer long Azad Pattan-Rawalakot road in Ghoin valley, has initiated a phase of mass-wasting processes including landslide and accelerated soil erosion, in the valley. Along the road a number of sites were examined where the sliding, rockfall, debris fall etc. have taken place. They are particularly frequent in the monsoon period when Rawalpindi-Rawalakot road through Ghoin valley remains blocked for days, due to the sliding of the material. They not only damage the road, bridges and retaining walls, but the trees, agricultural land and houses are also destroyed. Following are the few selected sites where mass-wasting processes have occurred, along the road (Figures 6 and 7).
